**FIGURE B1a  
FLOODING AND DRAINAGE ISSUES  
IDENTIFIED FROM FEILD INSPECTION**

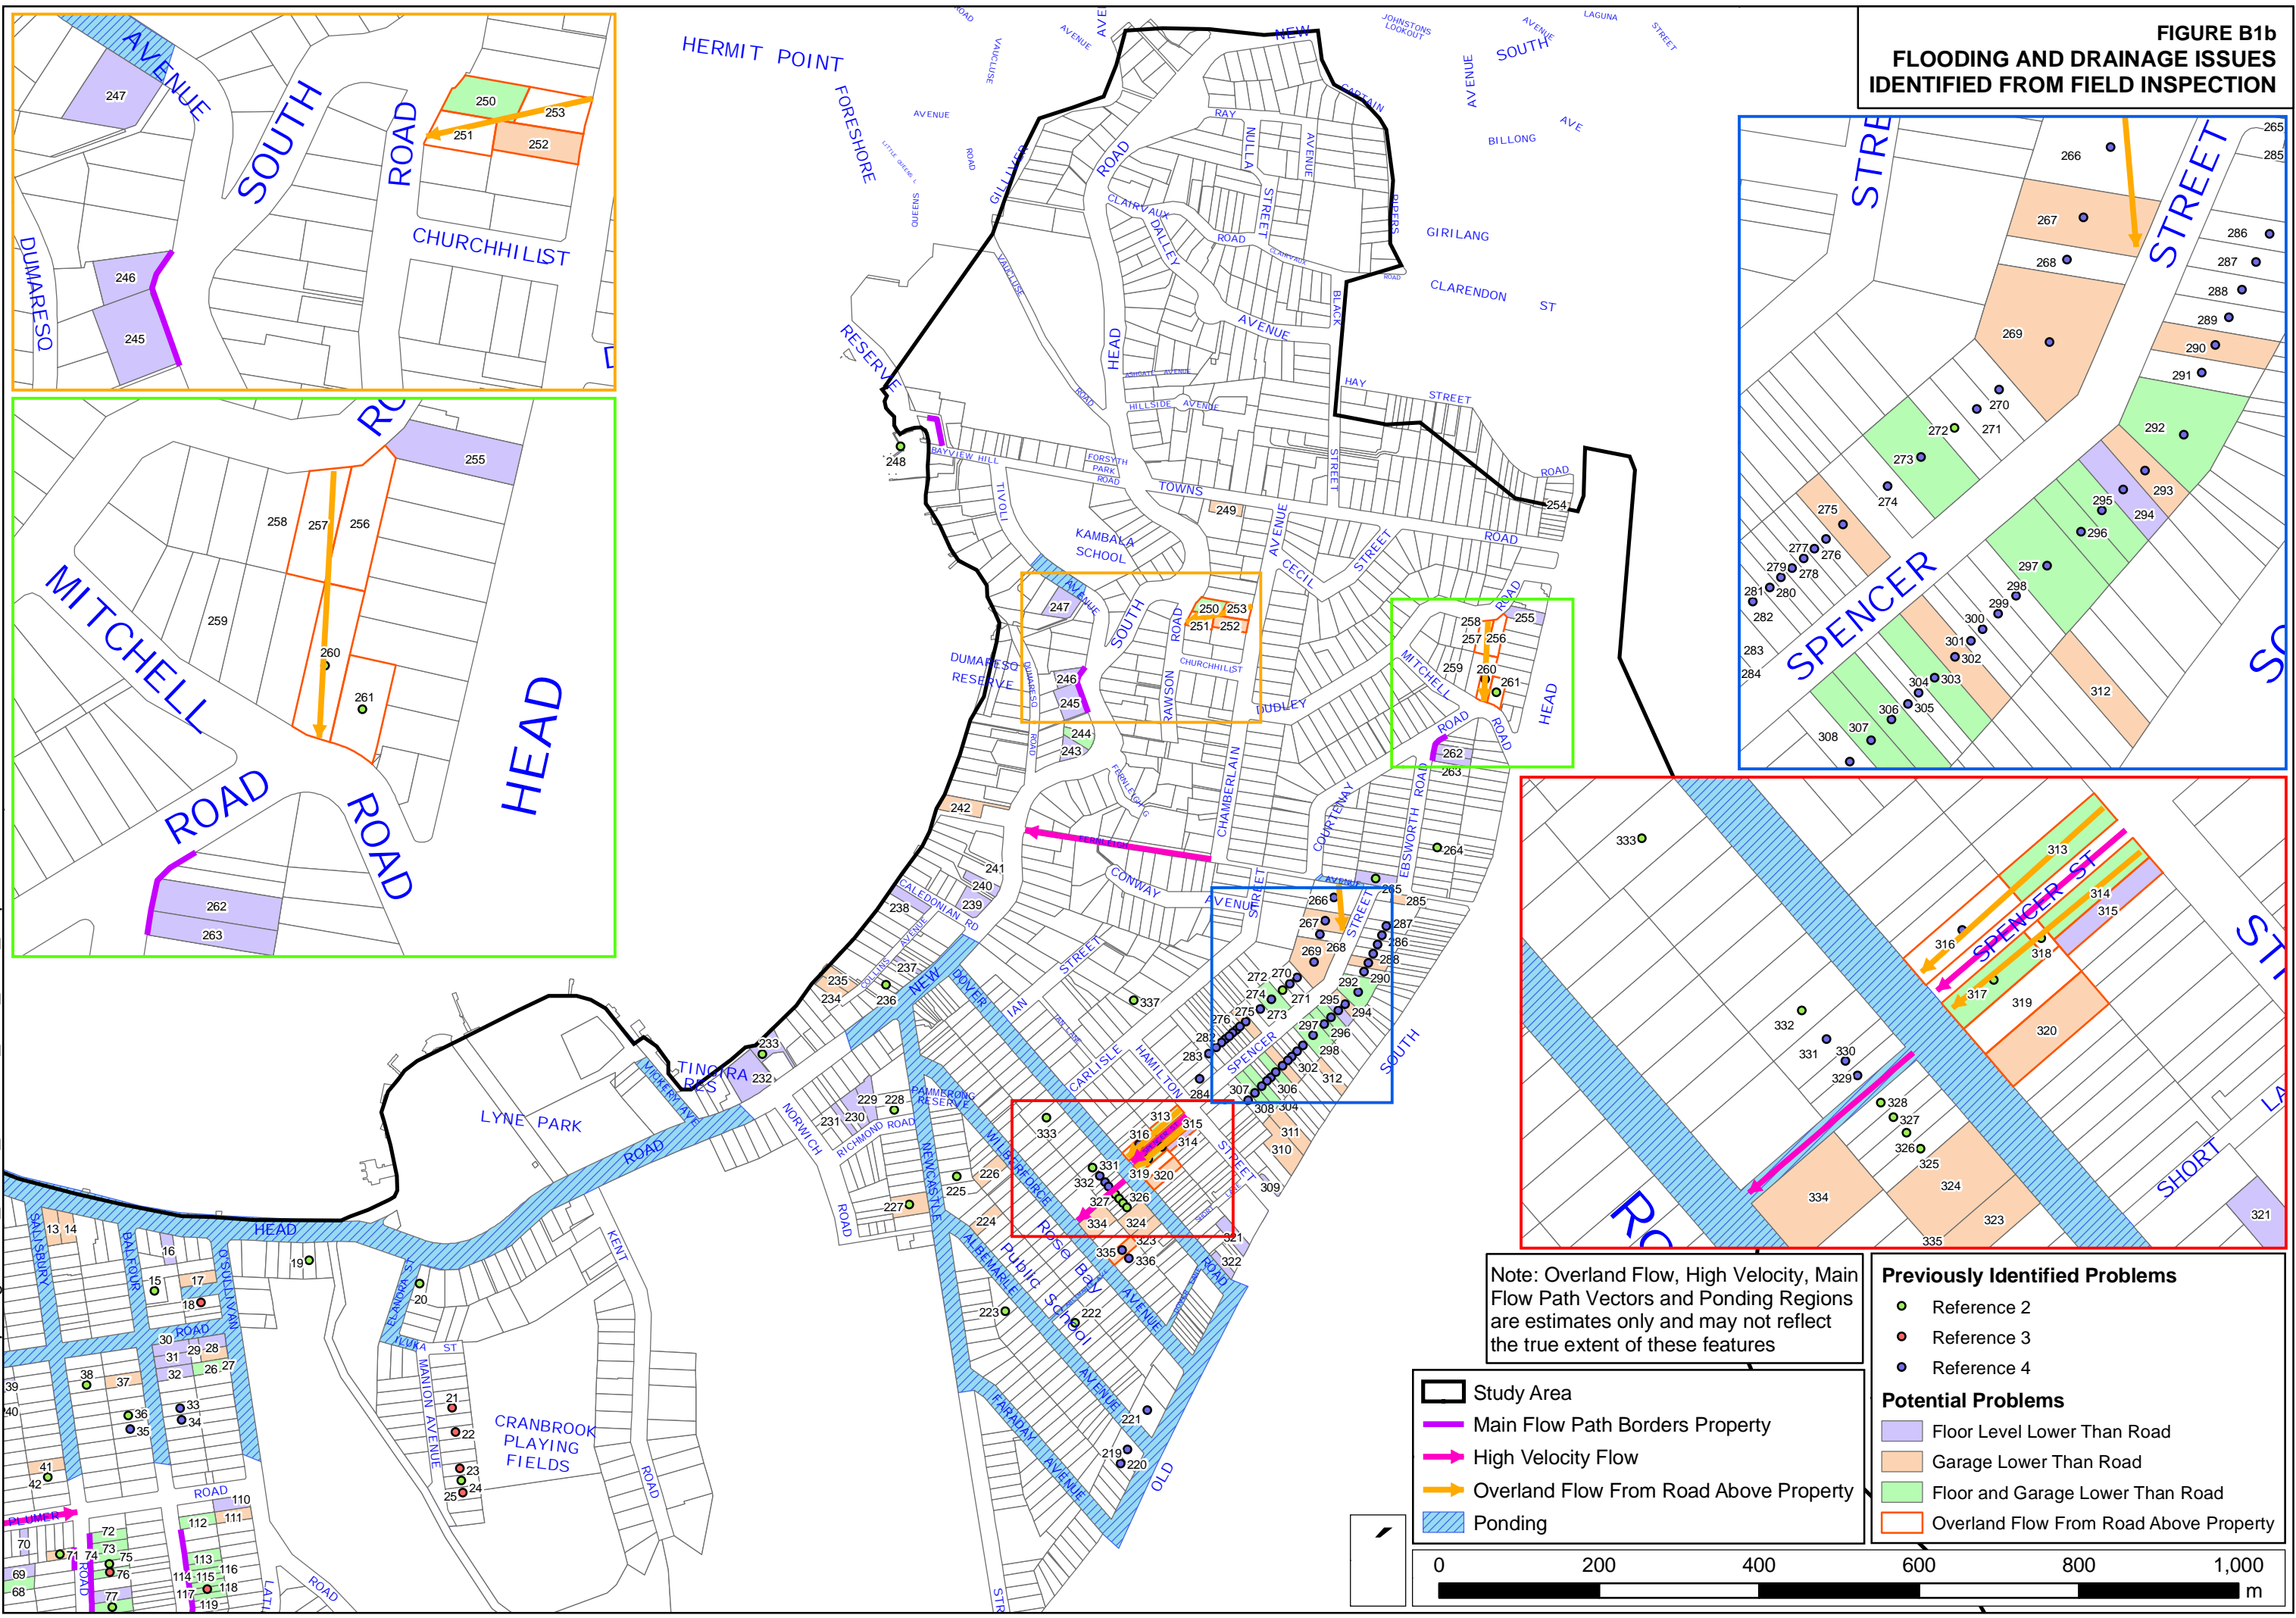
**FIGURE B1b  
FLOODING AND DRAINAGE ISSUES  
IDENTIFIED FROM FIELD INSPECTION**
