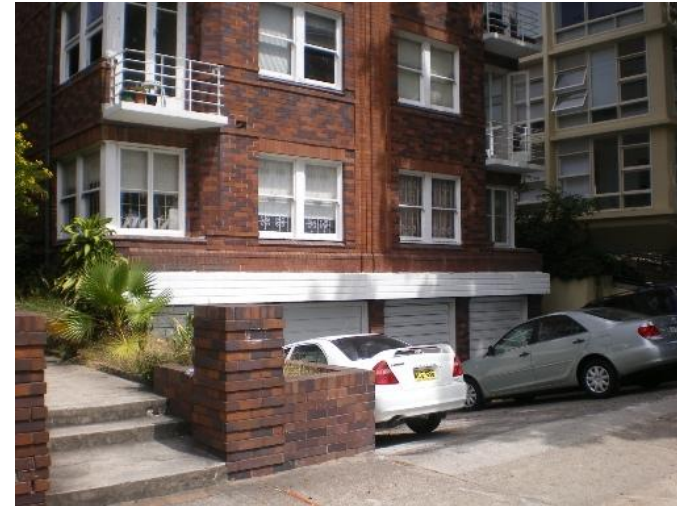
0. 7 Aston PL Problem identified by Reference 4, field trip results show: Floor below road, Ponding on street, Flooding due to overland flow from road above property

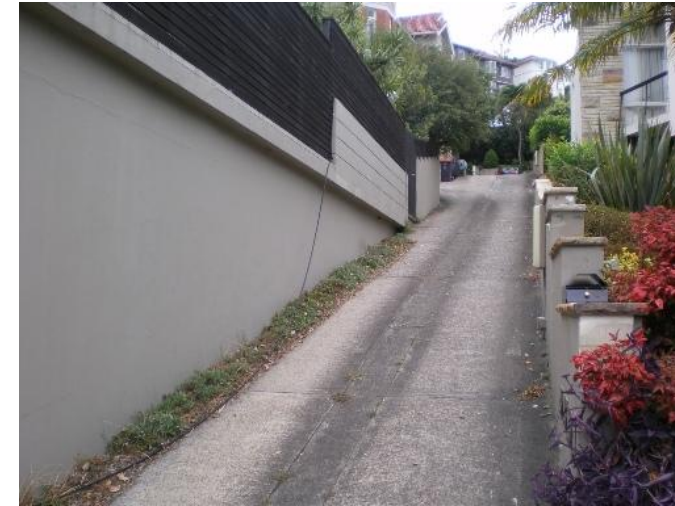
1. 595 New South Head Road Problem identified by Reference 2, field trip results show: Garage below road

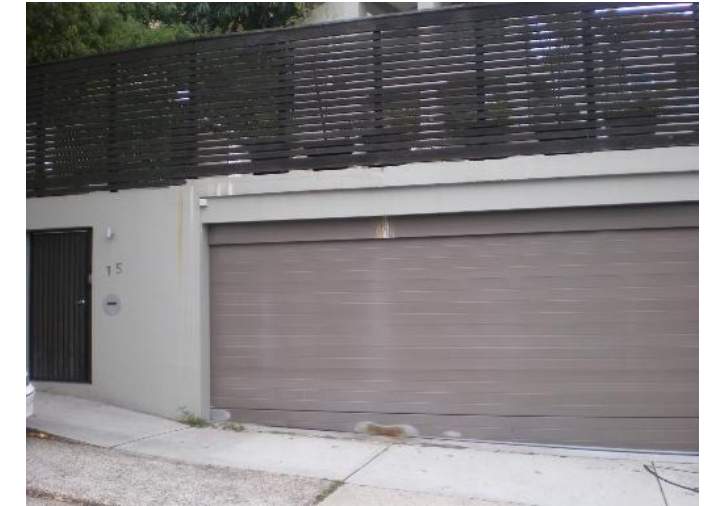
4. 13 Cranbrook Road Problem identified by Reference 4, field trip results show: Flooding due to overland flow from road above property

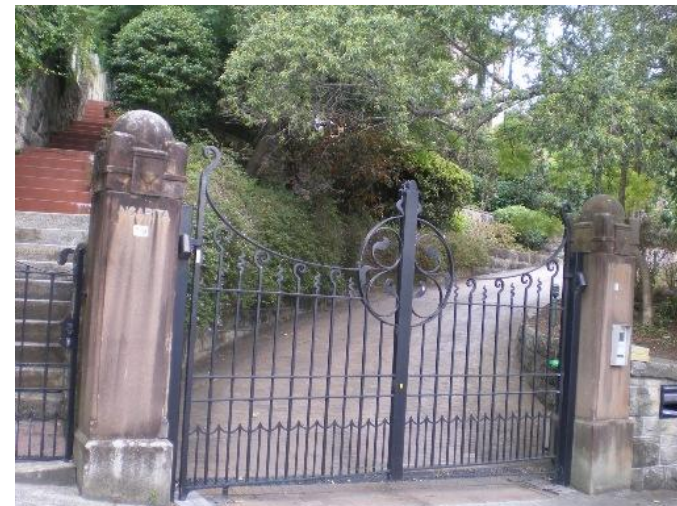
6. 9 Cranbrook Lane Problem identified by Reference 4, field trip results show: Floor below road, Garage below road, Main flow channel bordering residence, Ponding on street, Flooding due to overland flow from road above property

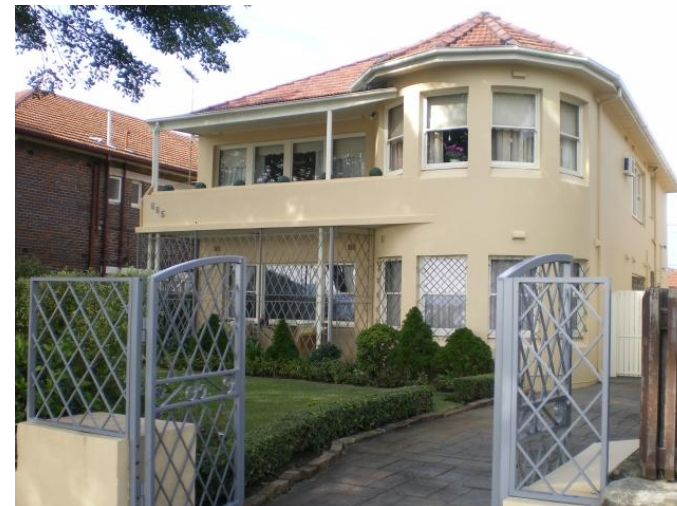
18. 63 O'Sullivan Road Problem identified by Reference 3, field trip results show: Street flooding reported

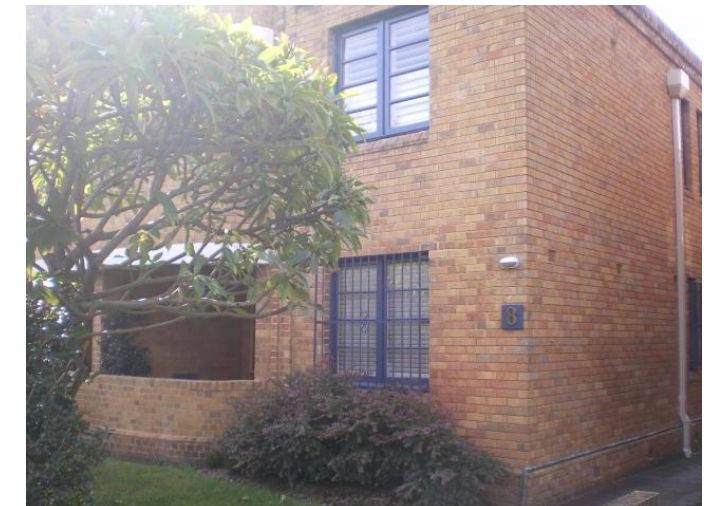
20. 673 New South Head Road Problem identified by Reference 2, field trip results show: Very high flow and water level in nearby channel

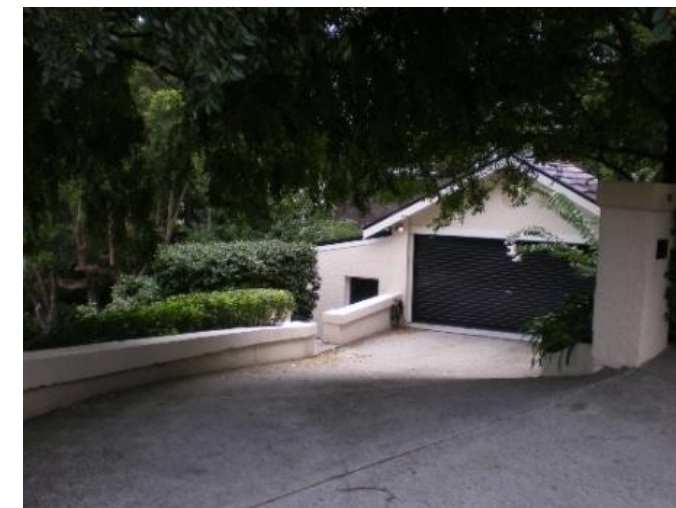
47. 2 Beresford Crescent Problem identified by Reference 4, field trip results show: Floor below road, Garage below road, Ponding on street

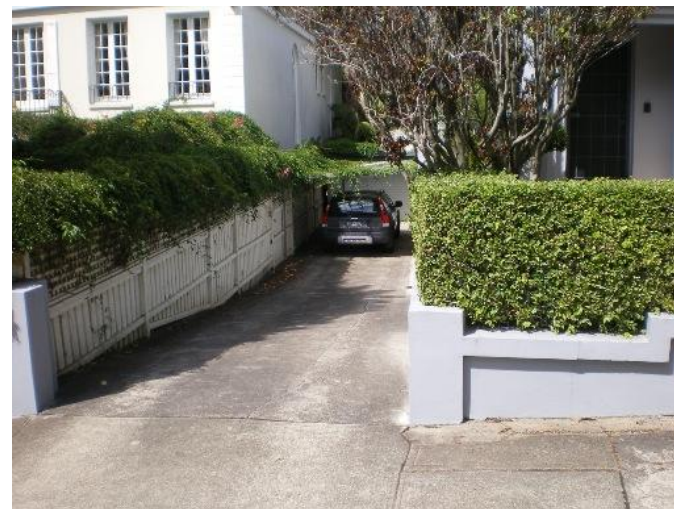
76. 60 Salisbury Road Problem identified by Reference 3, field trip results show: Floor below road, Garage below road, Main flow channel bordering residence

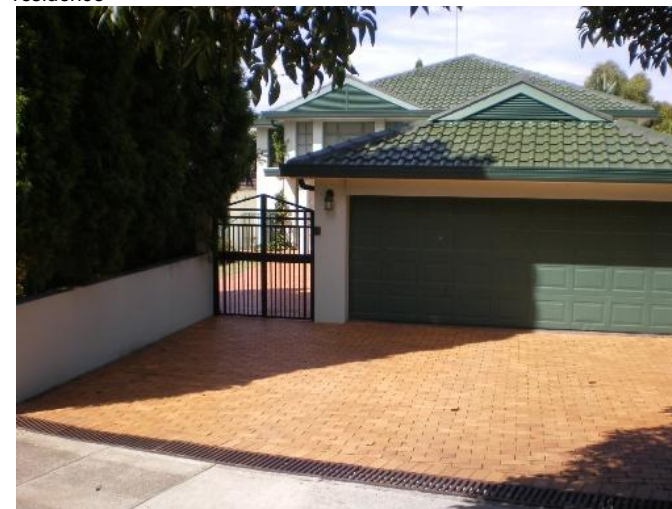
78. 68 Salisbury Road Problem identified by Reference 2, field trip results show: Floor below road, Garage below road, Main flow channel bordering residence,

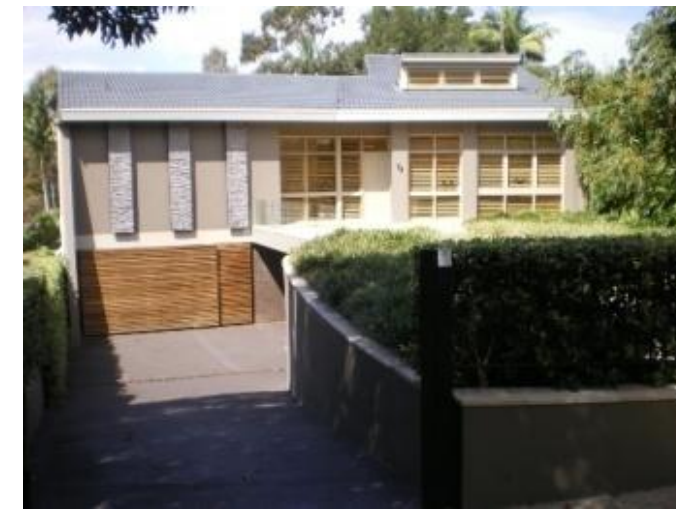
80. 72 Salisbury Road Problem identified by Reference 2, field trip results show: Floor below road, Garage below road, Main flow channel bordering residence

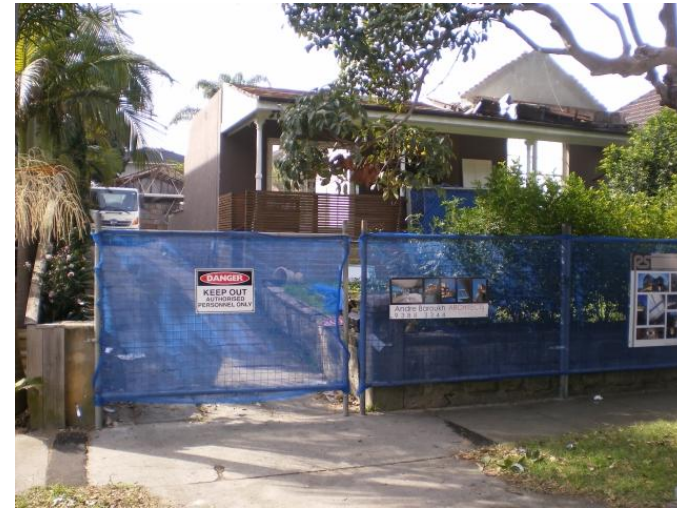
335. 56 Wilberforce Avenue Problem identified by Reference 4, field trip results show: Garage below road, Flooding due to overland flow from road above property
