**FLOODING/DRAINAGE ISSUES IDENTIFIED FROM FIELD INSPECTION**

FIGURE B2  
LISTING OF FLOODING/DRAINAGE ISSUES

FIGURE B3a  
**REPORTED ISSUES BUT NOT INCLUDED IN FIELD INSPECTION**

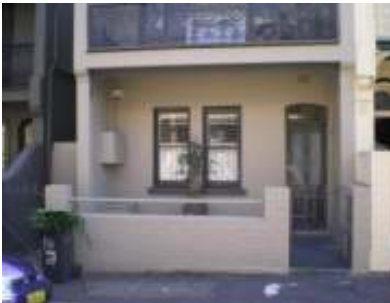
**133 Windsor St** Above floor flooding due to local drainage problem

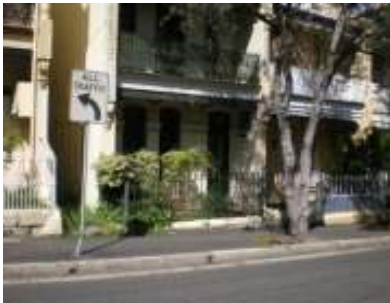
**121 Underwood St** Rising groundwater causes inundation of the basement during major storm events.

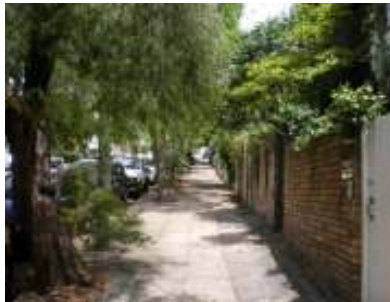
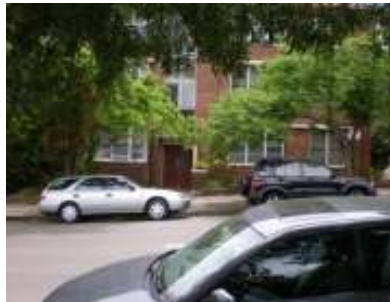
**Goodhope St** Flows to a depth of 0.15m on footpath reported. According to model no flow, but possibly up to 10m<sup>3</sup>/s.

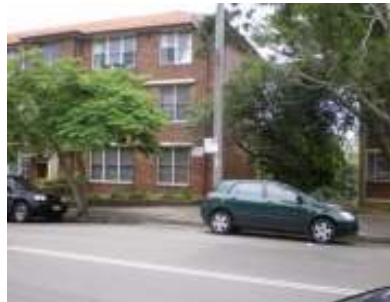
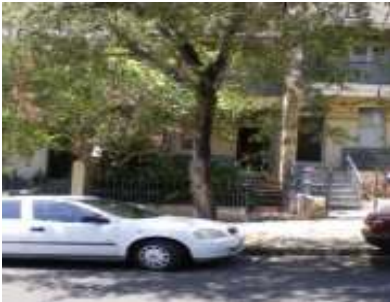
**29 Lawson St** Above floor level inundation reported, but no potential flows causing it could be found.

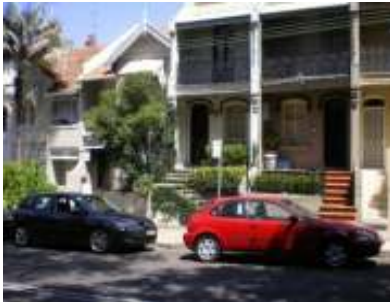
**311 Glenmore Rd** Groundwater seepage due to storm events.

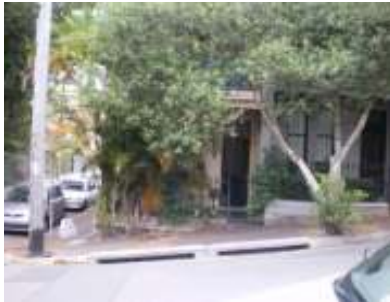
**440 and 450 Glenmore Rd** Above floor flooding reported, but no clear reason found.

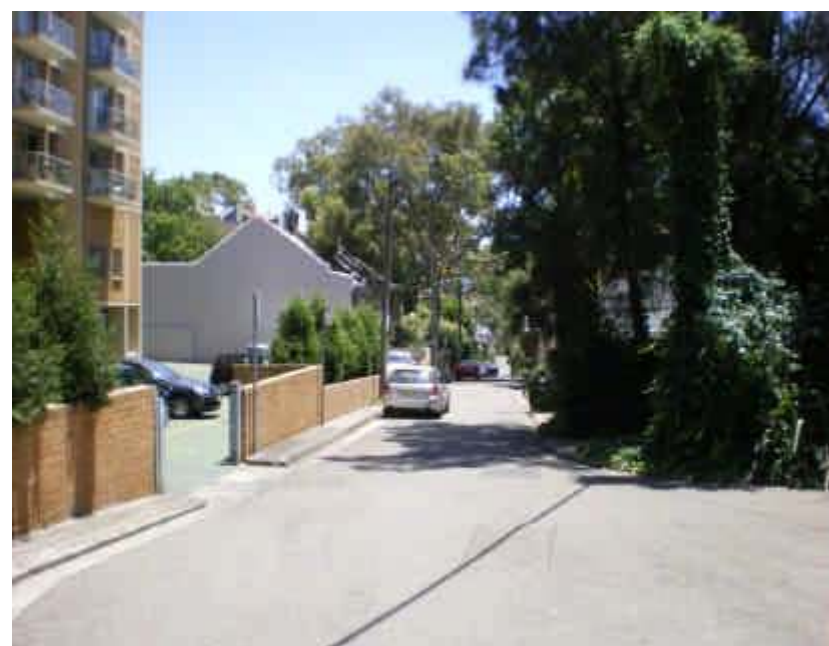
21. **Ponding & Ground Floor Inundation** Possibly property inundation, but the building is being refurbished

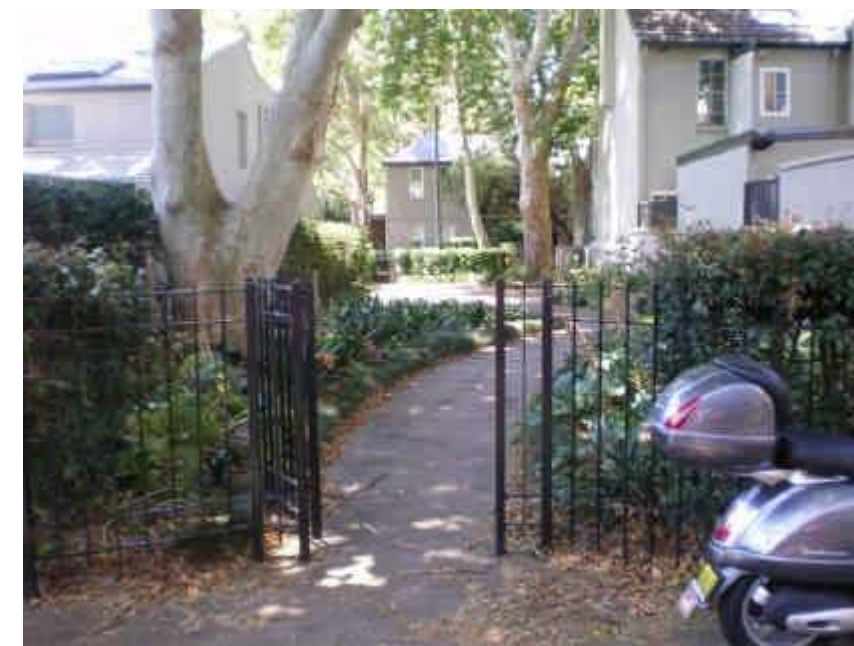
23. **Ground floor Inundation** Example of property at risk at Sutherland Ave

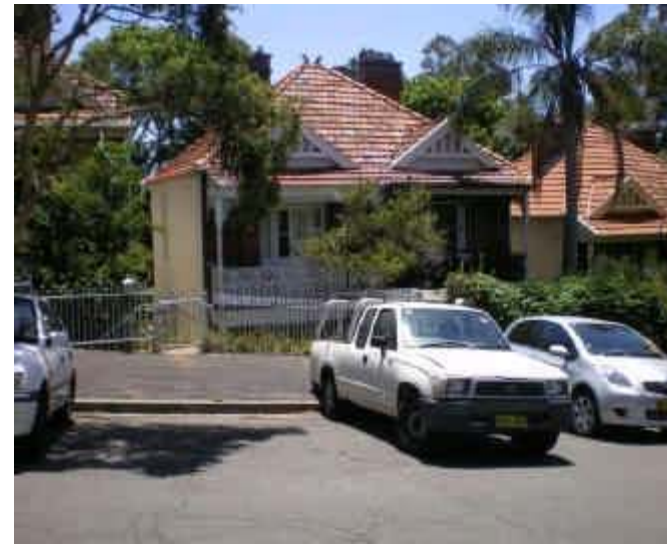
25 & 26. **Floor Below Road** Examples of several properties on Sutherland Avenue with floors lower than the road

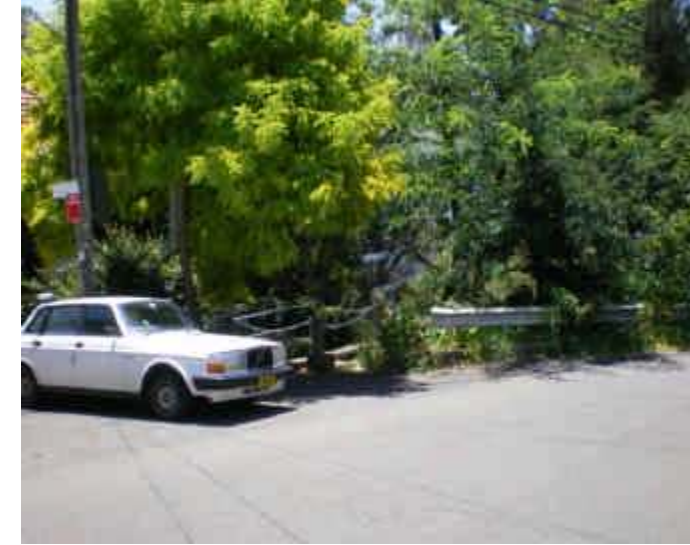
27. **Floor Below Road** Example of property on the north eastern end of Elizabeth St potentially inundated

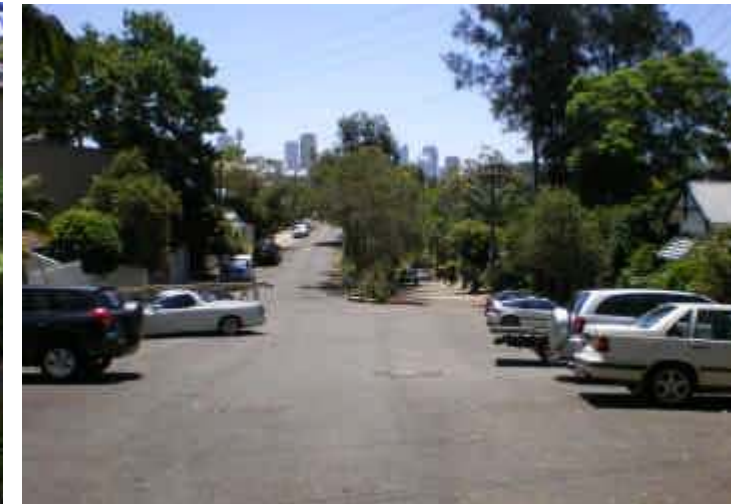
31. **Flow Diversion** Continued flow path

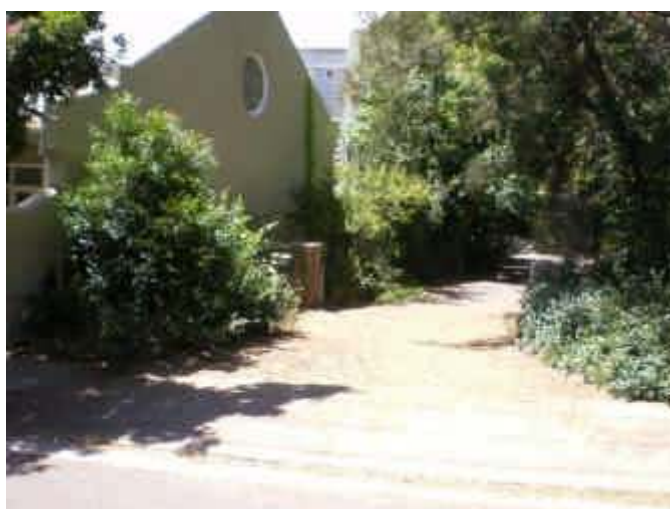
32. **Flow Diversion** Lower part of Harris Street

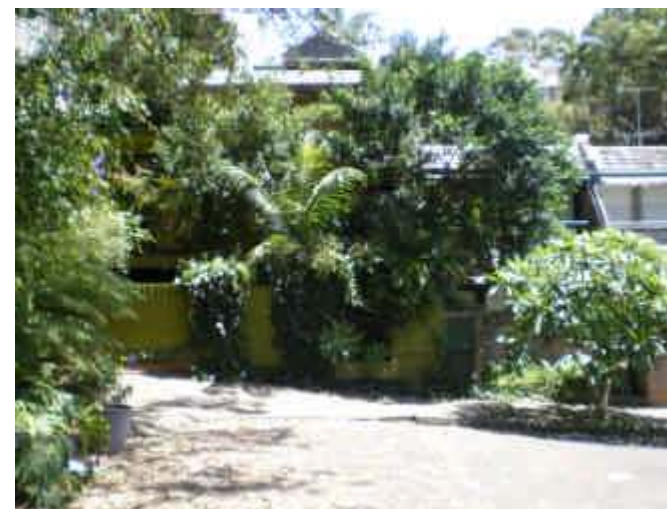
34. **No Flow Path** Ponding and possibly floor inundation (see 116 for close up)

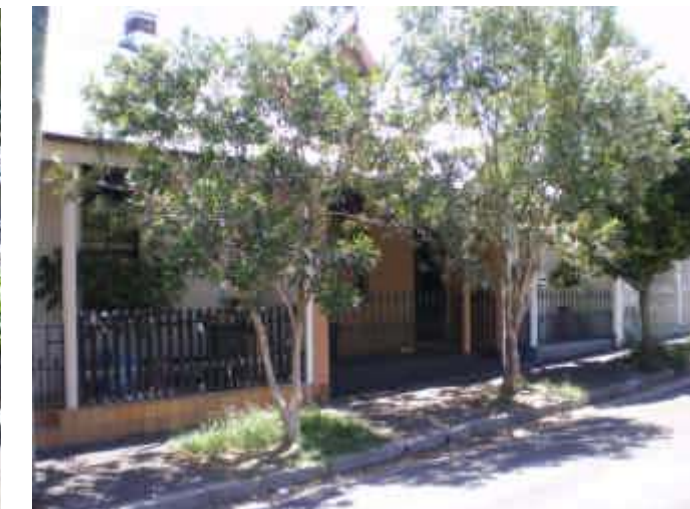
35. **Ground Floor Inundation or Floor Below Road** Properties with above floor level inundation recorded. Most likely flow from rear end where Sutherland Ave lies above floor level.

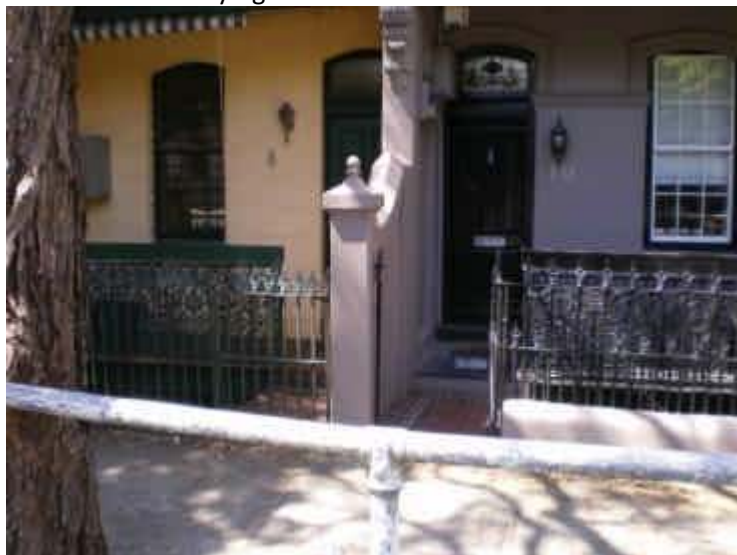
40. **Ponding** Low point in Hargrave St.

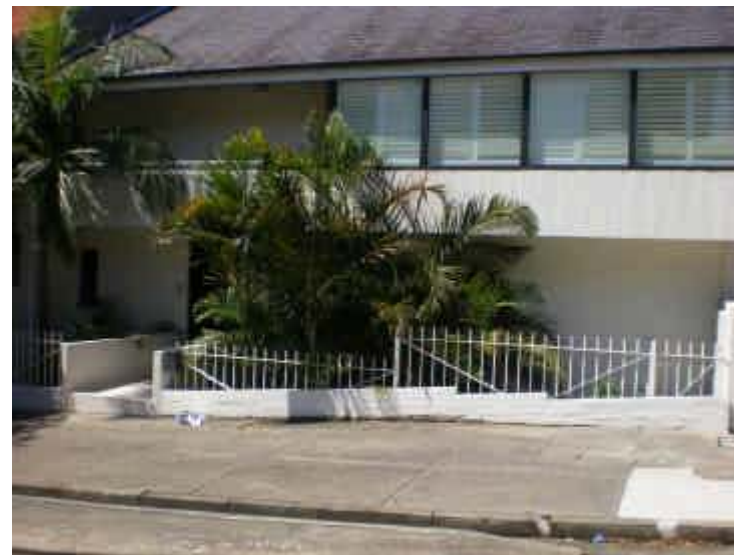
42. **Ground Floor Inundation** Possibly floor inundation due to large flow on Hargrave St (5-10 m<sup>3</sup>/s).

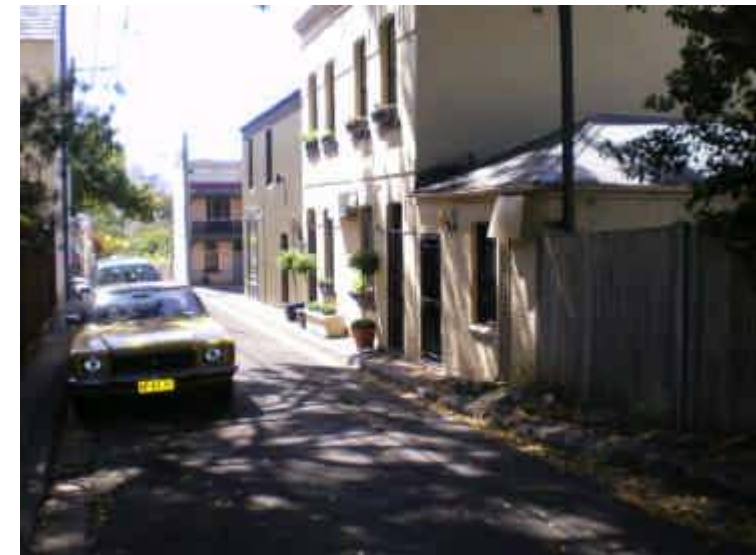
43. **Floor Below Road** One of several properties along Hargrave St with floor levels below road level.

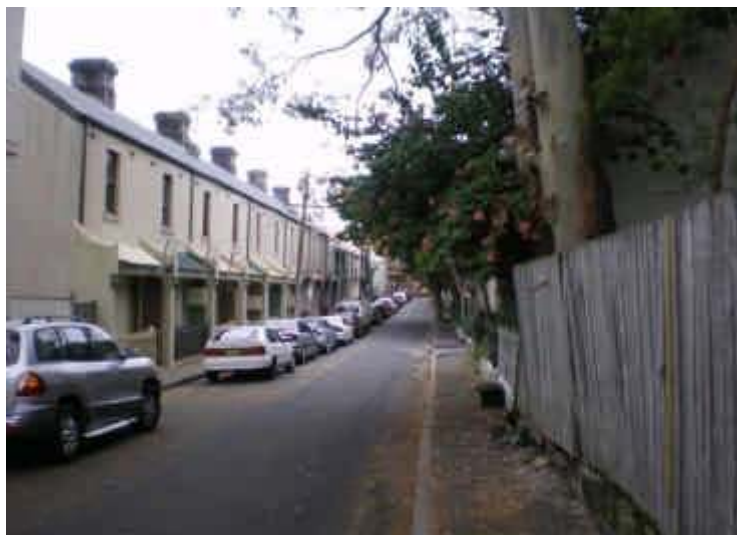
44. **Ponding & Ground Floor Inundation** Low point in road; possibly ponding and inundation above floor level.

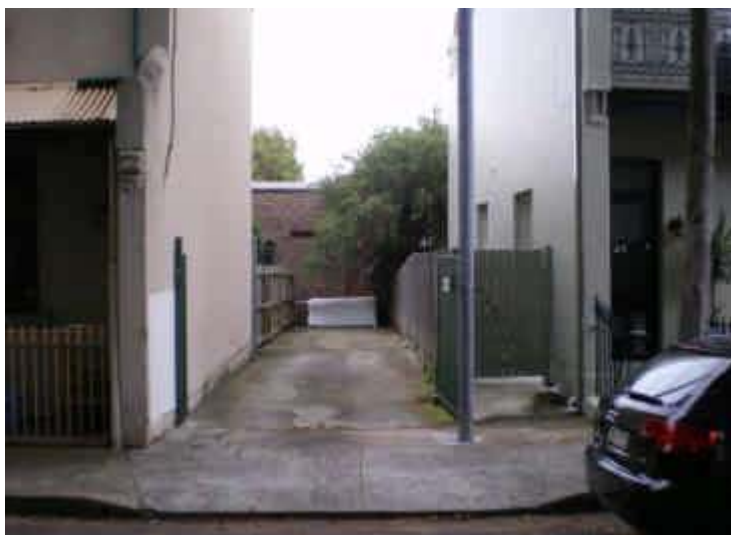
45. **Ponding & Ground Floor Inundation** Low point in George St; possibly ponding and inundation above floor level.

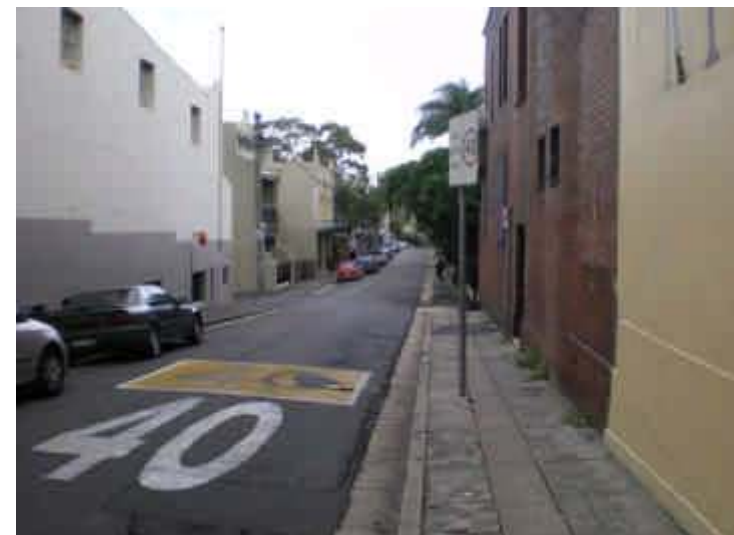
46. **No Flow Path/Ponding** Drive way off George St.

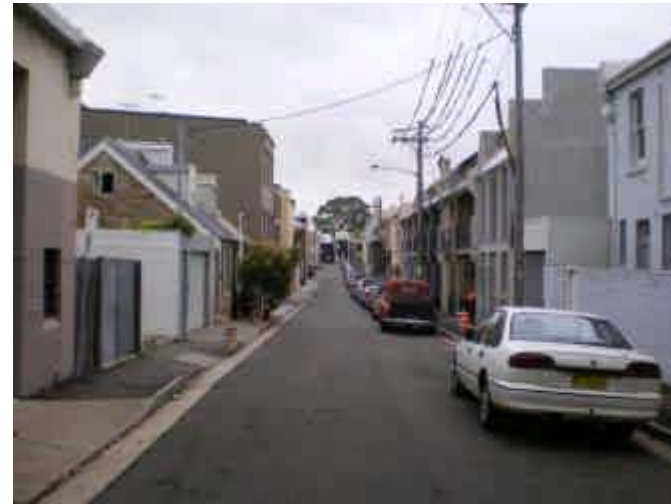
49. **Ground Floor Inundation** Example of house at risk of being inundated.

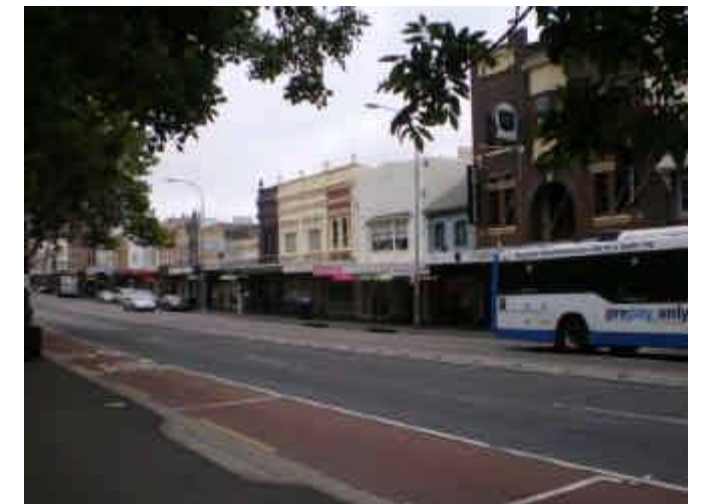
51. **Ground Floor Inundation** Example of house at risk of being inundated.

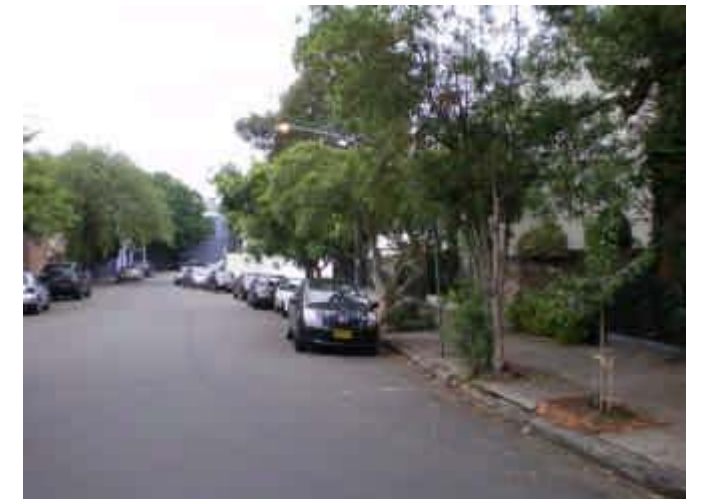
55. **Floor Below Road** Example of properties at risk of being inundated.

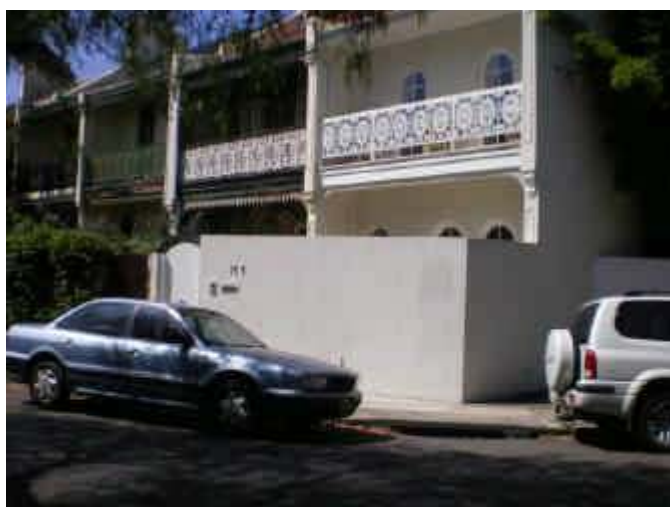
56. **Ponding & Ground Floor Inundation** Paddington St (see 57).

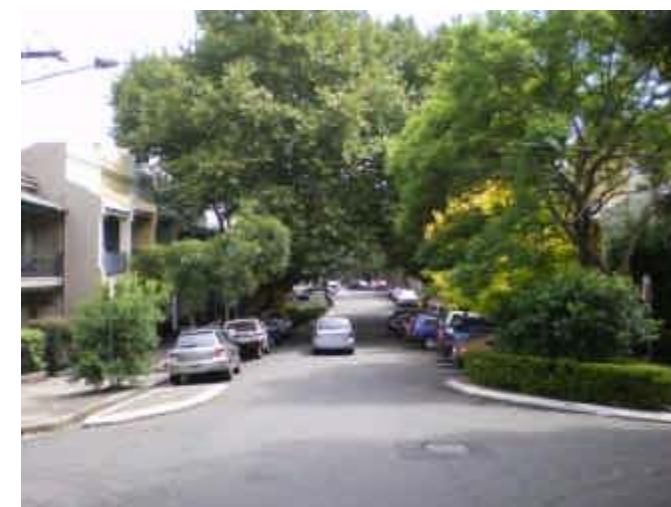
57. **Flow Diversion** Previous reports state water reached a level 0.15 m below the floor at No. 21. The protective walls at both No 21 and 19 could increase problems at adjacent properties.

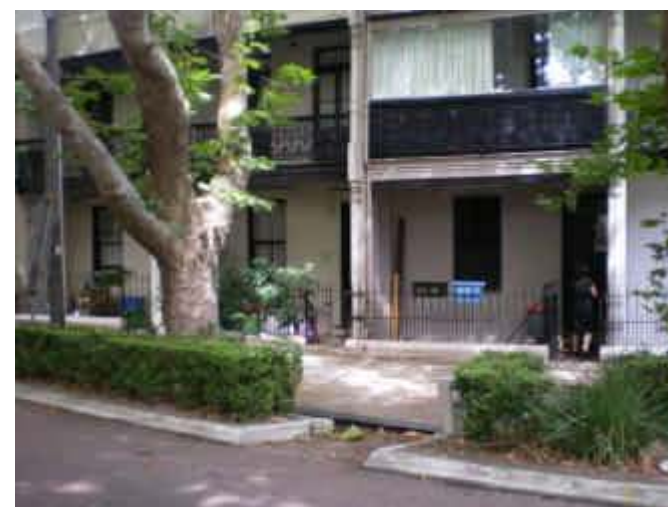
58. **Ponding** Low point in Hopewell St(see 59).

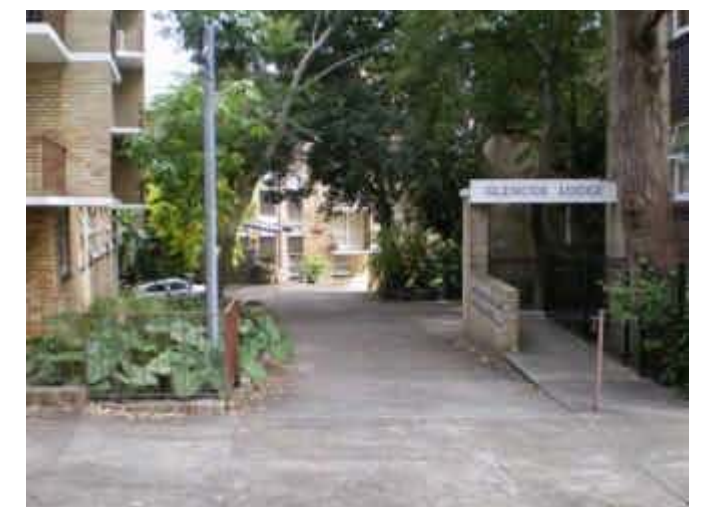
59. **Floor Below Road** Example of properties at risk of being inundated.

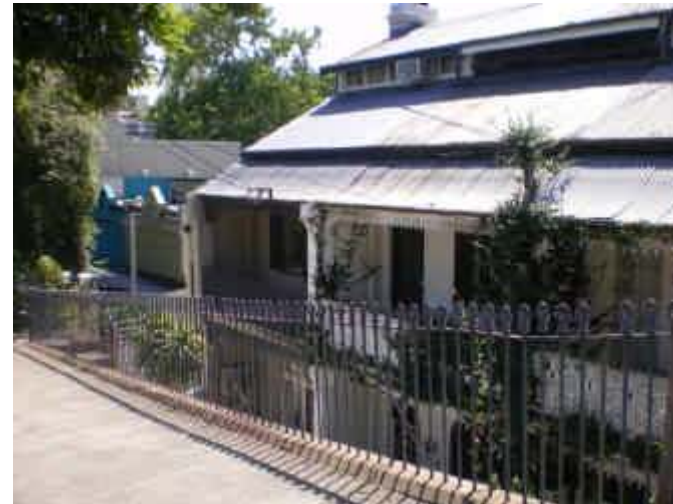
85. **Ponding** Hargrave Ln low point.

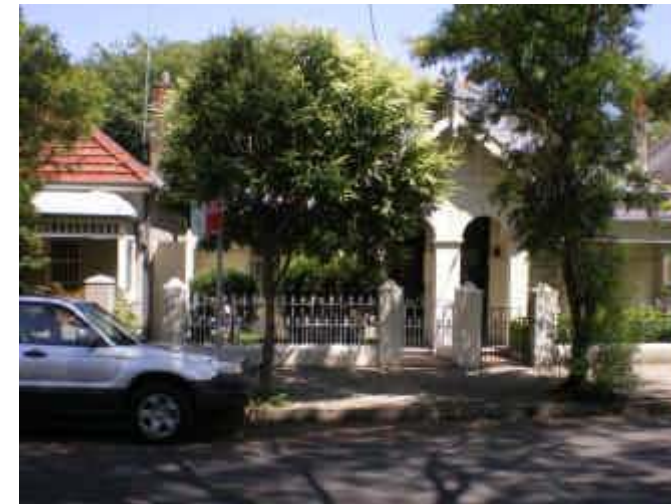
86. **Floor Below Road** Example of property on Cascade St at risk of being inundated.

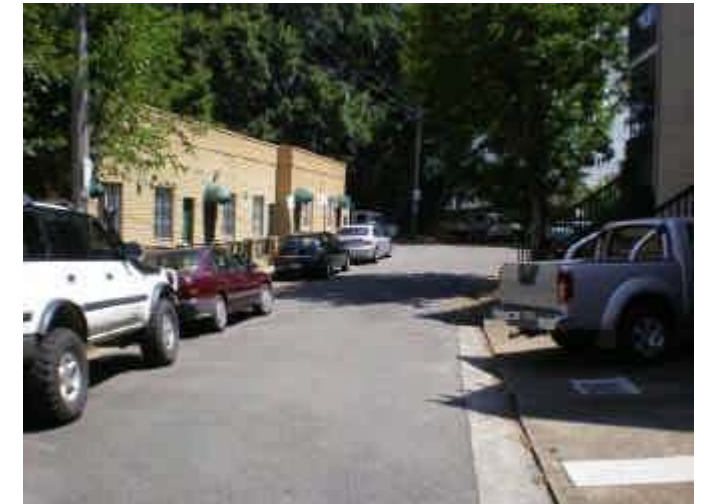
87. **Ground Floor Inundation** Properties on Glenmore Rd (close to culvert) at risk of being inundated.

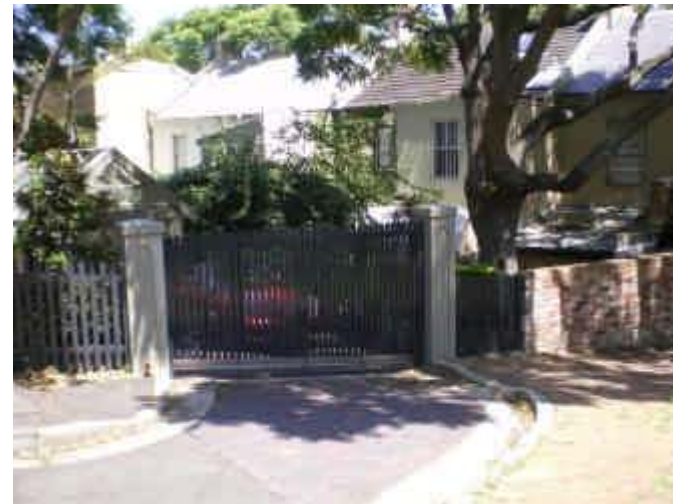
89. **Garage Below Road** Aldi car park/loading area at risk of being flooded

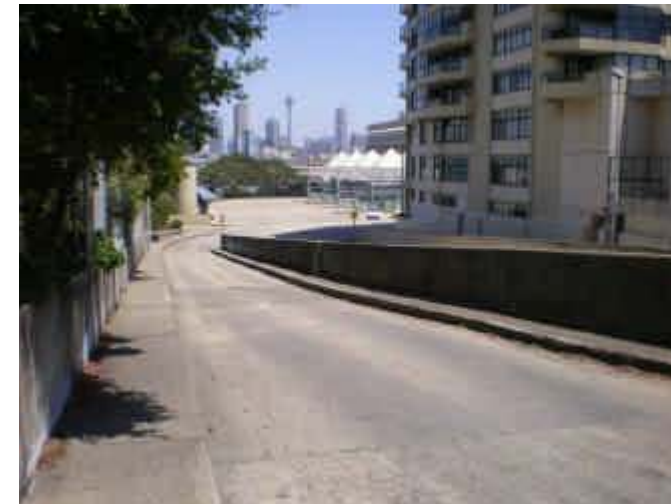
90. **Ground Floor Inundation** Property on Great Thorne St at risk of being inundated.

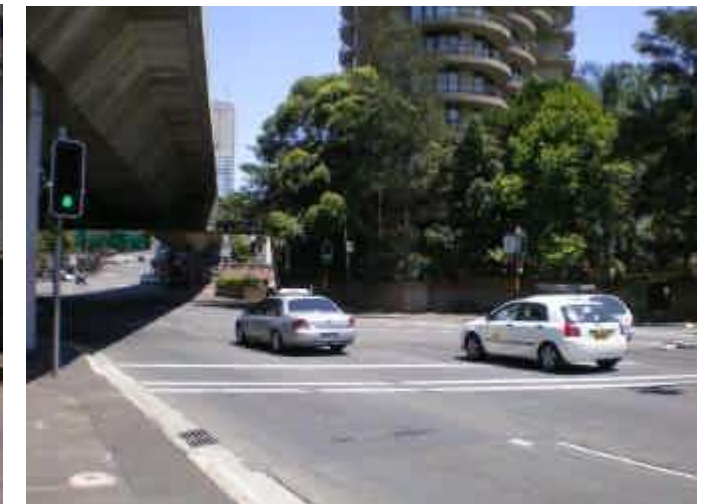
91. **Other** Edgecliff Station bus area at risk of being flooded by waters flowing down the ramps

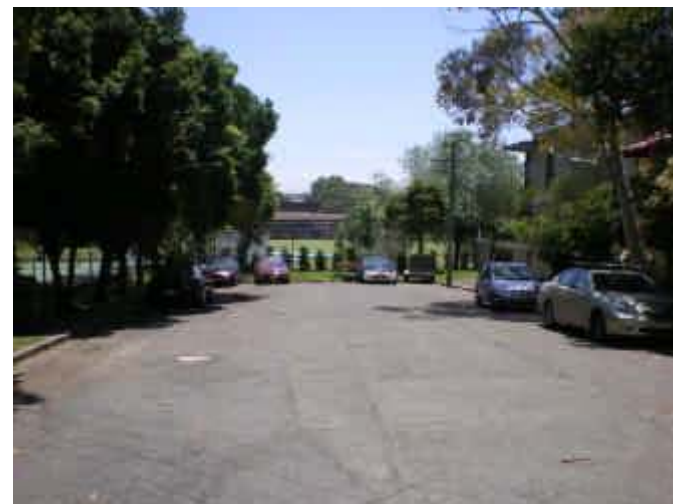
93. **Flow Diversion** Water could enter to the sportsground from Nield Ave

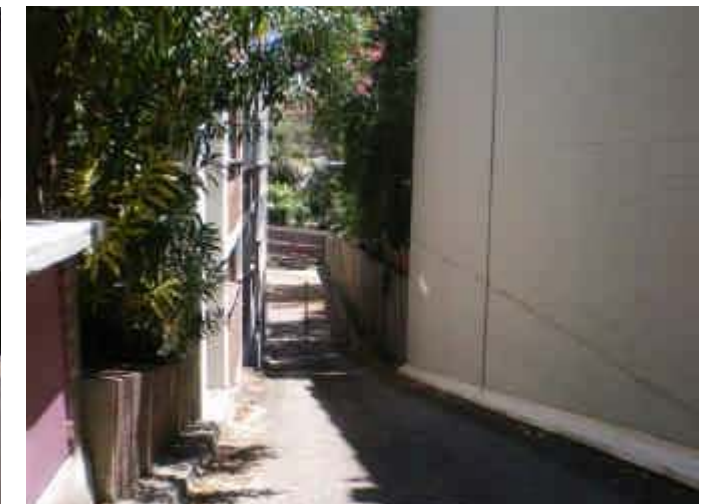
95. **Ponding** Potentially flow from Alma St will pond at the end and inundate the sportsground and the tennis club parking space.

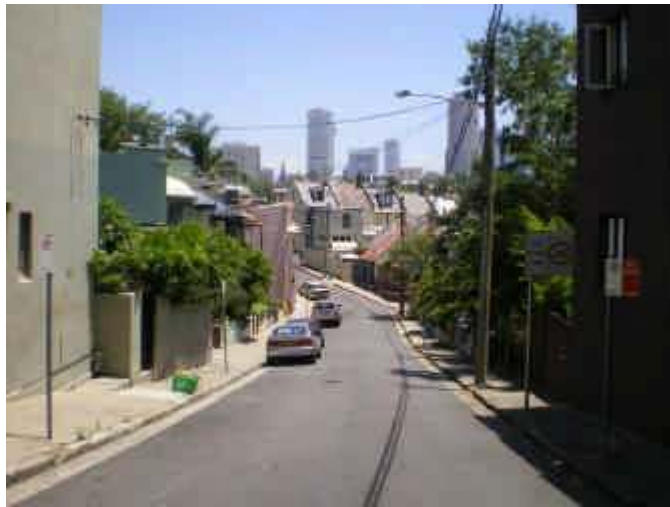
96. **Other** Property on Glenmore Rd at risk of being inundated, possibly garage.

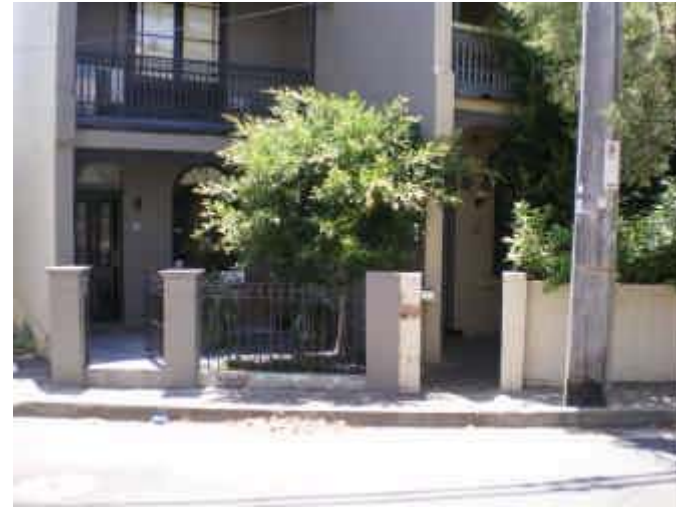
97. **Ponding & Ground Floor Inundation** Ponding at a low point in Hoddle St and possibly inundation above floor level(see 98)

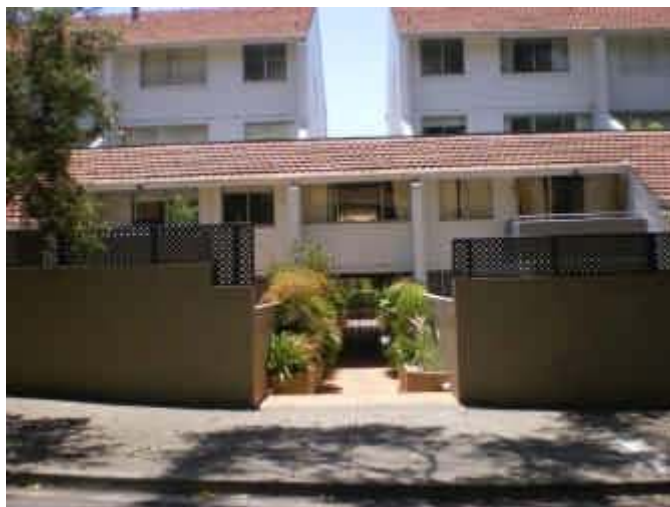
100. **Floor Below Road** Property on Glenmore Rd at risk of being inundated.

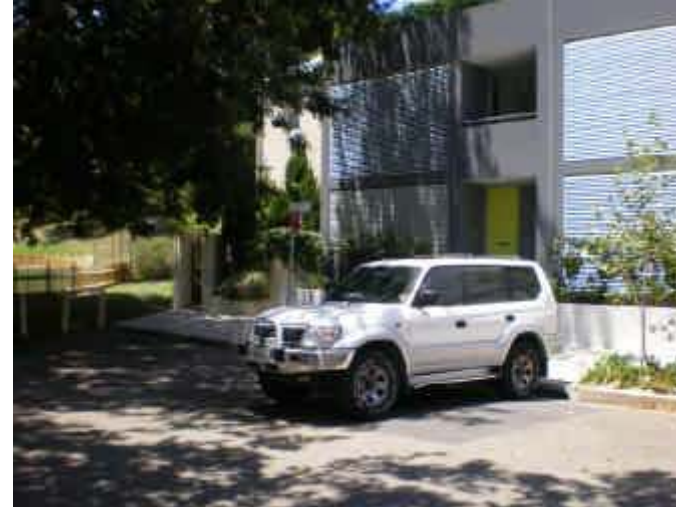
101. **Other** Rear of property at risk of being flooded.

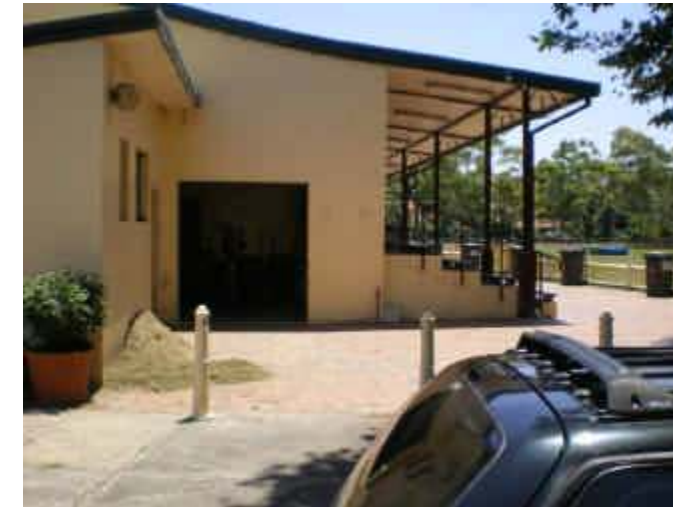
102. **Ponding & Ground Floor Inundation** Ponding at the end of Royston St and inundation above floor level

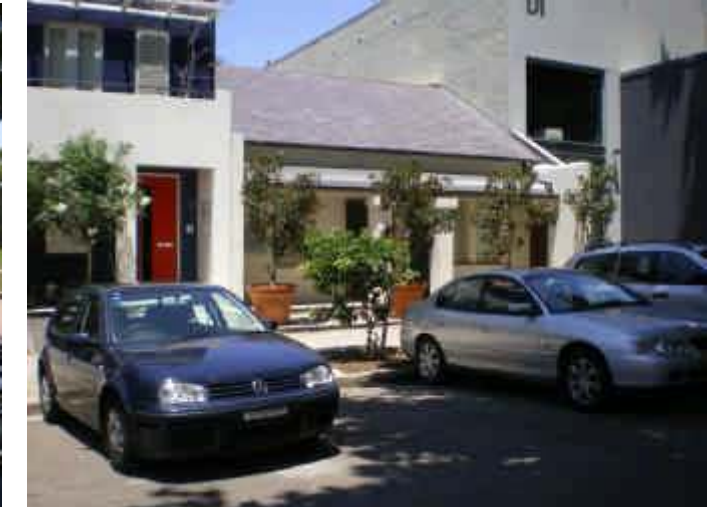
103. **Ponding & Ground Floor Inundation** Ponding at the end of Royston St and inundation above floor level

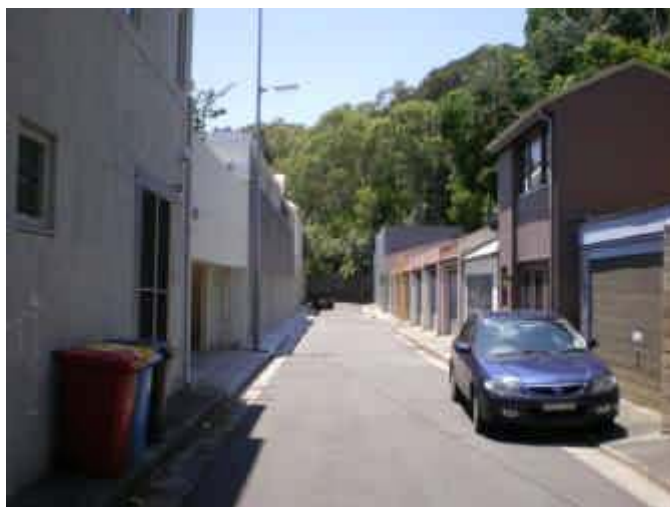
104. **Ground Floor Inundation** Example of properties on Royston Ave at risk of inundation.

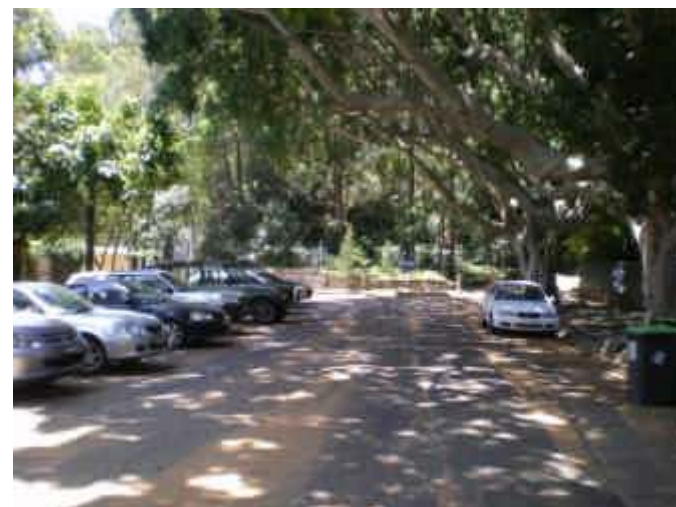
105. **No Flow Path** Dead end on Cecil Ln likely to cause ponding and flooding of garages.

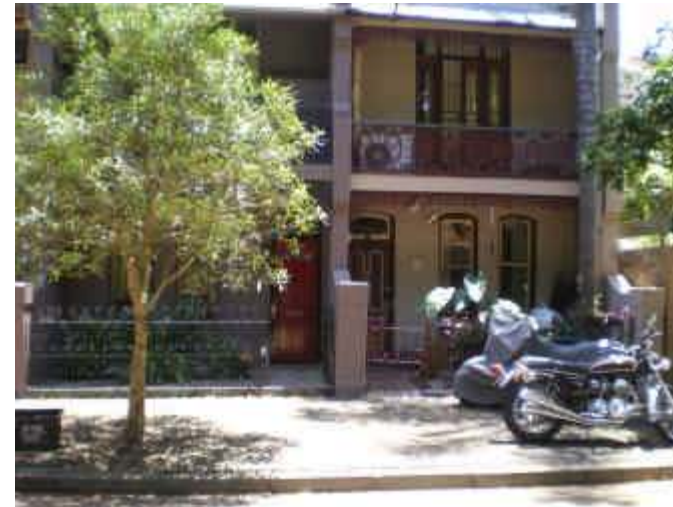
106. **No Flow Path** Ponding at the end of Cecil St and inundation above floor level

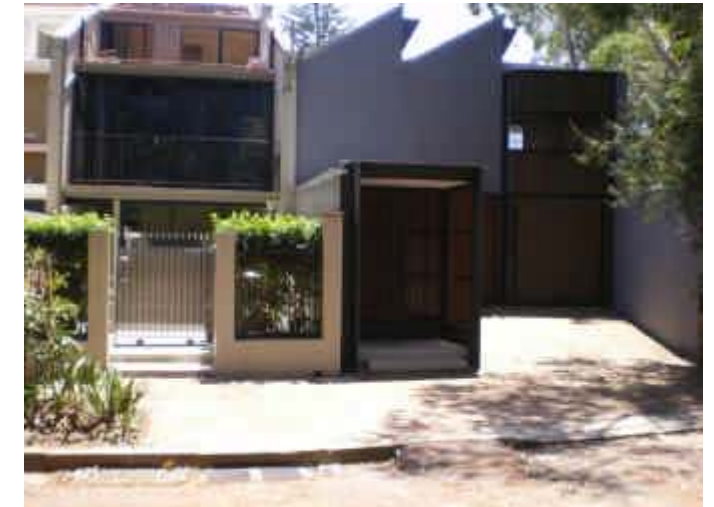
107. **Ground Floor Inundation** Example of properties on Cecil St at risk of inundation.

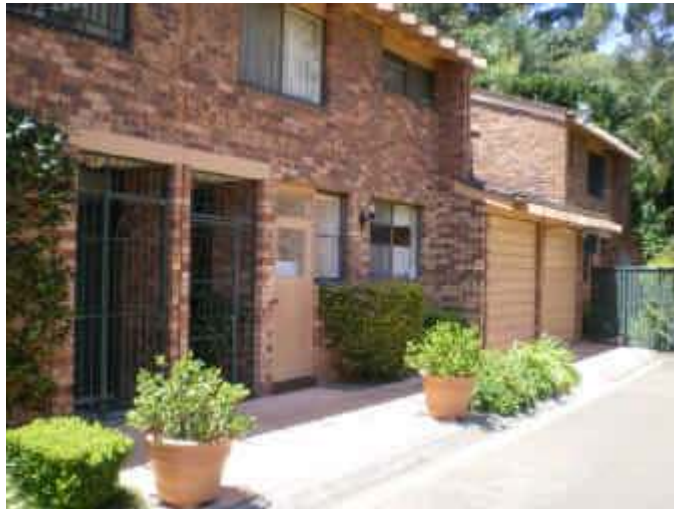
108. **Ground Floor Inundation** Example of properties on Cecil St at risk of inundation.

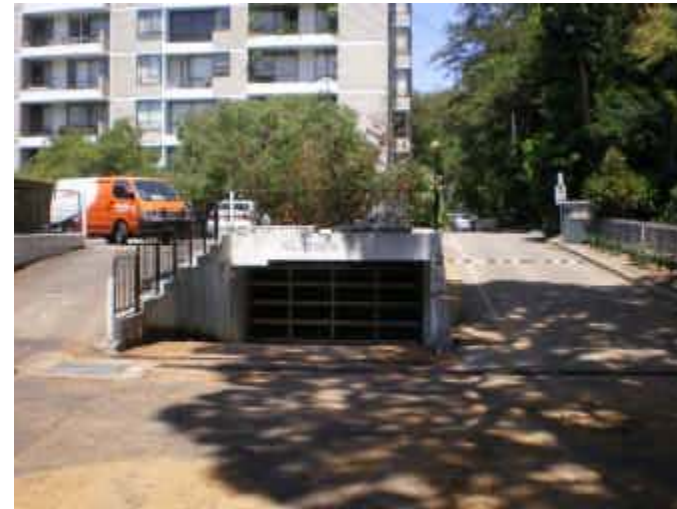
109. **Ground Floor Inundation** 14/17-23 Cecil St  
Example of properties at risk of inundation

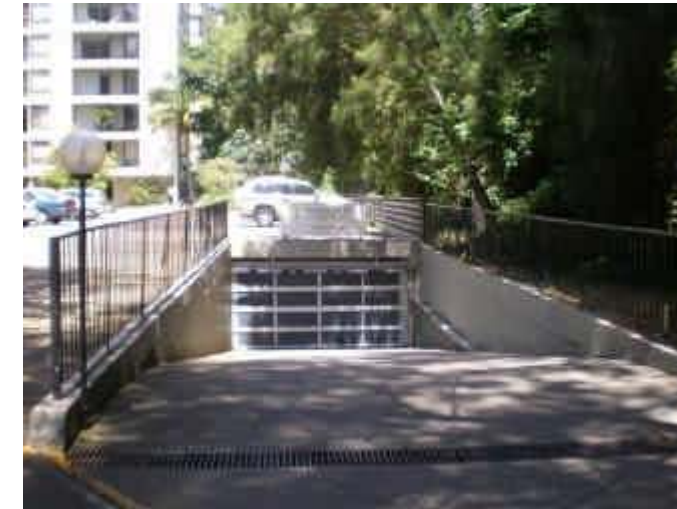
110. **Garage Below Road** Garage on Hampden Street at risk of being inundated.

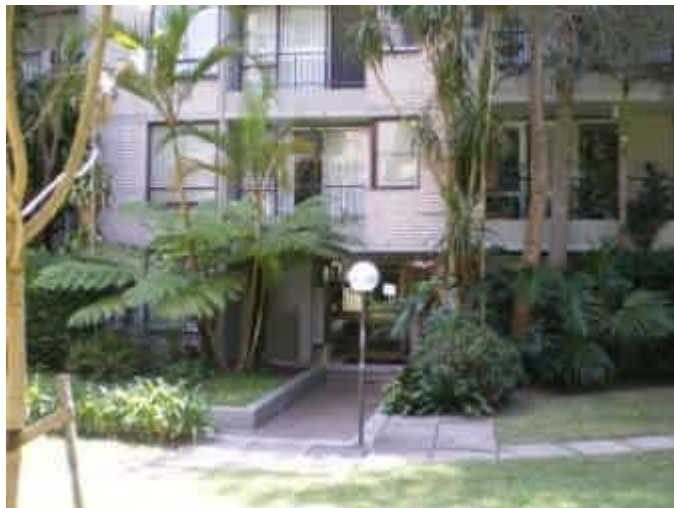
112. **Flow Diversion** Possible flow path from Harris St to Hampden St. (Continuation from 33)

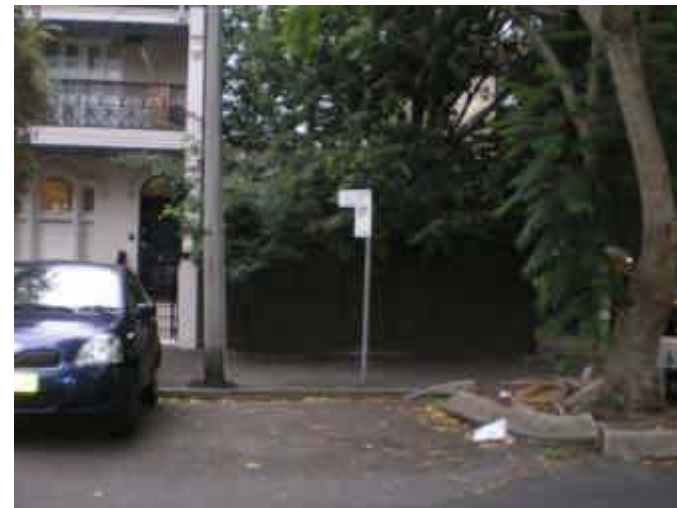
113. **Ground Floor Inundation** Example of property on Hampden St at risk of inundation.

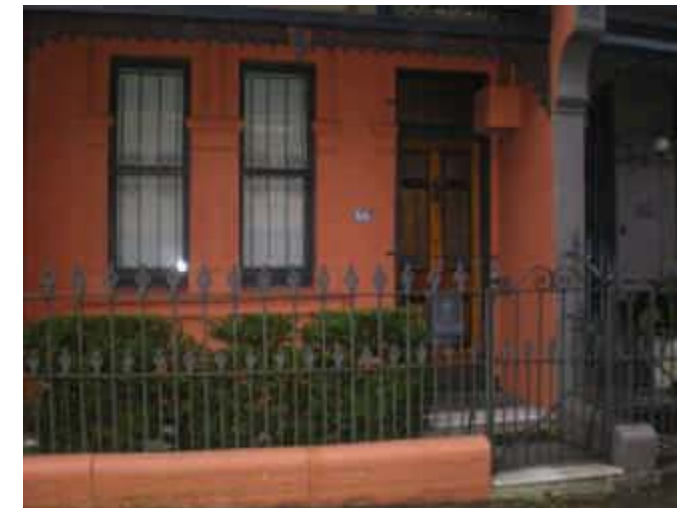
114. **Ground Floor Inundation** Property on Sutherland St with inundation reported. Walls could offer protection to some extent

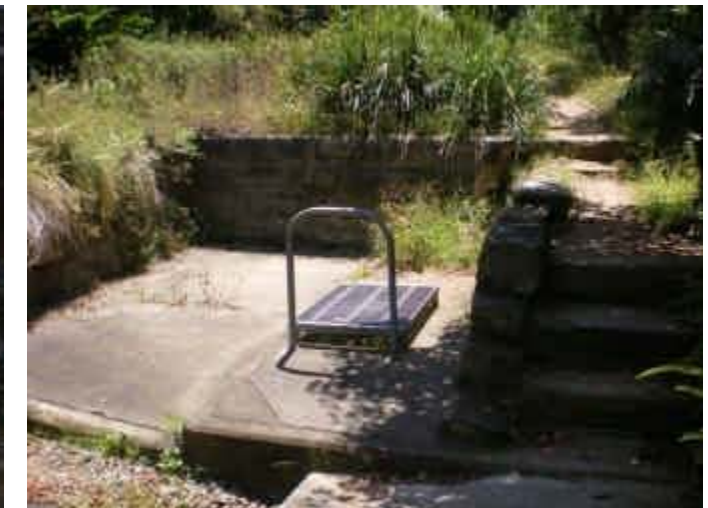
115. **Ground Floor Inundation** Example of property on Boundary St at risk of inundation.

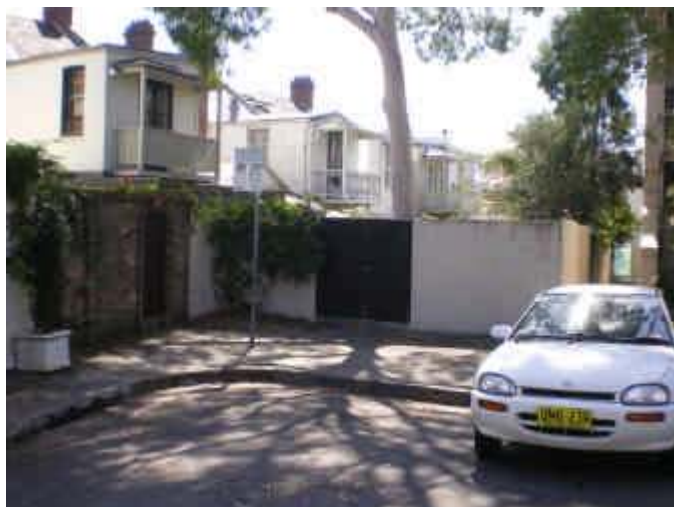
116. **No Flow Path** Close up of lower most part of Harris St (see also 34)

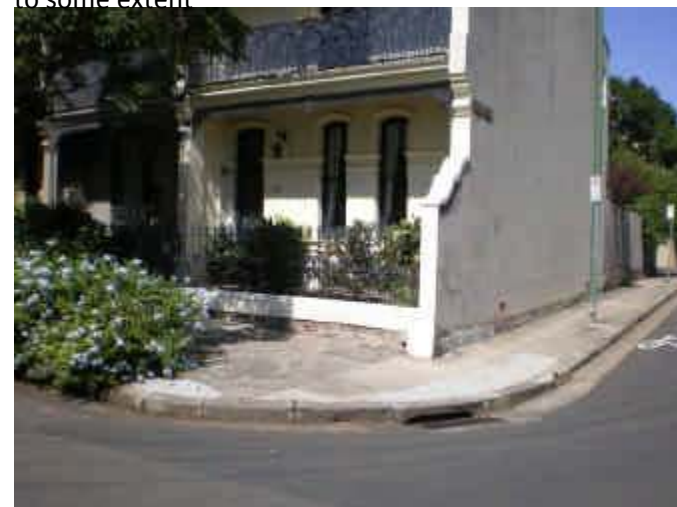
117. **Ponding & Ground Floor Inundation** Ponding at the end of Hopetoun St

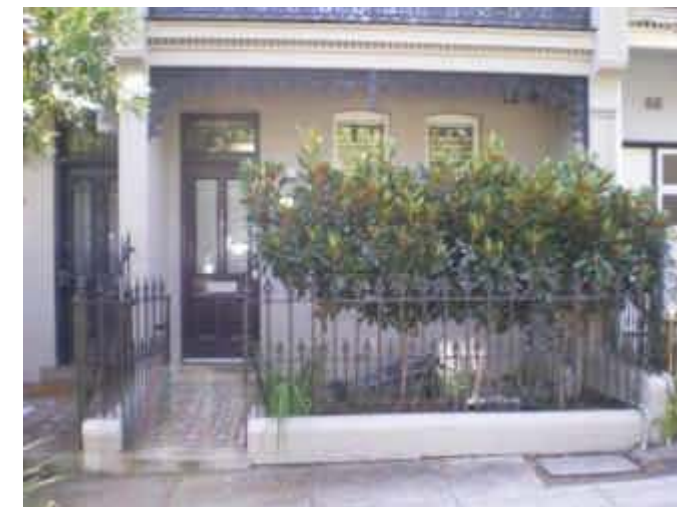
118. **Ponding & Ground Floor Inundation** Ponding at the end of Hopetoun St
