ARBORICULTURAL IMPACT ASSESSMENT (CONCEPT)

The Edgecliff Centre-New South Head Rd, Edgecliff.

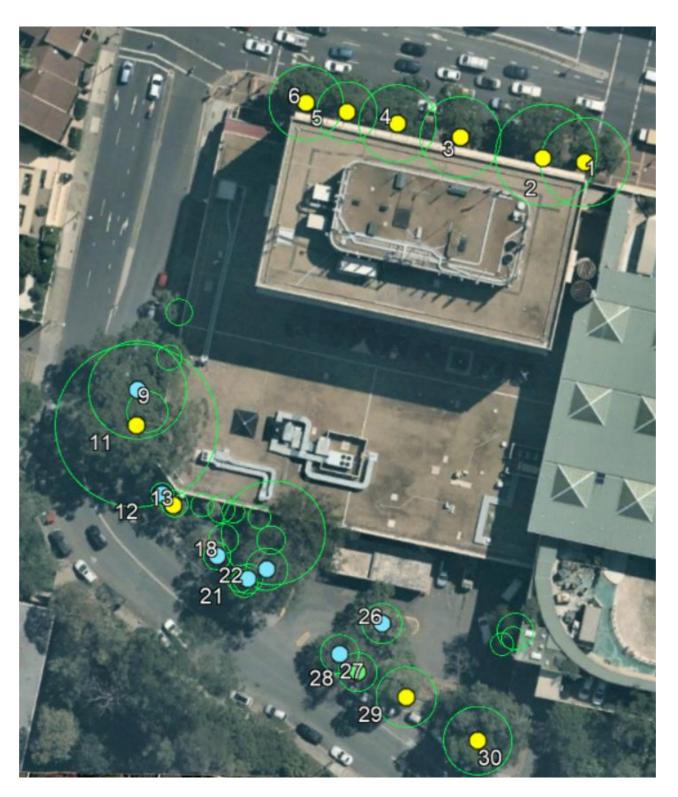
Whilst it may be possible to retain seventeen (17) trees on site, there are only eight (8) trees which warrant significant attempts to retain (1-2-3-4-5-6-11& 30).

Figure 4- Trees proposed for retention are shown numbered in the drawing above. Empty green circles represent removed trees.

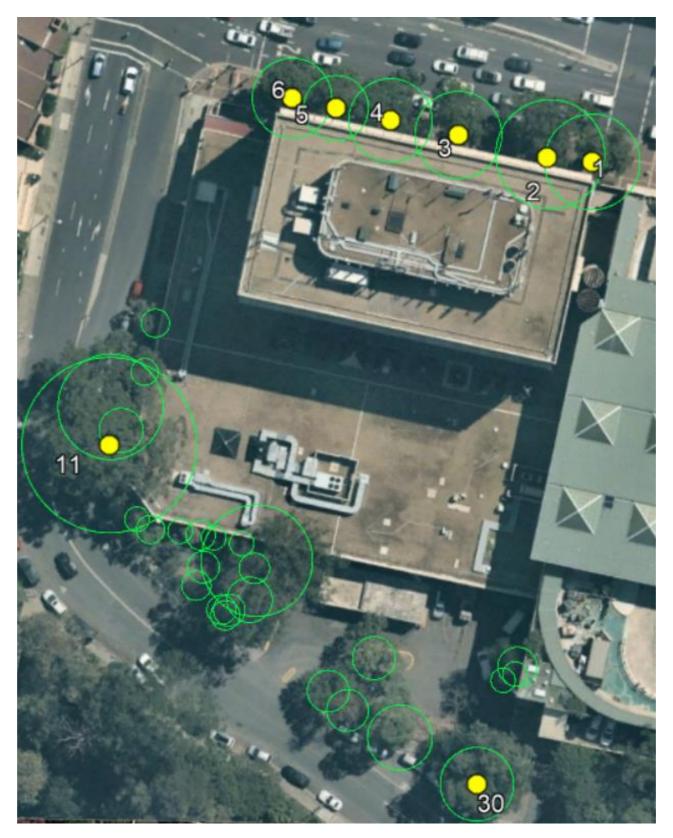
Figure 5- Trees recommended for retention are numbered in the plan above, empty green circles represent removed trees.

- Trees 1-2-3-4-5-6-11 & 30 should be retained and protected throughout development, the remaining trees should not be considered as a constraint to development.
