# ARBORICULTURAL IMPACT ASSESSMENT REPORT

# PROPOSED YOUTH RECREATION FACILITY

# RUSHCUTTERS BAY PARK, 2A NEW SOUTH HEAD ROAD, DARLING POINT

# **April 2024**

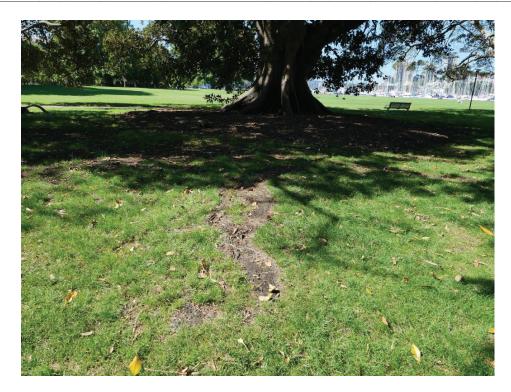
- 9.1.4 In the case of T3, large woody surface roots (200 to 400mm in diameter) were observed extending 14 metres radius south of the tree (refer to **Plates 1 & 2**). These roots may conflict with the footprint of the works and therefore some root pruning may be required to accommodate the slab sub-grade. It is noted that the slab is located slightly above grade within the TPZ (about 200mm) and therefore it may be feasible to avoid root pruning. In order to avoid any adverse impact on this tree, all excavation for the pavement sub-grade and skate park element foundations within the TPZ should be undertaken in accordance with **Section 10.8** and any required root pruning should be carried out in accordance with **Section 10.13**.

Plate 1 – Showing large woody surface roots extending approximately 14 metres south of T3 (Moreton Bay Fig).

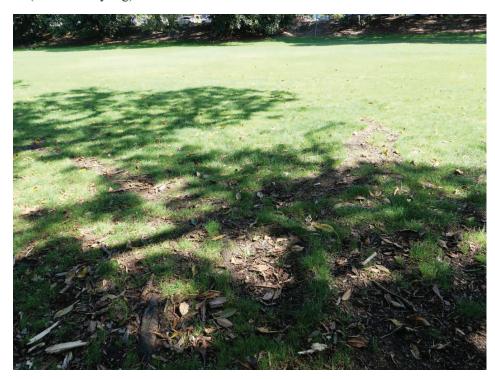
Plate 2 – Showing large woody surface roots extending approximately 14 metres south of T3 (Moreton Bay Fig).

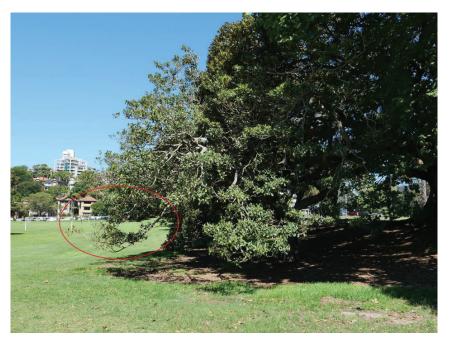
**Plate 3** – Showing descending tertiary branches on the north side of T12 (Port Jackson Fig) that mat require pruning to clear pedestrian access and facilitate construction.

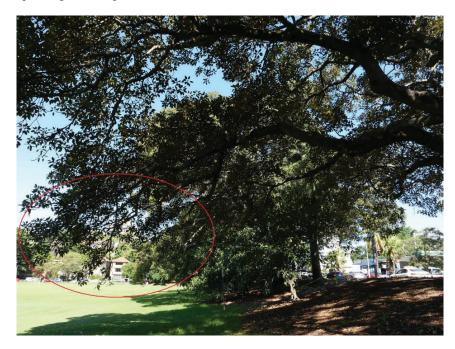
**Plate 4** – Showing descending tertiary branches on the north side of T14 (Moreton Bay Fig) that mat require pruning to clear pedestrian access and facilitate construction.

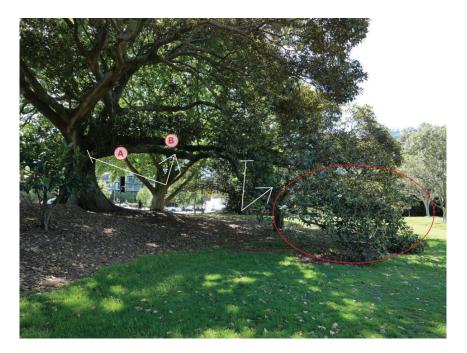
**Plate 5** – Showing descending tertiary branches on the north side of T13 (Moreton Bay Fig). Branch A will need to be removed back to the junction with the trunk as there are no other satisfactory points of reduction close to the conflict. The end portion of Branch B can be reduced to the junction with a more ascending secondary branch as indicated to achieve an acceptable degree of clearance,.
