Woollahra heritage inventory

ITEM DETAILS					
Name of item	Cliff Street archaeology				
Item type	Archaeological-Terrestrial/ Transport – Land/ Road				
Significant area or group					
Address	<p>Known archaeology exists in the area of Cliff Street south of Victoria Street extending the length of the carpark. Test pits were carried out past this point but did not reveal archaeological evidence. The area of Cliff Street highlighted red represents the extent of area where sandstone cobble stones are known to exist.</p>

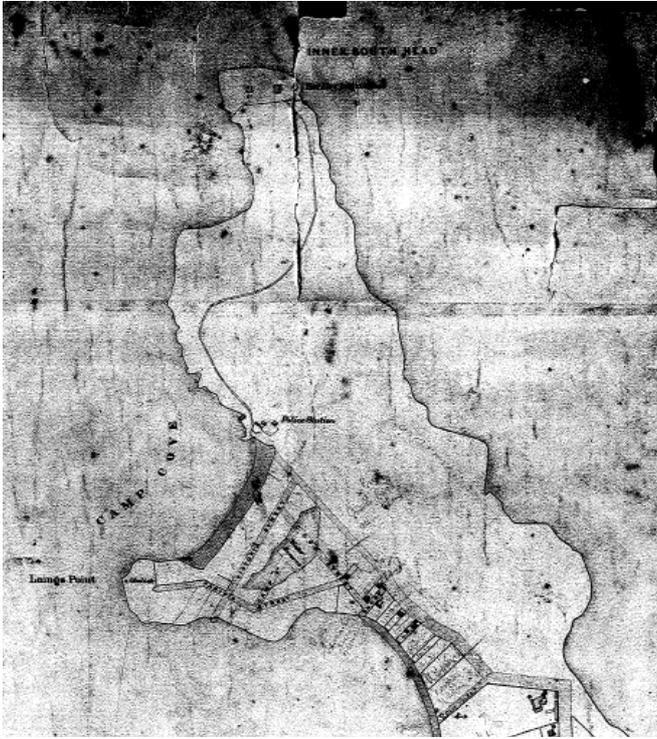
IMAGES			
Image caption	1860s Map of Watsons Bay showing the 1855 subdivision

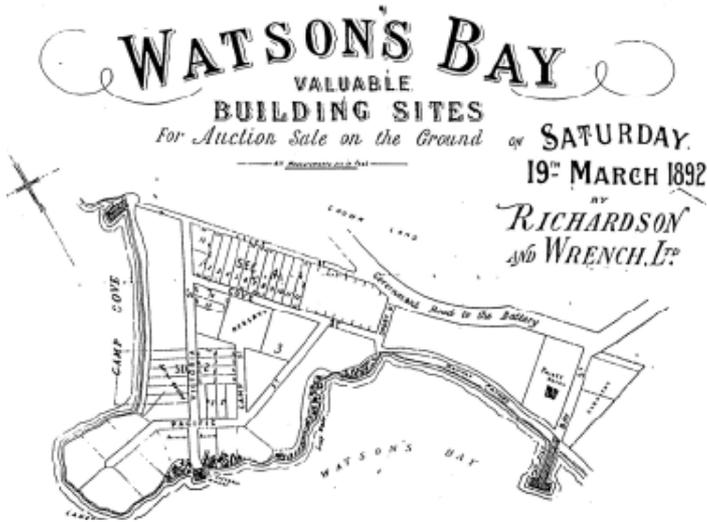
IMAGES			
Image caption	The 1892 sales advertisement, aiming to sell those blocks that had not been purchased following the original subdivision in 1855.

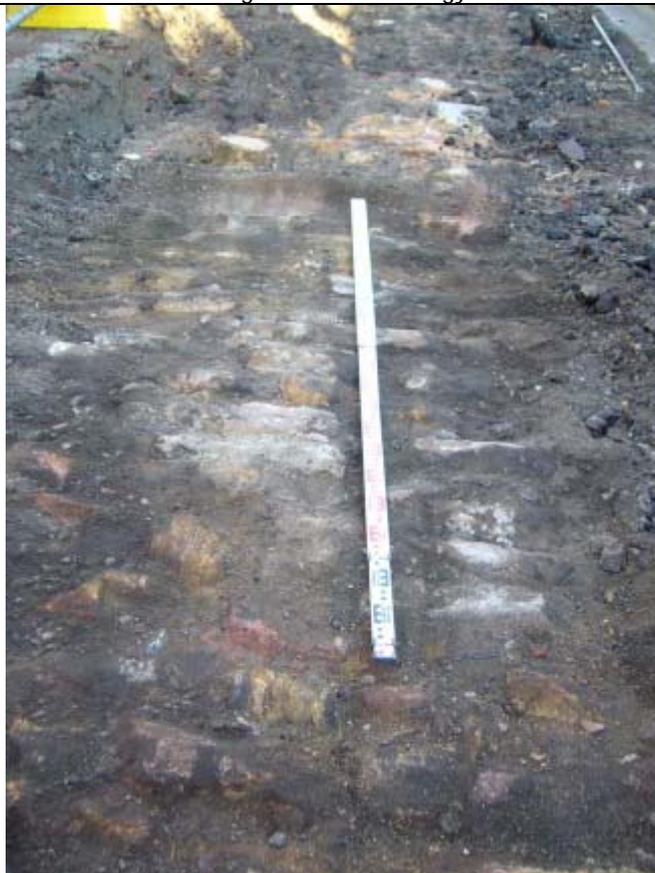
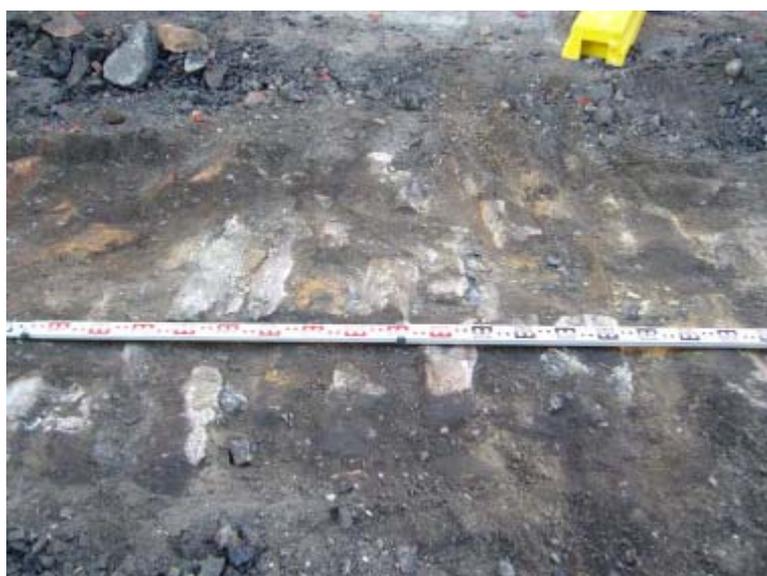
Cobbled surface exposed at northern end of Cliff Street
[The archaeology shown in these photographs was removed during the 2006 road and drainage works, as approved by the NSW Heritage Office. The photographs provide evidence of the remaining known archaeology in the southern section of Cliff Street.]

Rarity SHR criterion (f)	Known cobbled road surfaces are relatively rare. They are known sporadically from older parts of Sydney, but also exist as surviving local sections obscured by later surfaces. Until their presence is proven elsewhere within the Woollahra Municipality, the cobbled surface should considered to be locally rare.
Representativeness SHR criterion (g)	The archaeological resource has been compromised by later work. The most extensive section of the cobbled surface only represents half the original width. No side drainage has been preserved in the areas exposed, and may have been deliberately removed. It is not considered to meet this criterion.
Integrity	Where found, the sandstone cobble stones are in a consistent formation, in roughly shaped rectangular blocks laid across Cliff Street. Later disturbances and intrusions have impacted on the integrity.

RECOMMENDATIONS				
Recommendations	That the known archaeological evidence located in the section of Cliff Street between the Victoria Street intersection and 27 Cliff Street be listed as an archaeological relic in Woollahra Local Environmental Plan 1995 Schedule 3 – heritage items.			
INFORMATION SOURCES				
Type	Author/Client	Title	Year	Repository
Report	Banksia Heritage + Archaeology	Cliff Street, Watsons Bay: archaeological assessment of potential impacts by drainage works	2006	Woollahra Council
Report	Woollahra Council	Statement of Heritage Impact	2006	Woollahra Council
Thematic History	Megan Martin	Thematic History of Watsons Bay	1997	Woollahra Council
AUTHOR OF THIS REPORT				
Jodi Ayre, Strategic Heritage Officer Chris Bluett, Manager Strategic Planning			January 2007 April 2011

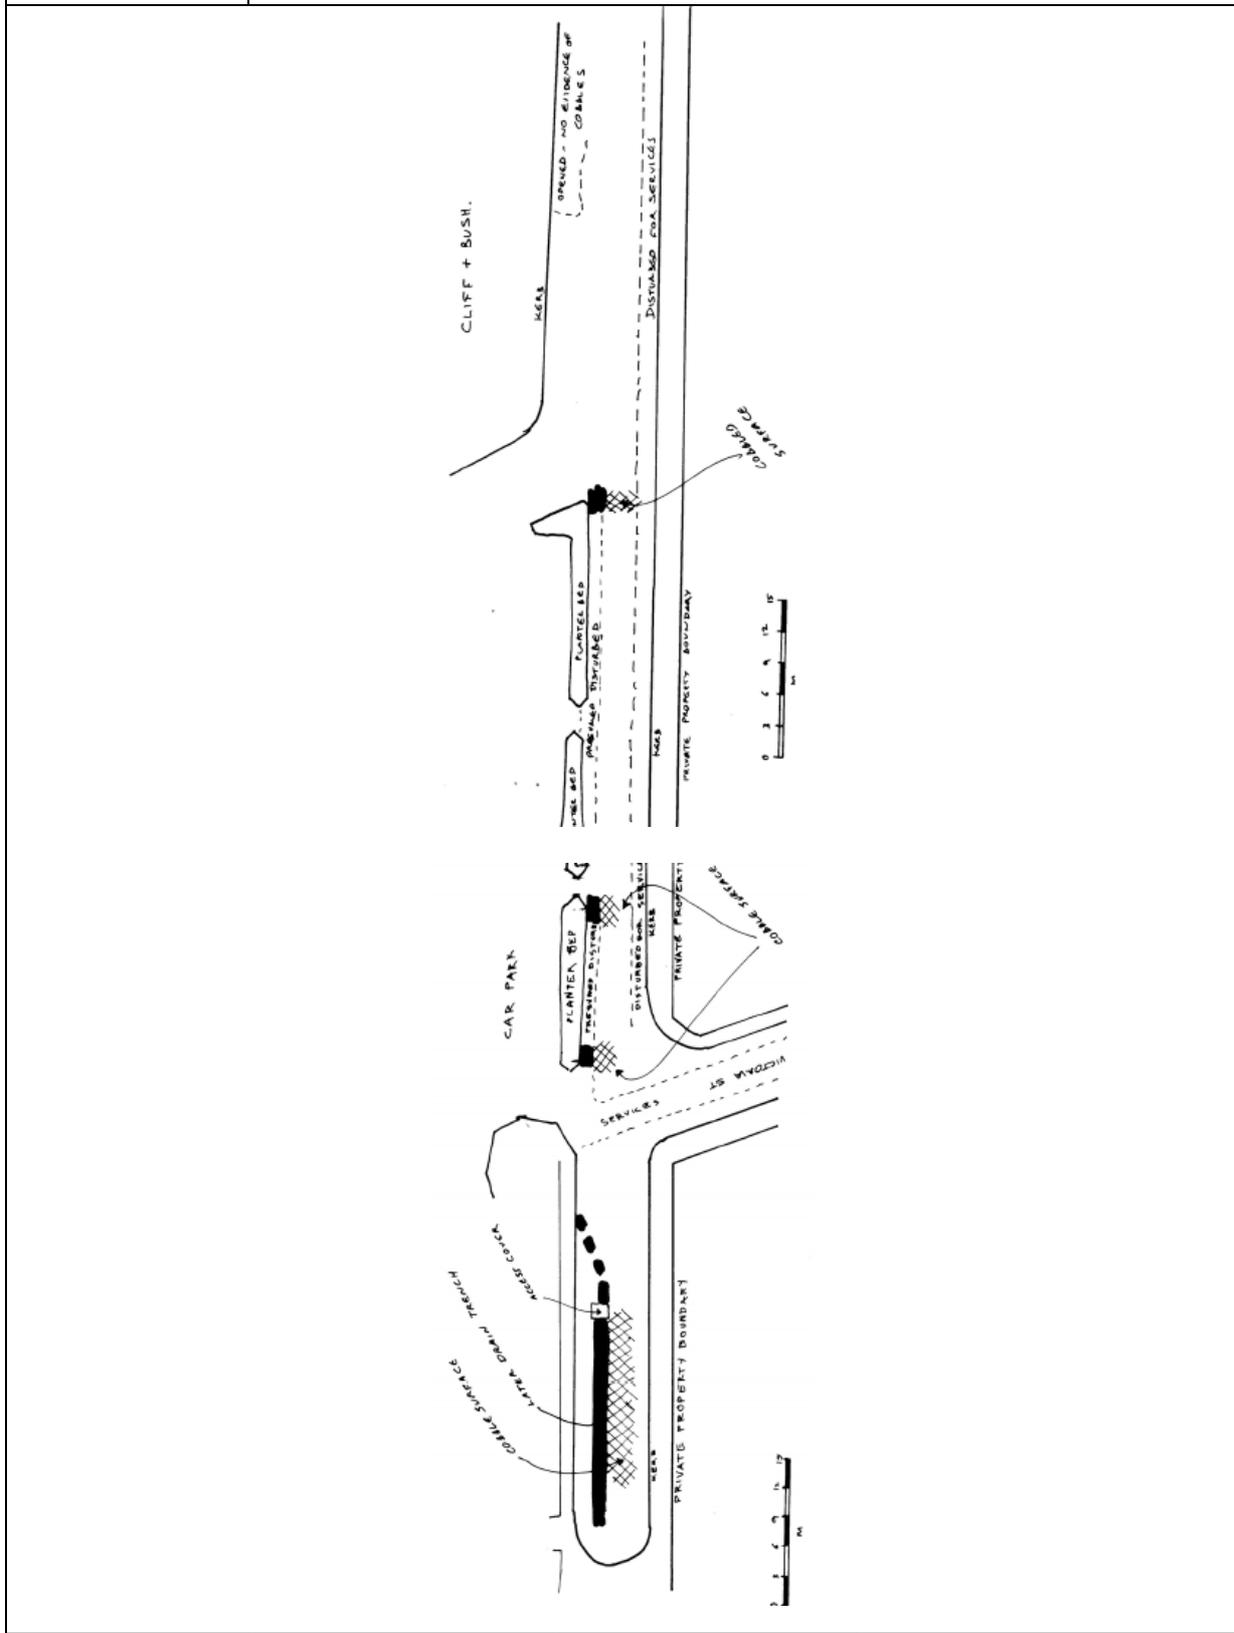
Image caption Plan prepared during archaeological work undertaken in 2006, showing exposed sections of sandstone cobble surfaces and known likely disturbances and intrusions.
