RE: 136-140 NEW SOUTH HEAD ROAD, EDGECLIFF - HERITAGE STATEMENT PLANNING PROPOSAL: DESIGN STATEMENT

Executive Summary	1
Conclusions & Recommendations	1
1. Introduction	2
1.1. Background	2
1.2. Site Location	2
1.3. Heritage Listing	3
1.4. Methodology	3
1.5. Author Identification	4

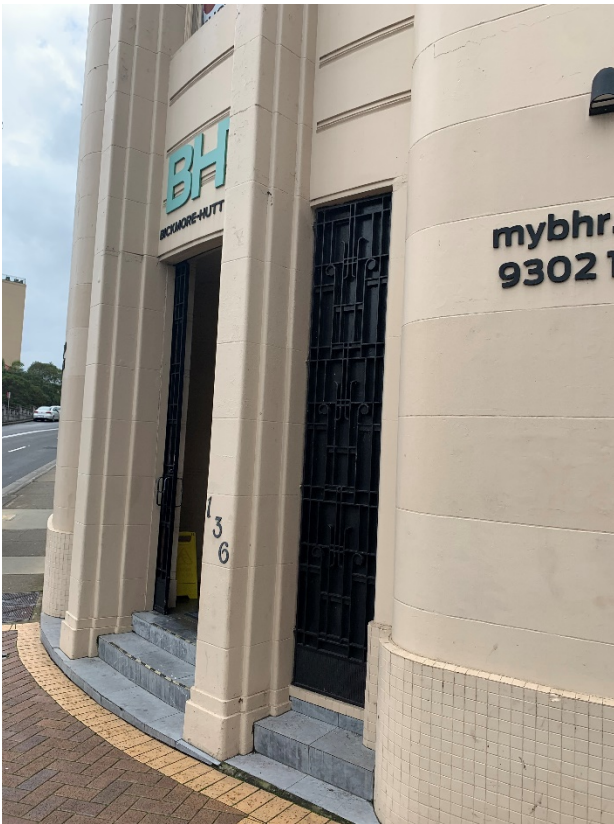
Figure 9 – Main entrance to ground floor banking chamber with metal grilles.

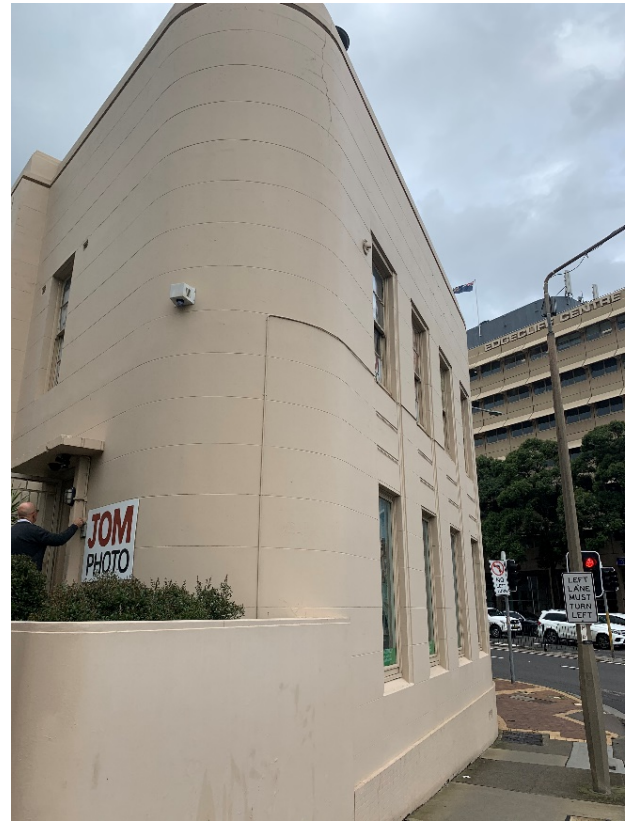
Figure 10 – Window arrangement on southern façade with curved corners.

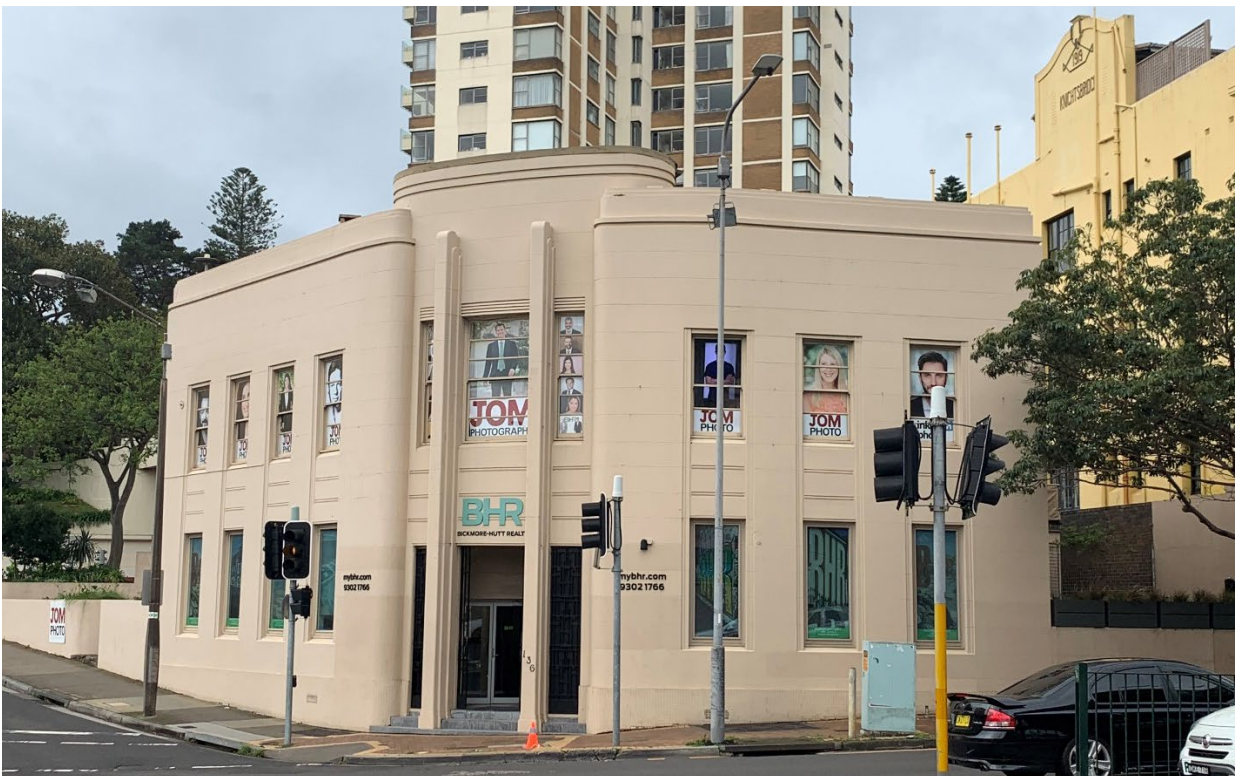
Figure 13 – View of No 136 showing the curved form of the painted rendered masonry walls with horizontal banding to spandrel panels, parapets and other decorative elements

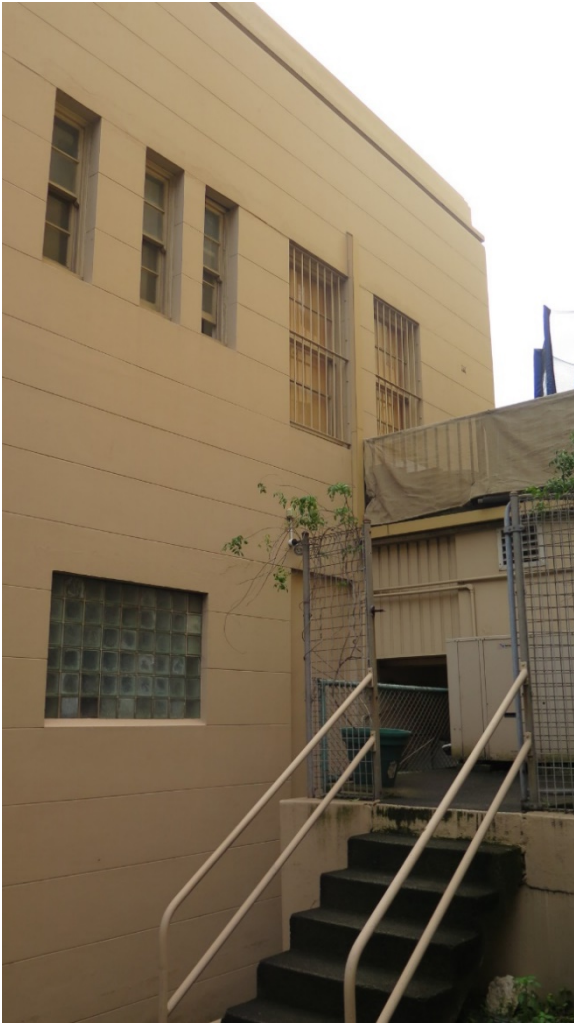
Figure 16 – East Elevation with later addition plant structure and kitchen on raised plinth. Former bank walls are rendered with horizontal banding

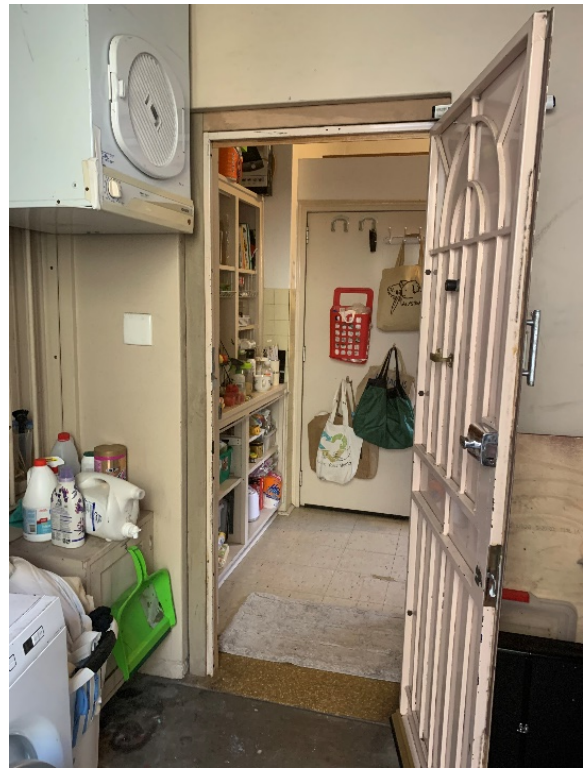
Figure 26 – First Floor, laundry and kitchen with later addition metal security door
 Source: Anka Property Group, 2020

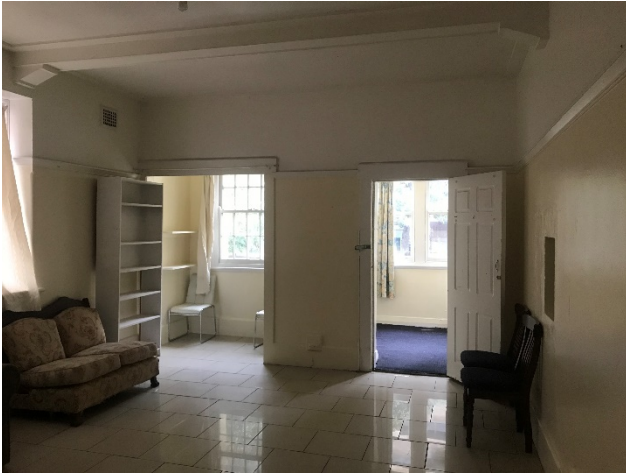
No plan of the flat building is available for this building. Each floor contains two flats accessible from the eastern stair. The interiors of the ‘Knightsbridge’ flats are generally in poor condition. The interior of the building is divided into multiple apartments across the three levels. The apartments contain early fabric, including timber framed sash windows, doors, decorative plaster ceiling and expressed timber ceilings and drop beam detailing, alcoves, timber joinery cabinetry and timber flooring, generally with carpet covering or tiled finish.

detailing remains including early joinery, cupboards, serveries and ceiling features, however most of the original cornices, ceiling roses, architraves and skirting have been removed. Many of the ceilings indicate evidence of mould. Sections of ceiling have been replaced overtime as a means of repair.

Figure 33 – Interior fabric, ground floor apartment with plaster finish masonry walls, timber architraves, skirting and pictures rails.

2. Given the deteriorated condition of the Inter-War flat building at No 138-140 New South Head Road and the loss of original fabric and detailing within the building, we have assessed the building to have little heritage significance. There is little opportunity to adaptively reuse or salvaging any fabric associated with the Inter-War Flat building due to degradation of fabric throughout the building. Urbis supports the demolition of the flat building.

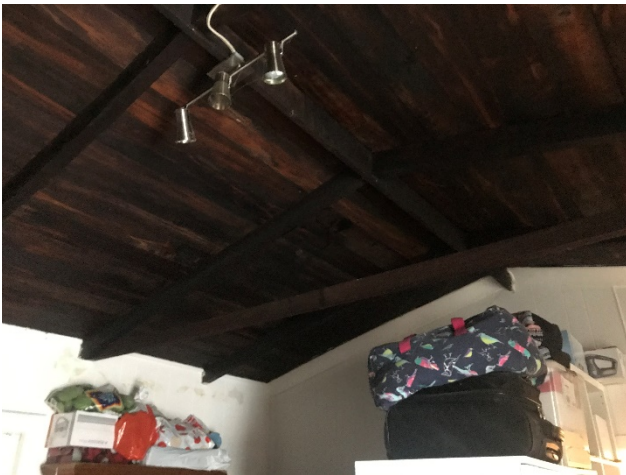
There is a single apartment located at the top of the building in the roof space which opens out onto the main roof plane of the building. The apartment contains early wooden ceilings, however, has clearly been modified to accommodate living quarters. The stairwell, located on the eastern side of the building is tiled throughout and the timber staircase has been repainted. The timber posts of the staircase appear early, however other elements are likely later additions. There are windows located on each level within the stairwell. Some windows have been replaced, the windows feature various different frames and panes including stained glass.

Figure 47 – Roof top apartment - timber roof structure with exposed stained beams and lining.

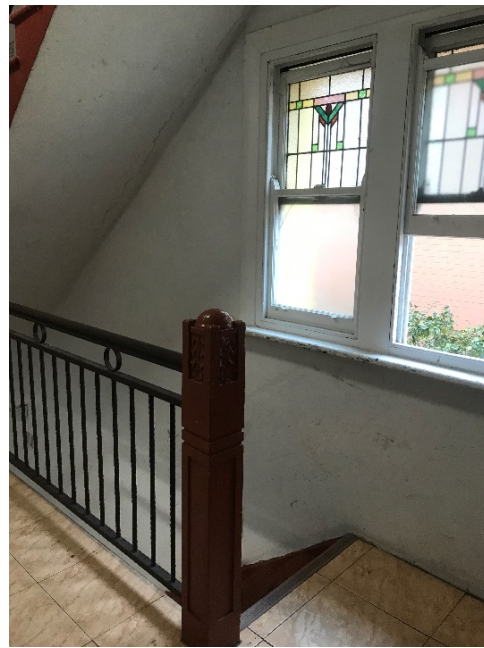
Figure 50 – Stairwell, window and timber staircase and stained-glass window to upper sash.

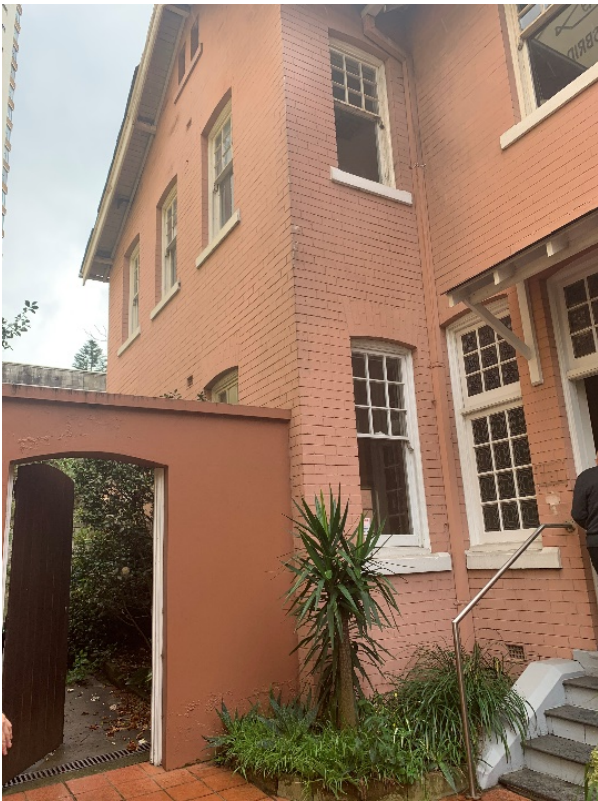
Figure 55 – Western elevation with later addition painted brickwork.

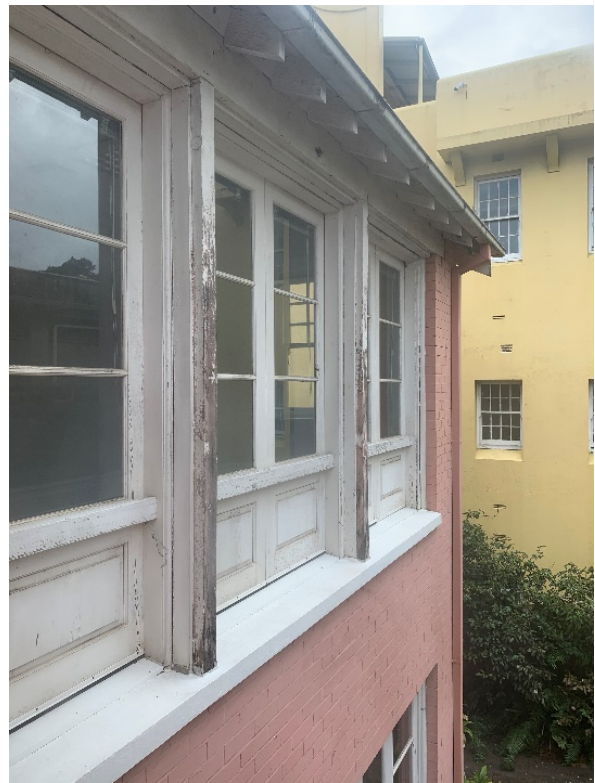
Figure 56 – Detail of eaves overhang and exposed timber rafters to roof at rear of dwelling. Later addition windows.

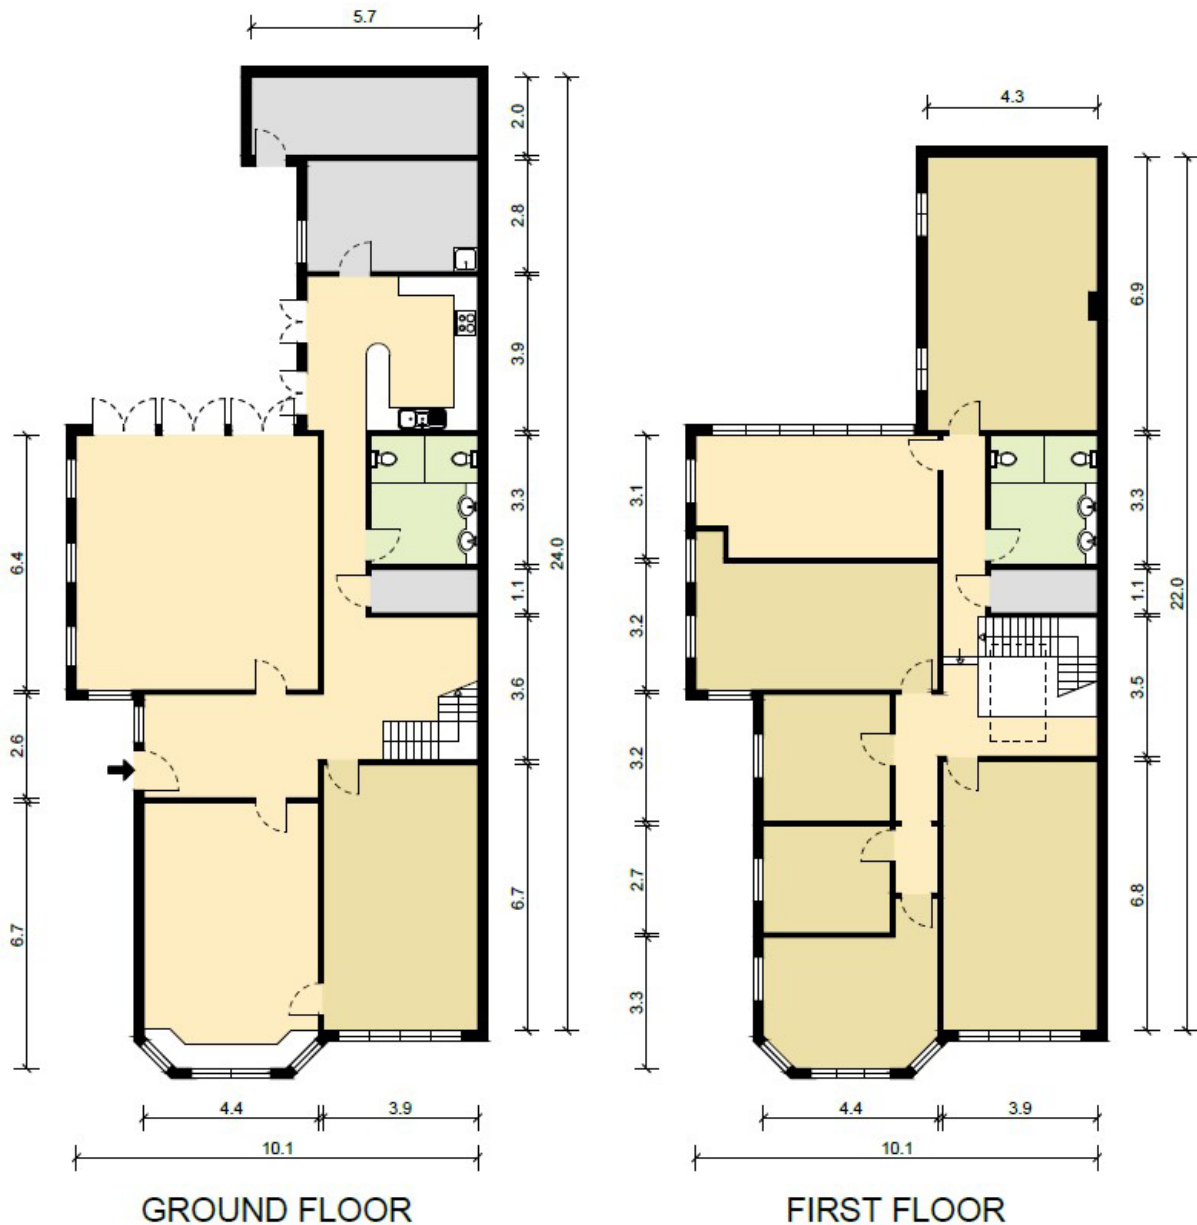
Figure 59 – 142-146 New South Head Road, showing Ground Floor (left) and First Floor (right). North at top of page

The ground-floor contains several large rooms which are accessed off an east-west hallway between the main entry and stairwell. The rooms to the south (including the room with the bay window) have timber flooring, possibly original (carpeted over), original timber skirting boards, and original timber architraves and door surrounds. Ceilings and cornices are modern and have been modified to introduce air-conditioning throughout. Concrete slab flooring is evident at the southern extent, a door opening with fanlight above from the adjoining room, and a non-original window within the original arched opening suggests a former verandah, since enclosed.

The ground-floor rooms to the north – bathroom, kitchen and laundry – are mostly later addition fitouts. However, the timber flooring, skirting boards and architraves remain in the north-south hallway. With the exception of the main entry, all door leaves throughout the ground-floor are timber replacements. It is noted, original ground floor timber joinery was shellac finish and has been overpainted in white.

3. The two-storey, semi-detached Federation Arts and Crafts building comprising professional suites at 142-146 and 146 New South Head Road does not meet the threshold for heritage listing. However, the building does contain a number of quality materials that would be considered suitable for salvaging, including joinery, stained glass windows, ceiling timbers, timber panel doors and hardware and marble fireplaces.

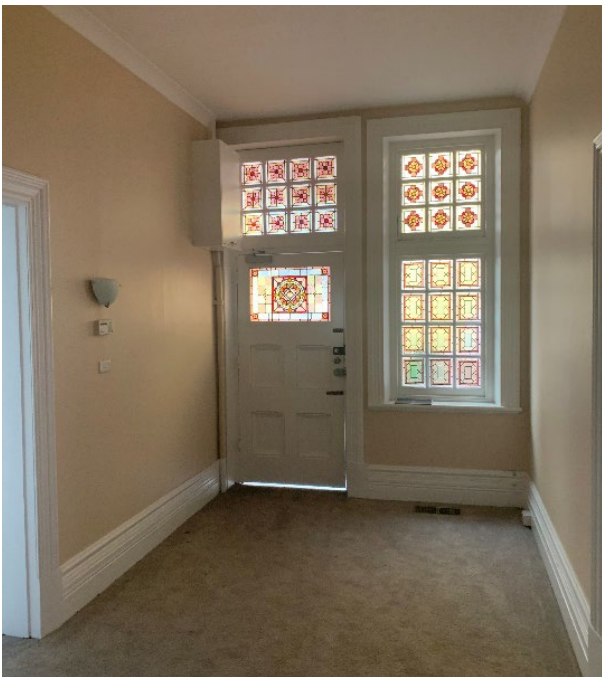
The entry to the dwelling is made at the western side of the ground-floor. The timber panel front door is surrounded by a tall transom with fanlight and large fixed side light. The door and surrounding elements contain decorative coloured stained-glass panels.

Figure 60 – Main door entry, internal view. Original timber architraves and stained-glass panel fanlights and side lights.

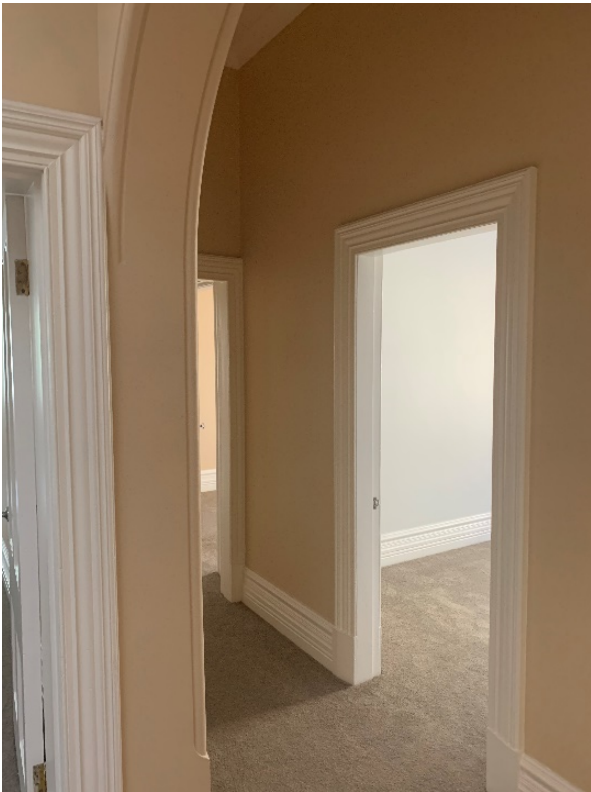
Figure 74 – First floor, southern hallway with original timber architraves and skirtings.

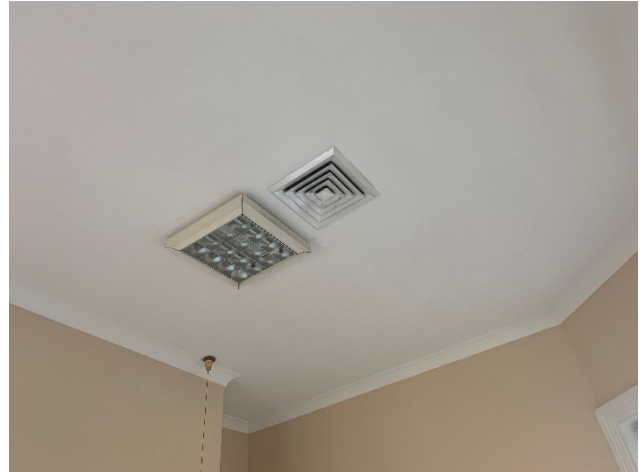
All rooms have timber flooring with carpeted finish and original timber architraves, timber skirting boards and multi-paned timber-framed windows. All ceilings and cornices – except for northern room – contain later addition plasterboard ceilings and cornices, with air conditioning mounted in the roof space and ceiling-mounted vents.

Figure 77 – First floor, south-western room with later addition, plasterboard ceiling and cornice and air condition vent.

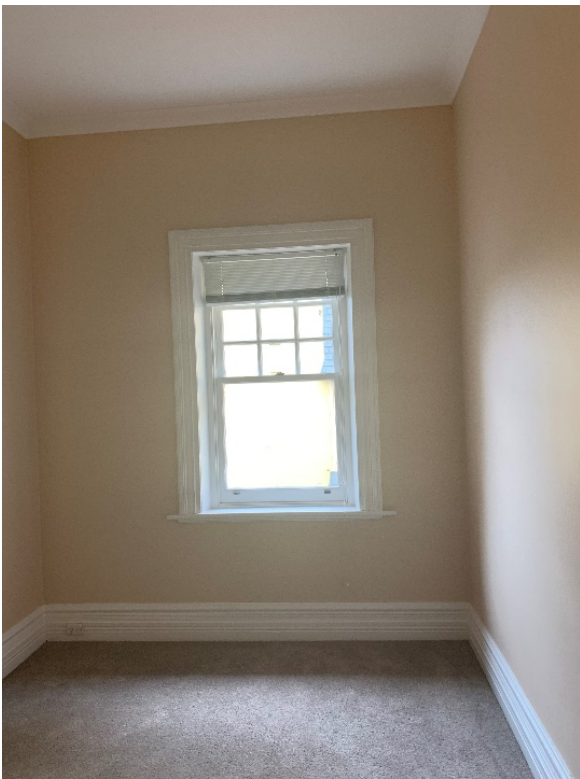
Figure 78 – First floor, showing original timber framed double-hung sash window and skirting.

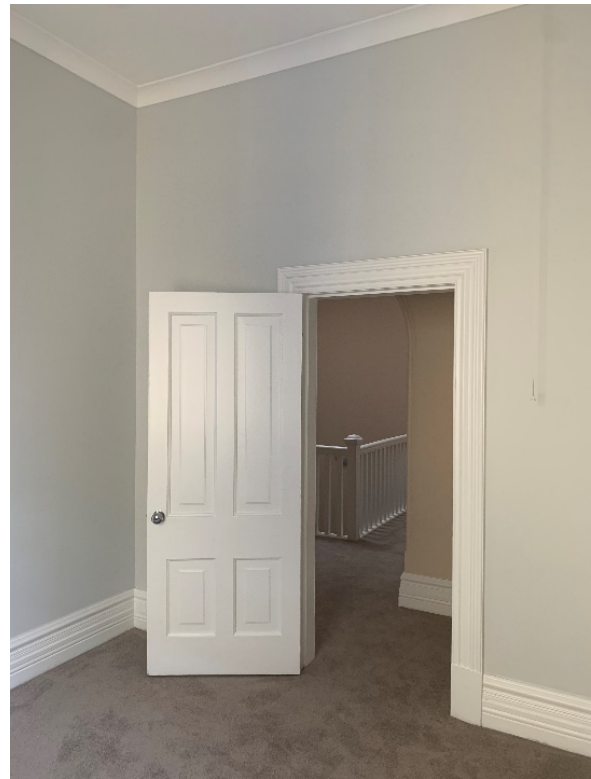
All first floor doors are later addition timber leaves. As with the ground-floor, all first floor timber elements are painted white.

Figure 79 – First floor, later addition timber door with original timber architrave and skirting board.

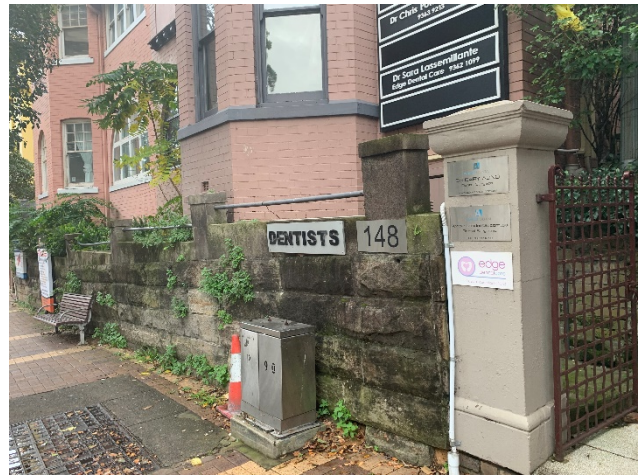
The southern property boundary at New South Head Road is defined by a rusticated sandstone wall with extended piers forming a balustrade – this is the same wall extending from adjoining semi-detached property at Nos 142-146. The entrance to the property is made from the eastern end of the property, via a metal entrance gate set between early rendered masonry gateposts. The masonry rendered gateposts are painted to match the non-original finish of the building.

Figure 89 – Detail of rusticated sandstone boundary wall, which runs across 142-148 New South Head Road where the semi-detached properties sit.

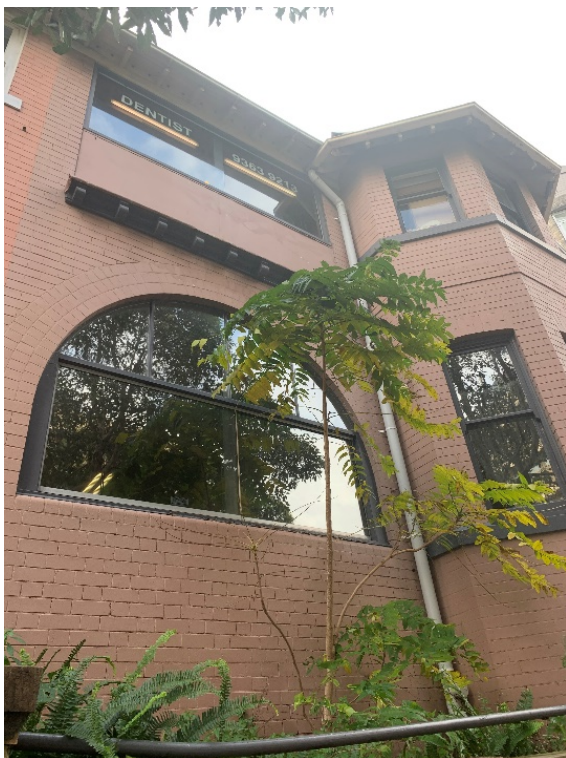
Figure 90 – Detail of south elevation to New South Head Road. Note the enclosed verandah to ground and first floors.

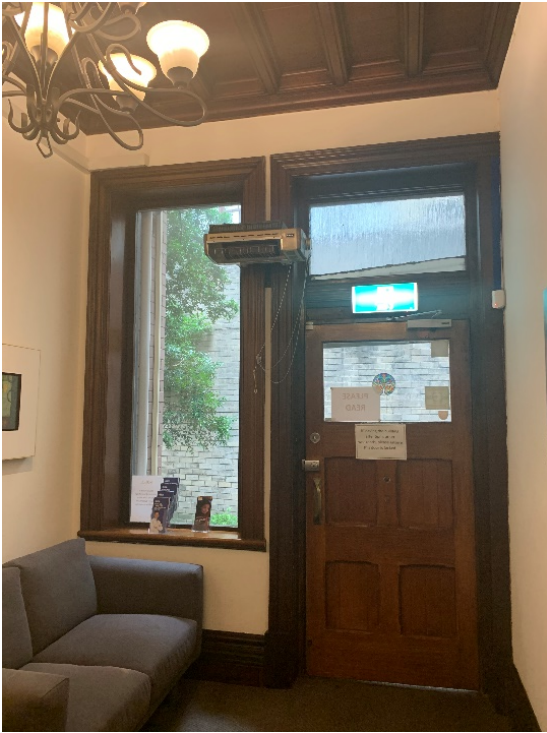
Non-original fabric is associated with lightweight partitions, replacement window frames, plasterboard ceilings and new timber door leaves. Stained glass windows have been removed from the main entry.

Figure 101 – Main entry foyer, internal view showing timber door and window architraves, skirting and ceiling with shellac finish. Later addition front door and timber panel ceiling. Stained glass removed and windows modified.

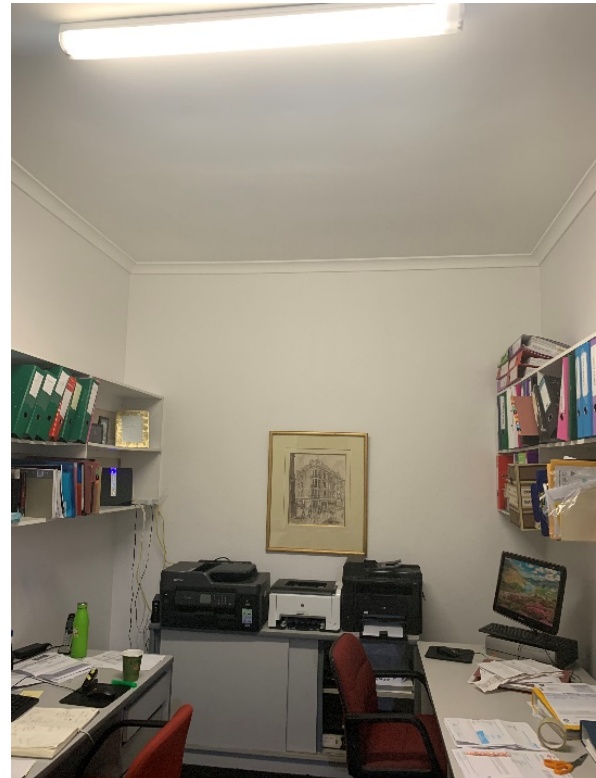
Figure 124 – Office space within second tenancy at northern wing of ground floor. Later addition plasterboard ceiling and cornices.

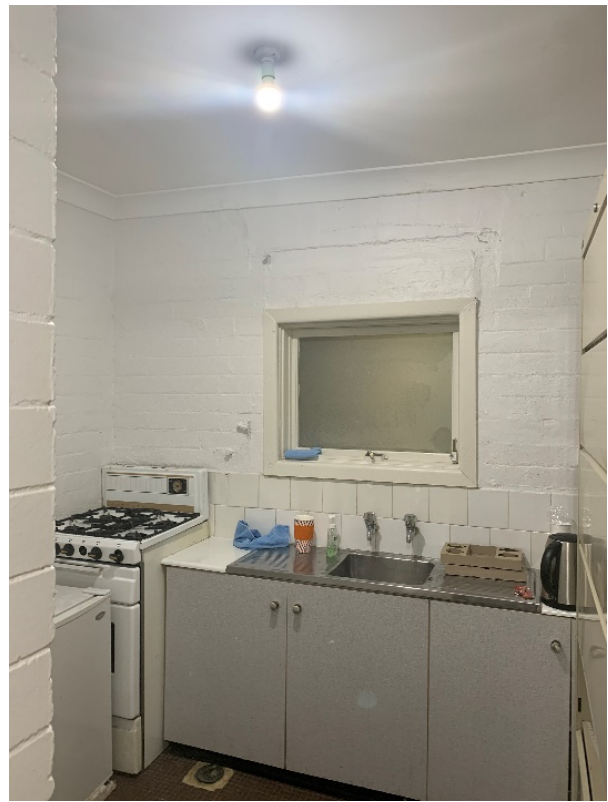
Figure 126 – Kitchen within secondary tenancy at northern wing of ground-floor. Painted face brickwork walls.
