Report on  
Detailed Site Investigation (Contamination)

Proposed Mixed Use Development  
136-148 New South Head Road, Edgecliff

Prepared for  
Edgecliff Central Pty Ltd

Project 200333.00  
March 2021

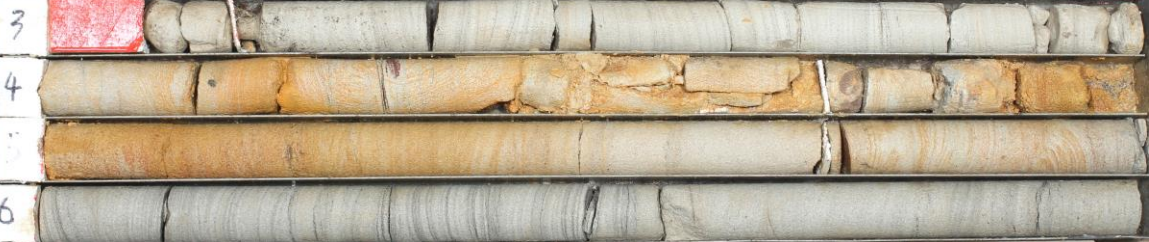
2.40 - 7.00m

200333.01 - Edgecliff - BH1 - Start = 2.4m

For boreholes drilled at 142-146 New South Head Road (BH1 and BH3), pavers (40 mm thick at BH1) and a terracotta pavement (0.18 m thick at BH3) was underlain by brown and grey sand fill to depths of 0.6 m and 1.3 m. Ripped sandstone gravels and trace igneous gravels were observed in the sand fill. Fill was underlain by brown and yellow sand to a depth of 1.8 m at BH3 (i.e., the borehole target depth) and to a depth of 2.4 m at BH1. Grey and brown sandstone was encountered from a depth of 2.4 m to a depth of 18.82 m.

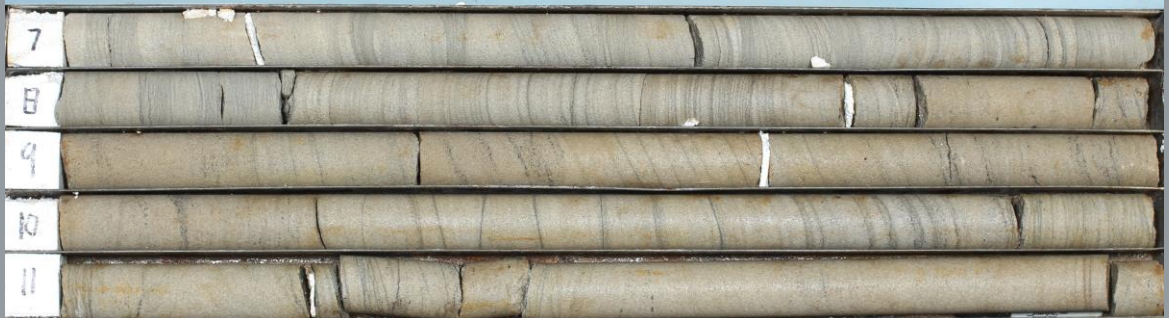
Project No: 200333-01  
BH ID: BH1  
Depth: 7.00 - 12.00m  
Core Box No.: 2/4

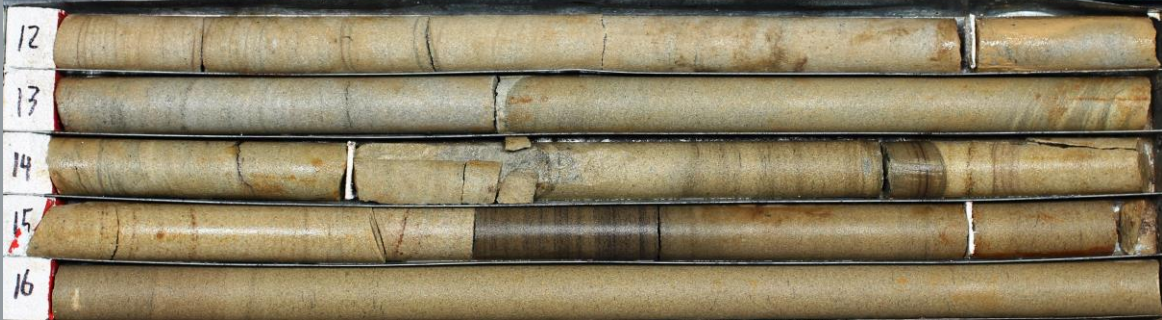
12.00 - 17.00m

Project No: 200333-01  
BH ID: BH1  
Depth: 12.00 - 13.00m  
Core Box No.: 3/4

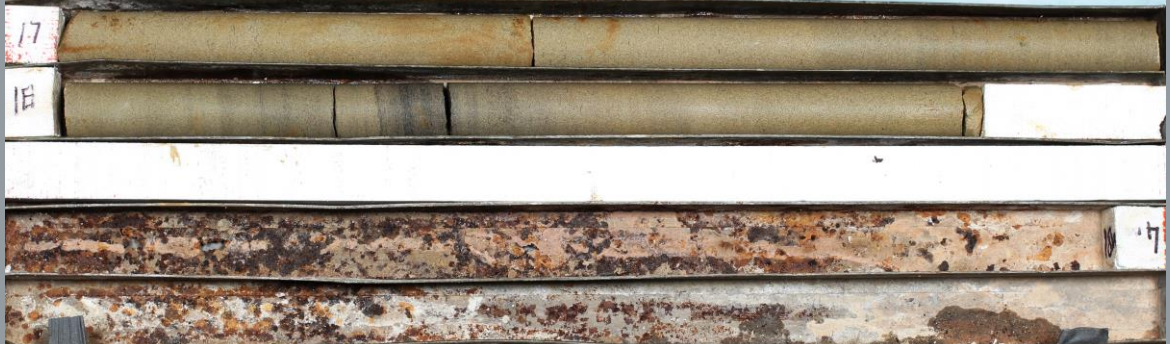
Project No: 200333-01  
BH ID: BH1  
Depth: 17.00 - 19.00m  
Core Box No.: 4/4

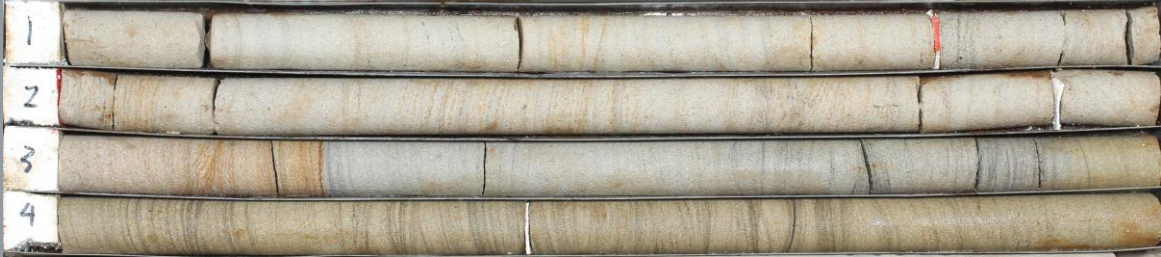
0.80 - 5.00m

200333.01-Edgelyft-BH2 - Start=0.8

At BH2, drilled at the lower portion of 136 New South Head Road, a concrete slab (50 mm thick) was underlain by grey to brown sand fill to a depth of 0.6 m. The fill also contained ripped sandstone gravels and cobbles. Fill was underlain by grey and brown sandstone to a depth of 15 m. It is noted that the soil descriptions are somewhat different to those for the bore drilled at this area in EI (2019).

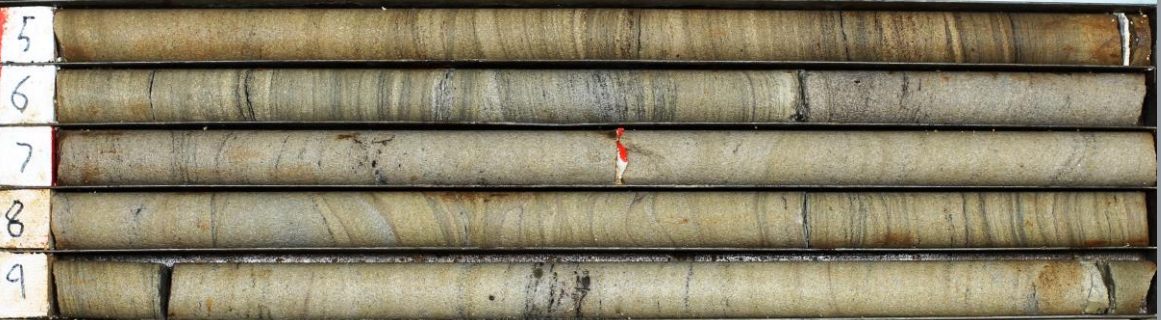
5.00 - 10.00m

Project No: 200333.01  
BH ID: BH 2  
Depth: 5.00 - 10.00  
Core Box No.: 2/3

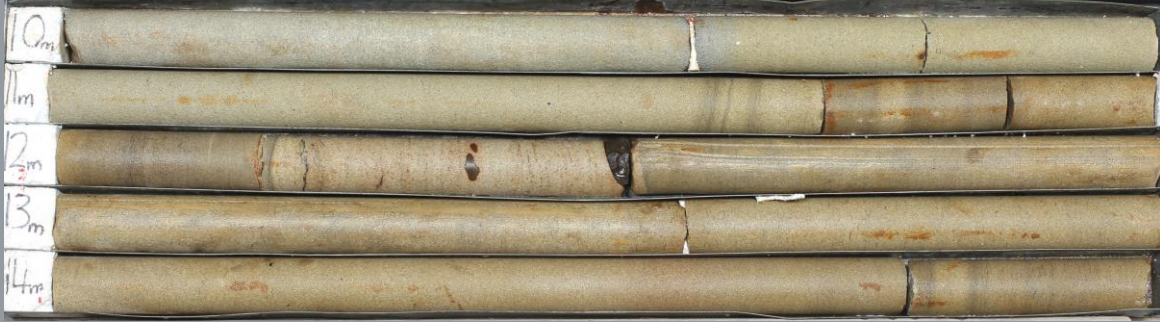
Project No: 200333.01  
BH ID: BH 2  
Depth: 10.00 - 15.00m  
Core Box No.: 3/3
