**Preliminary Site
Investigation**

8-10 New McLean Street, Edgecliff NSW

Mount St 4 Pty Ltd
27 July 2023

AU123019

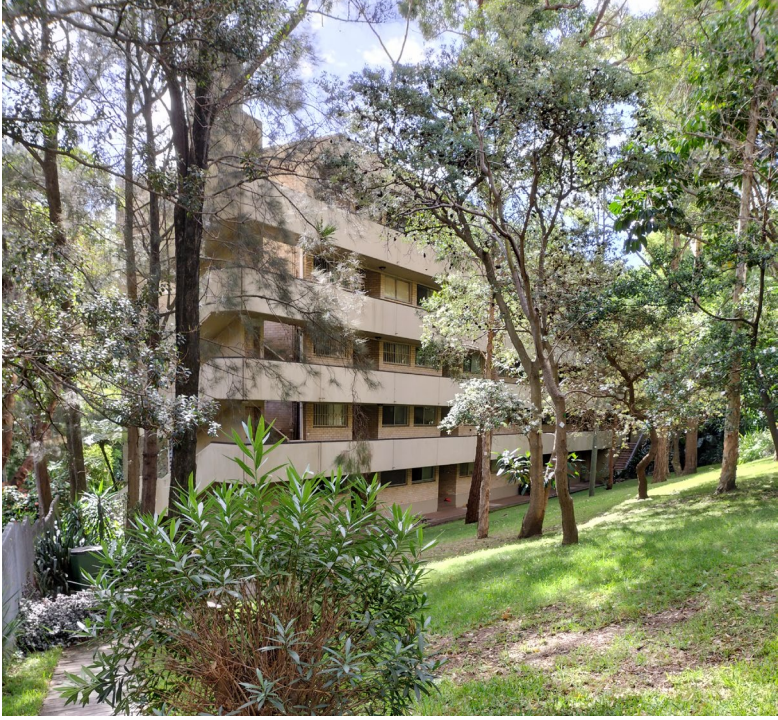
Photo Number: 1	Date: 13/04/23

<p>Description:</p> <p>Western residential apartment building and south-western site boundary bordering Trumper Park.</p>

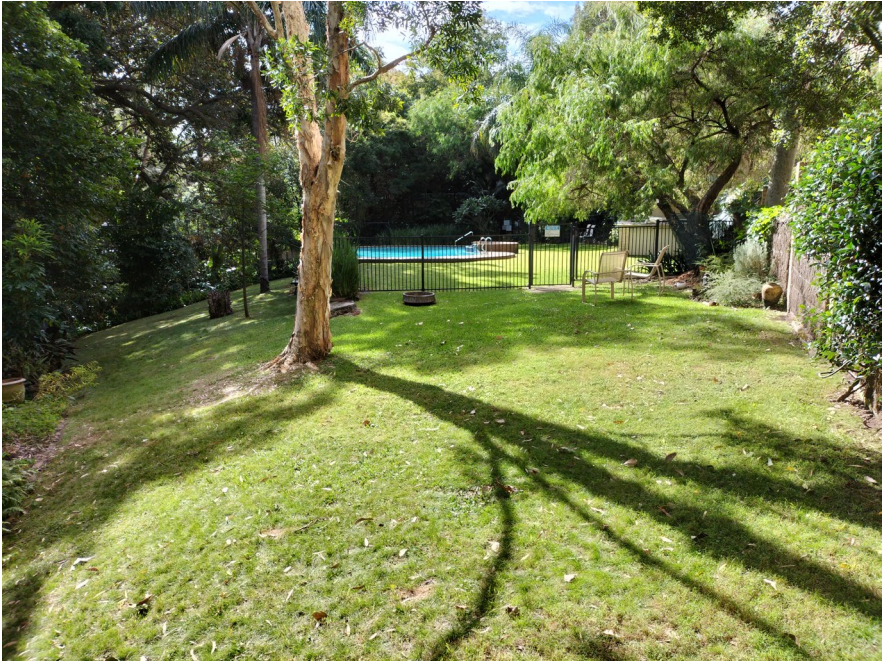
Photo Number: 2	Date: 13/04/23

<p>Description:</p> <p>Pool and western area of the site. Vegetation appears healthy.</p>

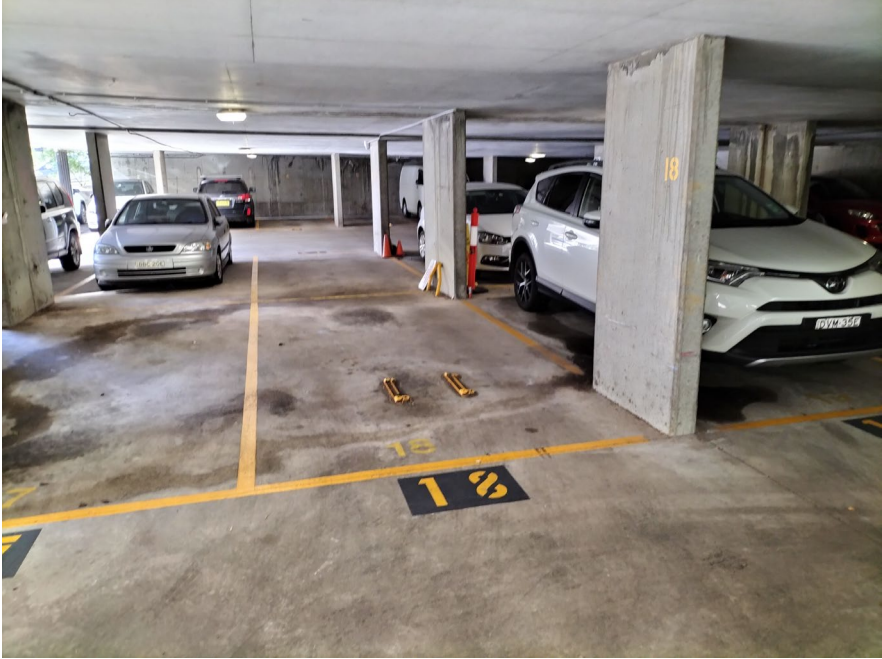
Photo Number: 3	Date: 13/04/23

- A two-storey concrete carpark is located on the eastern side of the site. Concrete slab flooring is in good condition. Minor surface staining from vehicles is present on the bottom level.

<p>Description:</p> <p>Bottom level of car park. Darker staining trail apparent on sealed concrete surface.</p>

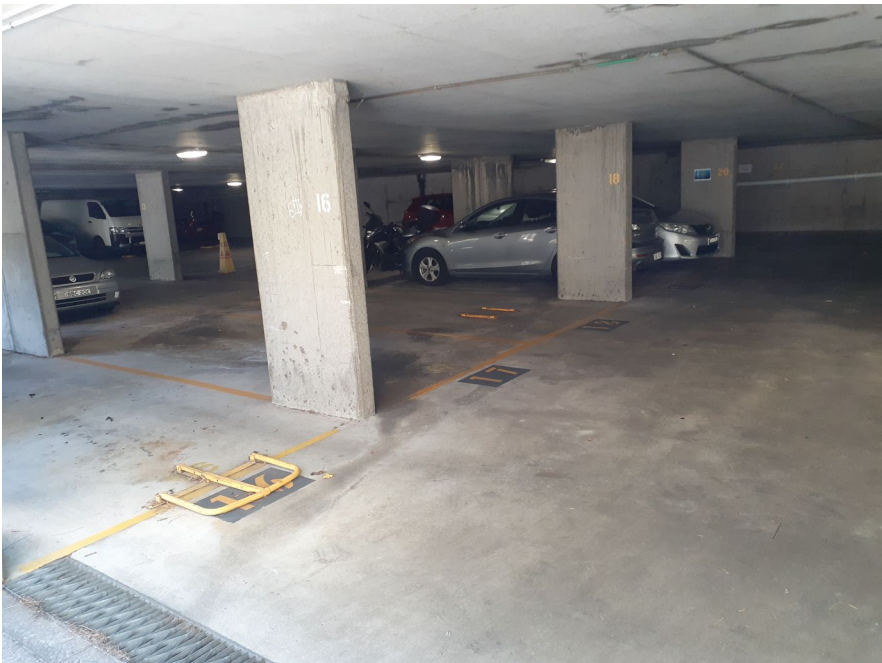
Photo Number: 4	Date: 17/02/22

- Surface water would predominantly infiltrate the unsealed ground surfaces with overflow following the topography towards Trumper Park. Rainwater in carpark and building areas would likely enter municipal stormwater systems.

<p>Description:</p> <p>Bottom level of car park. Staining trail can be seen leading into carpark stormwater drain.</p>

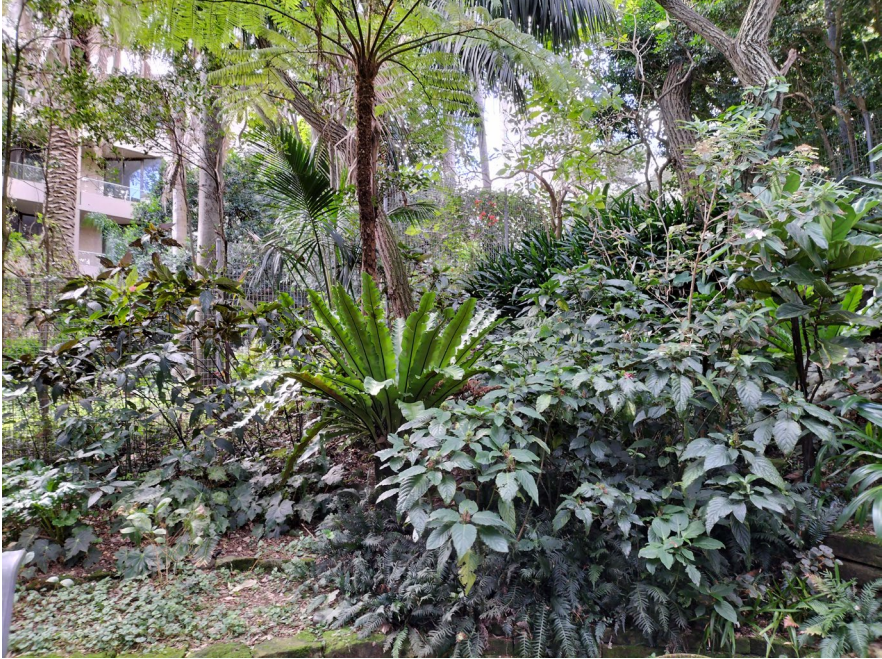
Photo Number: 5	Date: 13/04/23

<p>Description:</p> <p>Dense and healthy vegetation present on the northern corner of the site. Neighbouring residential apartments behind.</p>

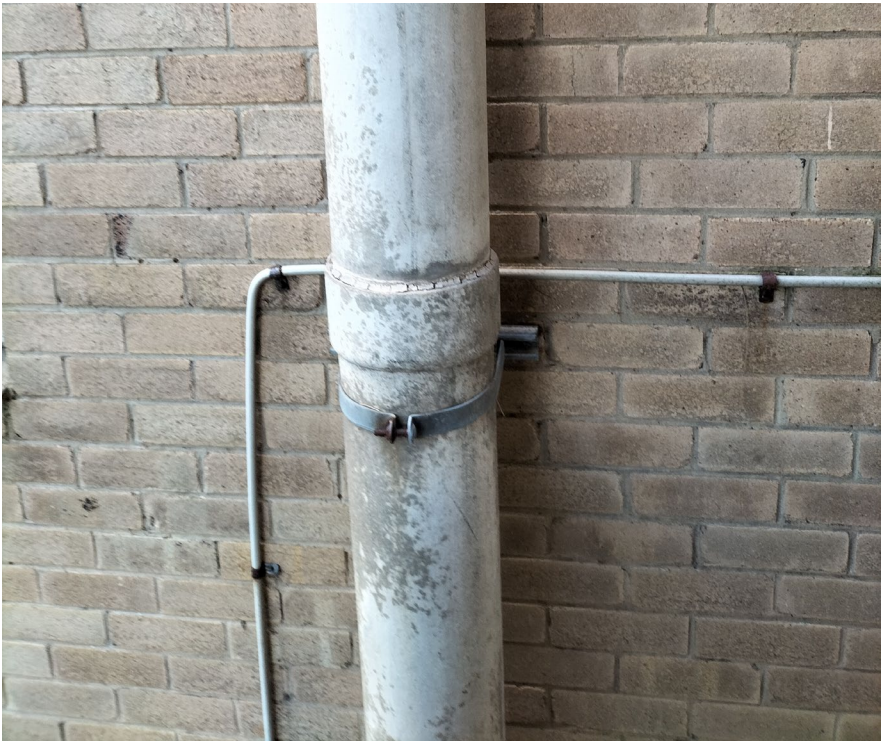
Photo Number: 6	Date: 13/04/23

- The site area was occupied predominantly by 2 residential apartment buildings parallel to each other spanning the north-eastern to south-western border. The buildings were 5-stories with walkway balconies on each floor. Buildings were constructed with brick and concrete. Considering the date of construction and an observed fibre cement stormwater pipe, it is likely that the building contains asbestos containing materials (ACM).

<p>Description:</p> <p>Fibre cement materials used on drainage pipes. Pipe located on residential apartment buildings.</p>

It is very likely that the apartment buildings were built with hazardous materials. It is recommended that the current Asbestos Management Plan is sourced from the site owners to determine the extent of hazardous material identification and management.
