Geotechnical Assessment

Prepared for: Woollahra Municipal Council

Address: Wilberforce Avenue & Ian Street Car Parks,
Rose Bay

Job No: 23921

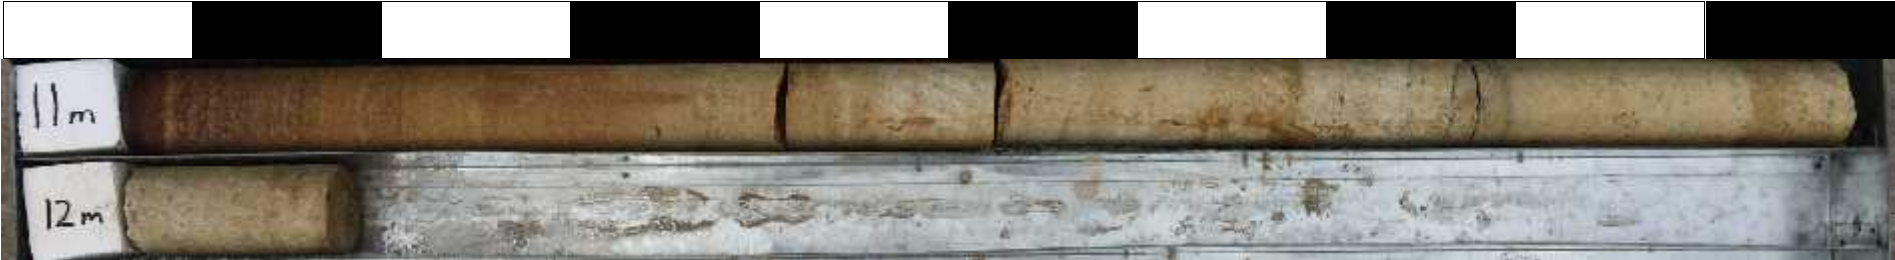
BH5 11.0m – 12.11m

Method	WATER	Tests	RQD	DEPTH (m)	UNIFIED CLASSIFICATION	SOIL DESCRIPTION <small>(SOIL TYPE, COLOUR, MOISTURE, CONSISTENCY)</small>	Moisture/ Weathering	Consistency/ Rock Strength	REMARKS and DEFECT DESCRIPTION
				11		Start coring at 11.0m			
NMLC			100%	11.5		Quartz SANDSTONE, fine to medium grained, pale orange-pale grey	DW	H	
				12		pale grey	FR	H	
				12.5		Borehole terminated at 12.11m			
				13					
				13.5					
				14

Core Photograph: 23921 – Ian Street Car Park, Rose Bay

Borehole	Depth (m)	Rock Type	Range of Is (50)	Strength
BH5	11.7	Sandstone	0.7 – 0.9	Medium
BH5	12.0	Sandstone	0.8 – 0.8	Medium
BH5	12.7	Sandstone	0.5 – 0.8	Medium
