Paddington Flood Study

Draft Report

VOLUME 1: Report and Appendices

Catchment Simulation Solutions

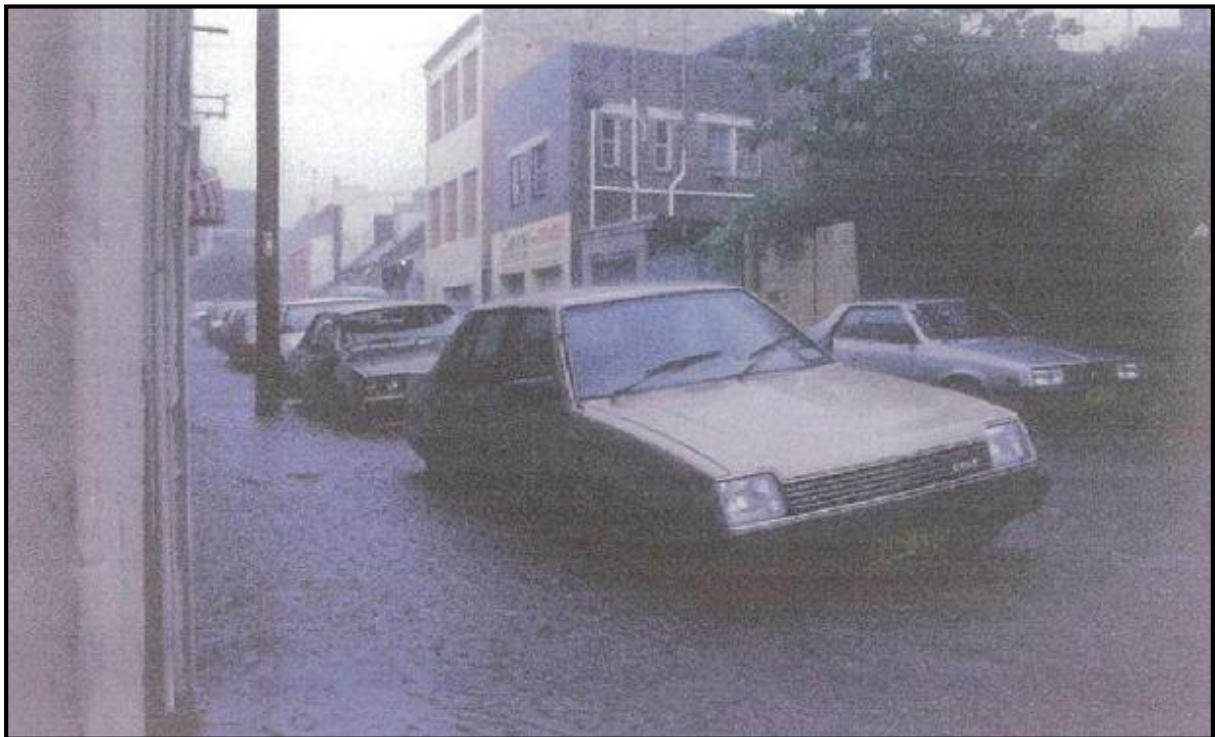
Plate 1 Flooding in Victoria Street, Paddington on 6 January 1989 (WMAwater, 2013)

This study also notes that significant flooding was experienced across the catchment in 1984, 1989 and 1991. A photograph is also provided in the report showing flooding in Victoria Street, Paddington on 9th January, 1989 (refer **Plate 1**). A number of historic flood marks are also documented in the study for the 1989 and 1991 floods. The location of the flood marks is shown in **Figure 2**.

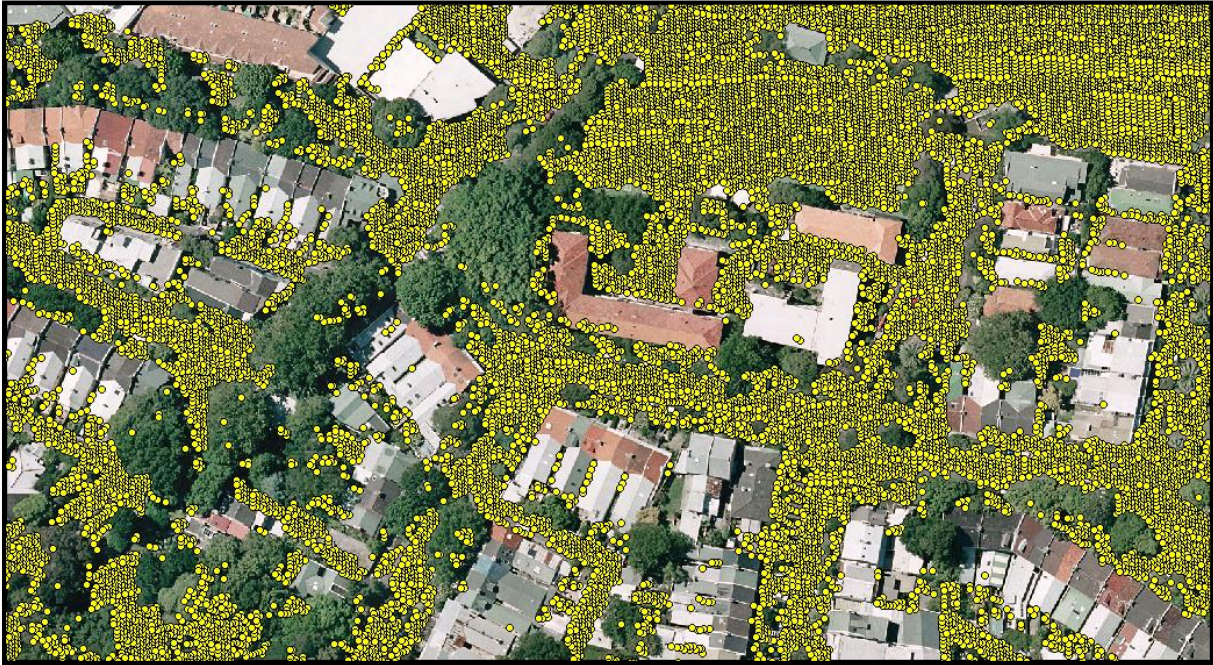
Plate 2 ALS ground data points (yellow) near the corner of Neild Ave and Lawson Street

Plate 2 provides an example of the LiDAR ground point density near the corner of Neild Avenue and Lawson Street. **Plate 2** shows the point density is high across non-vegetated areas (e.g., sports fields, car park, roads). The point density is also generally high in the vicinity of sparse vegetation. However, the point density drops considerably in the vicinity of buildings and dense vegetation. Although this indicates that non-ground points have been removed, it is noted that the lower point density may result in a weaker definition of the variation in ground surface elevation across heavily vegetated sections of the study area. Accordingly, care needs to be taken when extracting terrain information directly from the LiDAR in the vicinity of dense vegetation.

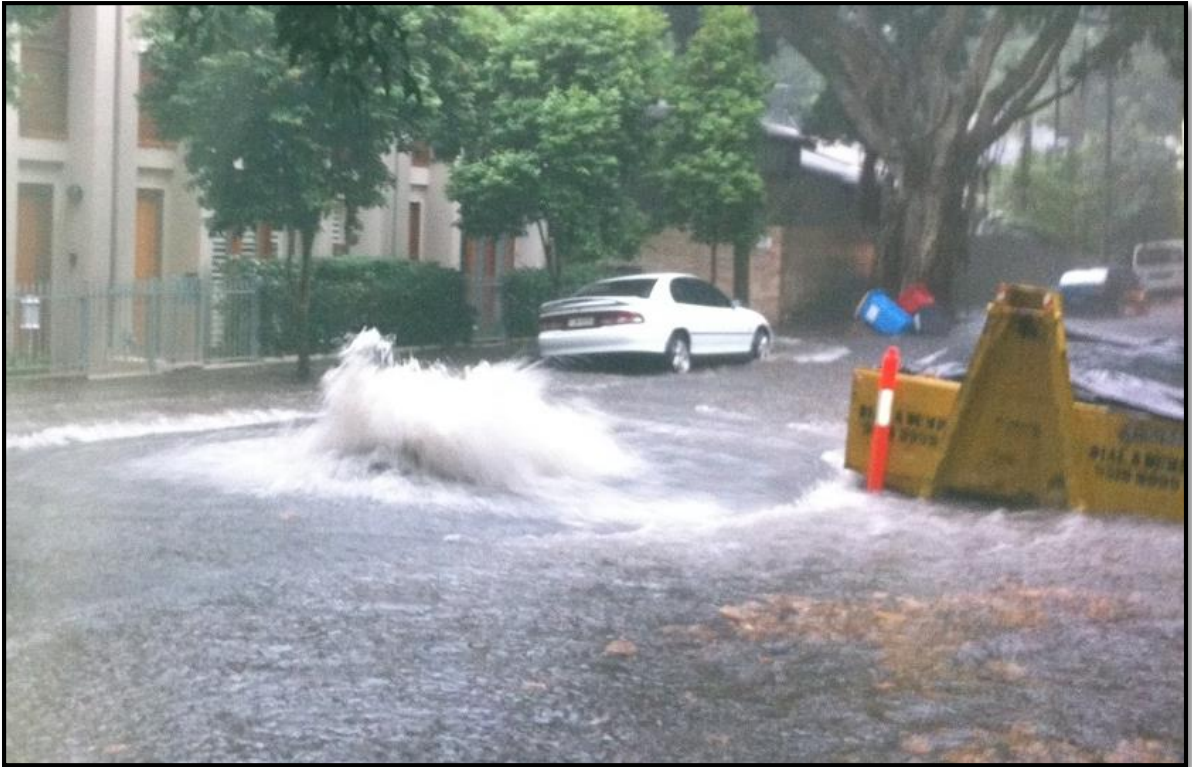
Plate 3 Surcharging stormwater pit in Hampden Street during April 2012 flood

- Flooding from a surcharging stormwater pit in the lower catchment (**Plate 3**);
- Shallow but fast moving water that is largely contained within the roadway but extending onto the adjoining footpath across the steeper sections of the catchment (**Plate 4**, **Plate 8**, **Plate 9** and **Plate 11**); and,
- Deeper “ponded” water contained within localised depressions (**Plate 5**).
- Water cascading down stairs (**Plate 12**)

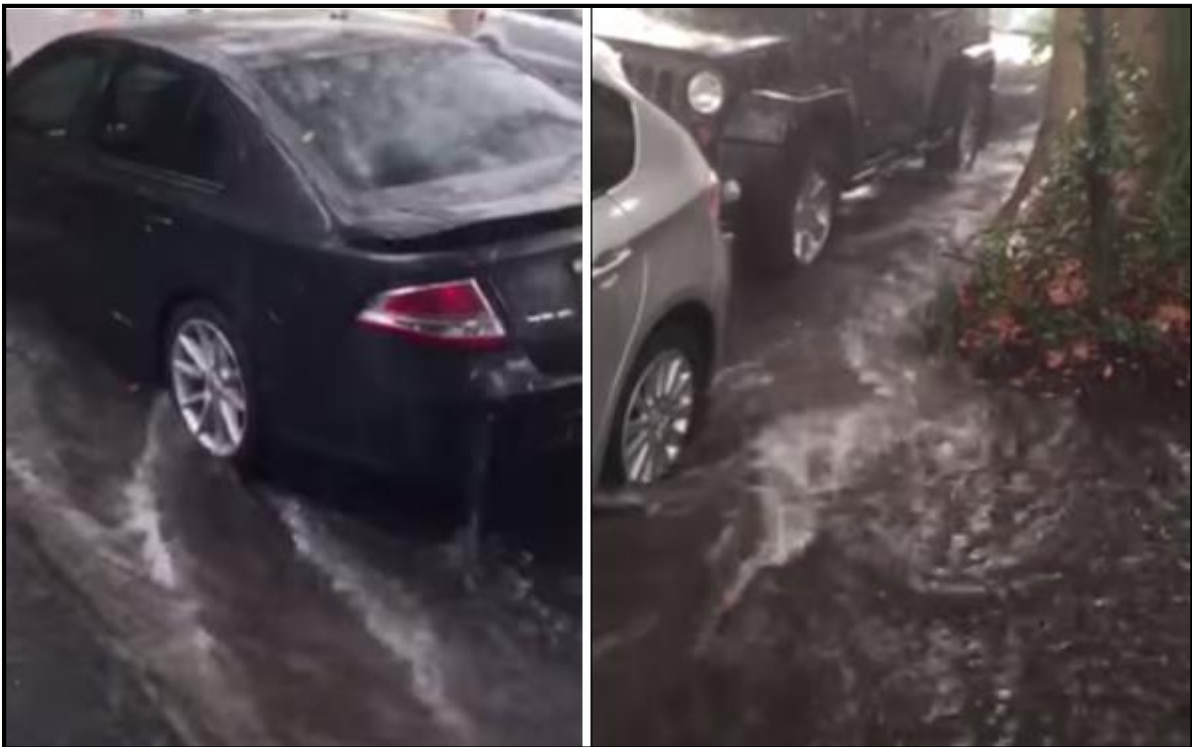
Plate 4 Flooding along Paddington Street during April 2015 flood

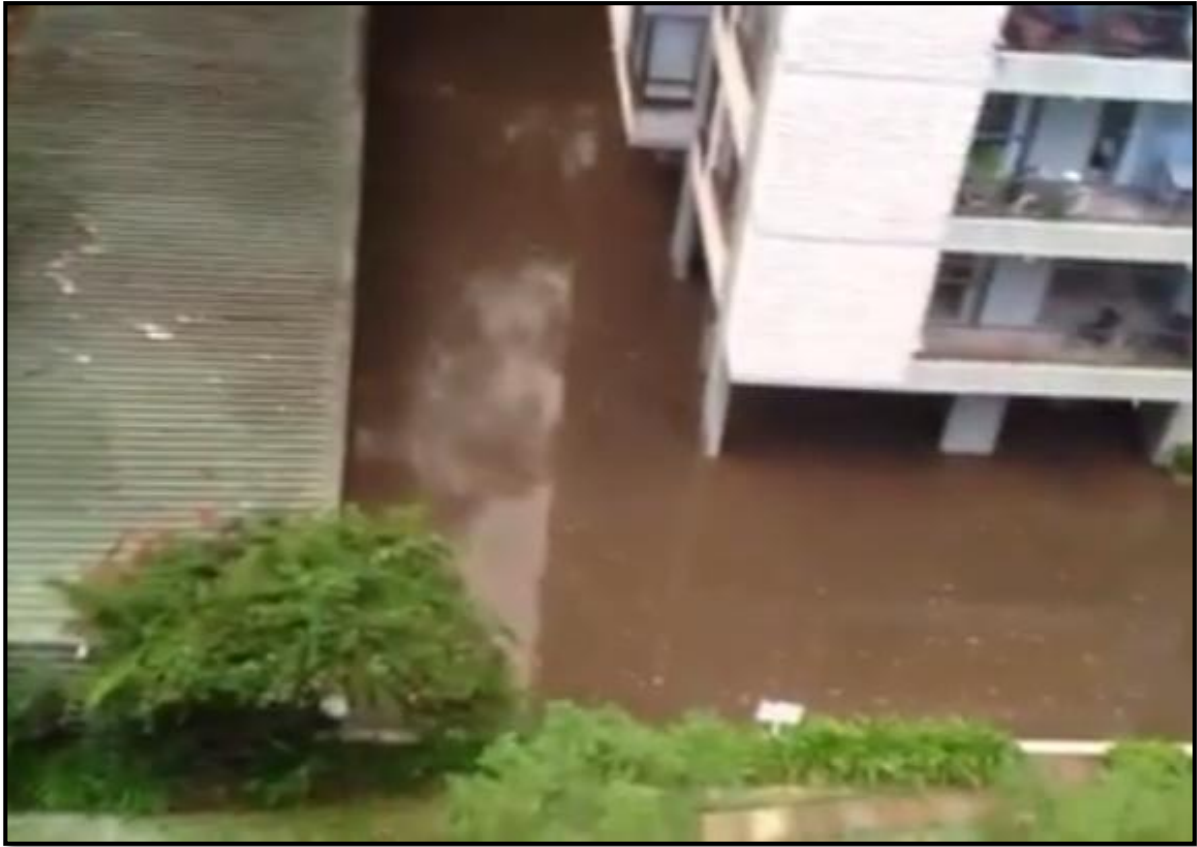
Plate 5 Flooding near Trumper Park during April 2015 flood

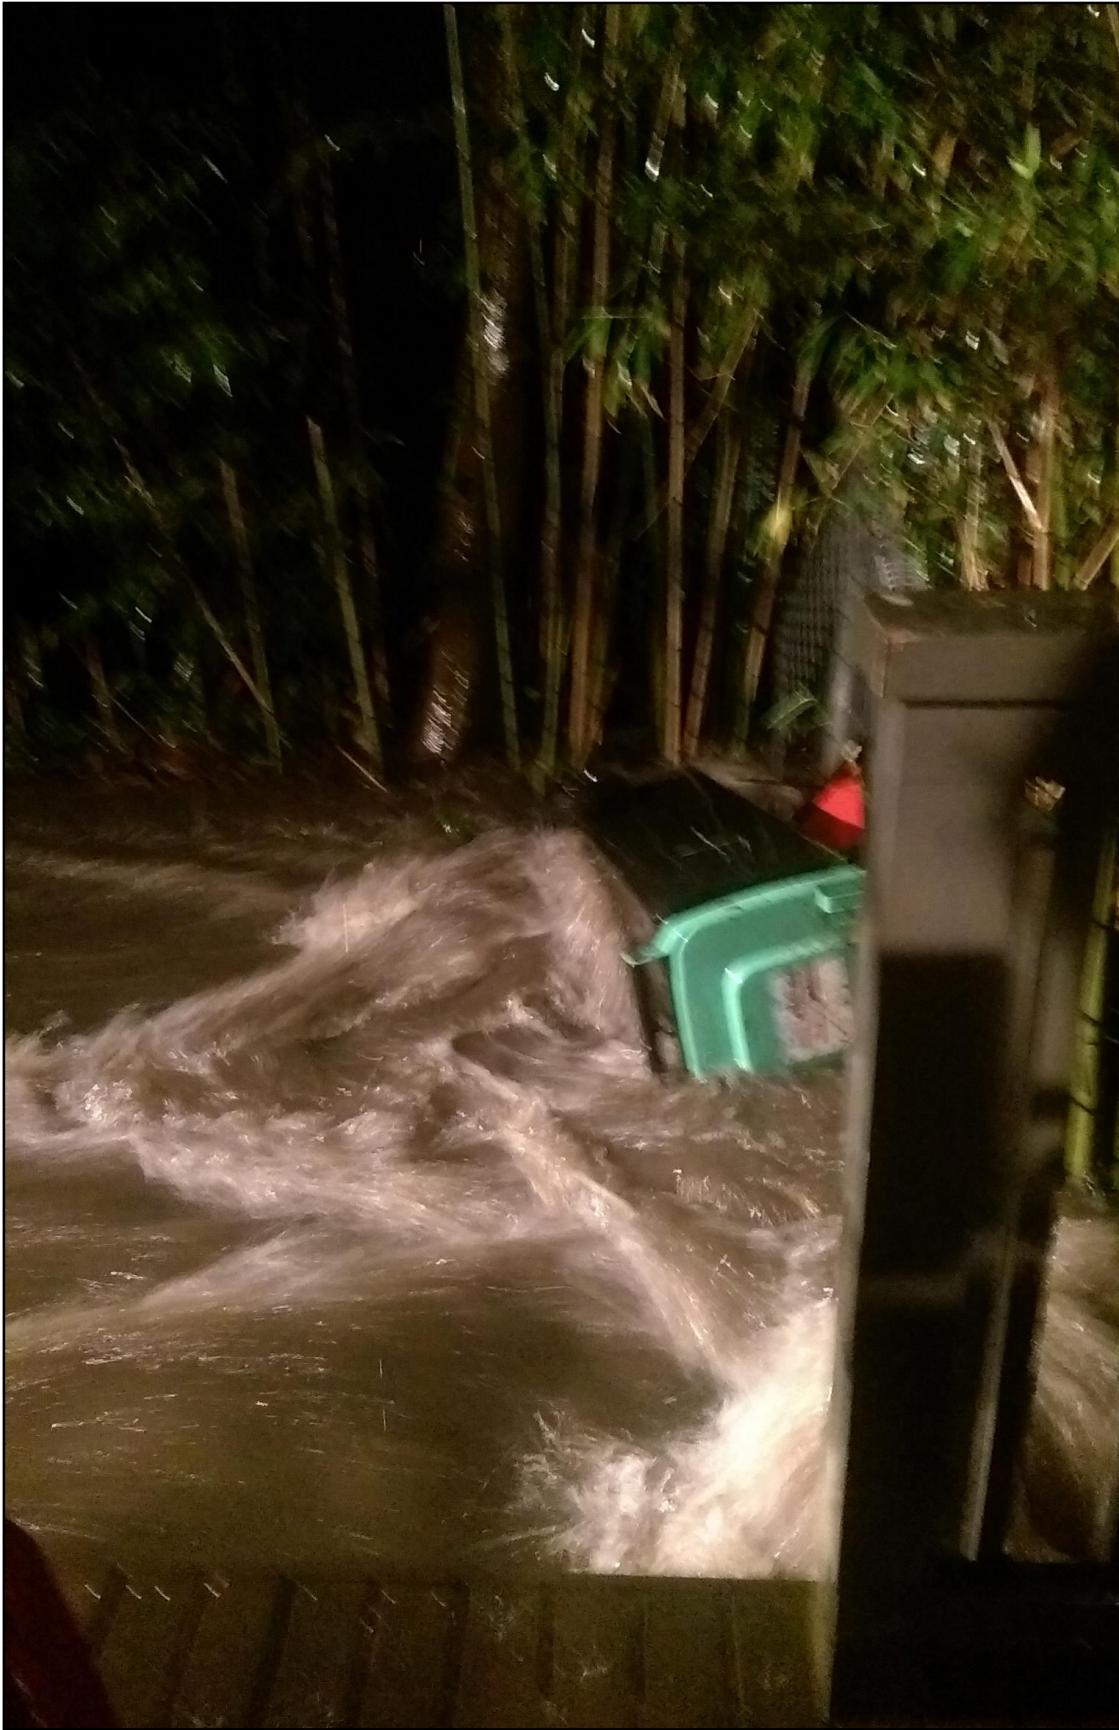
Plate 7 Fast moving water outside of 4 Harris Street during August 2015 event

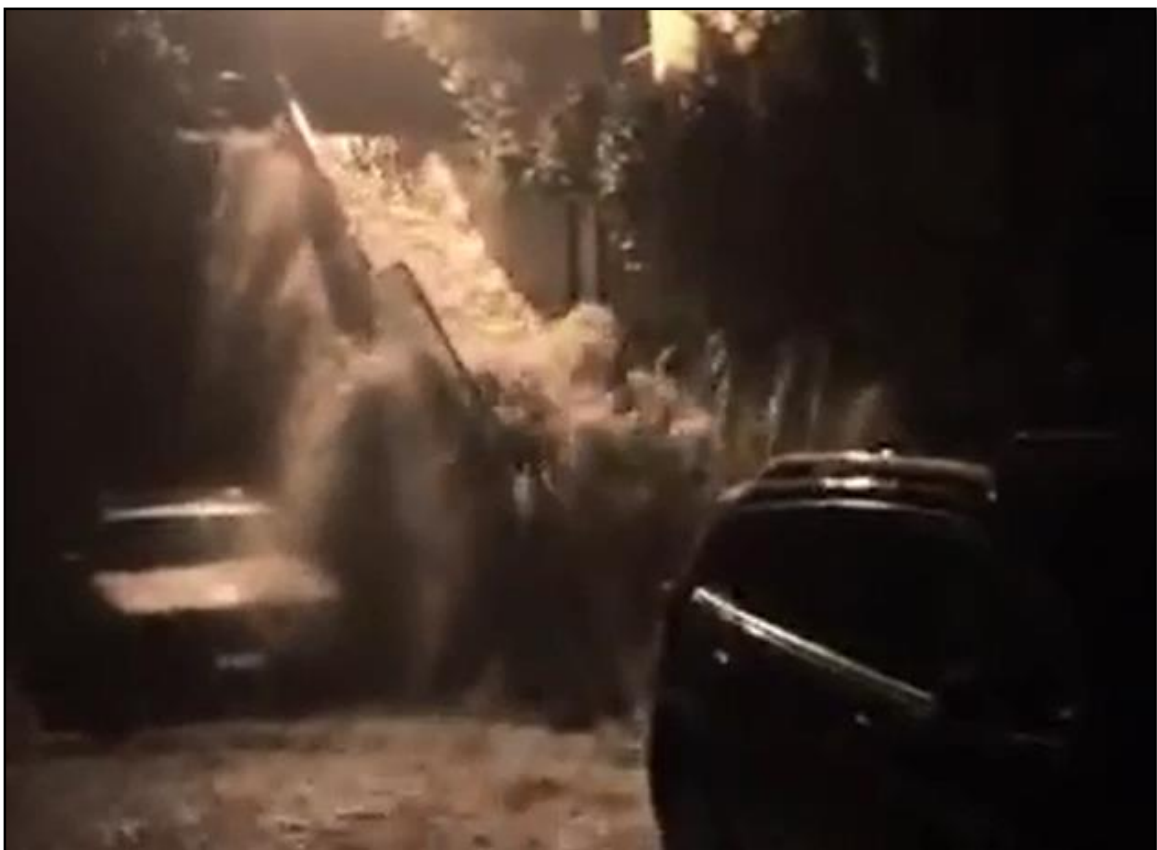
Plate 12 Water cascading down stairs between Forbes St and Sutherland Ave during August 2015 event

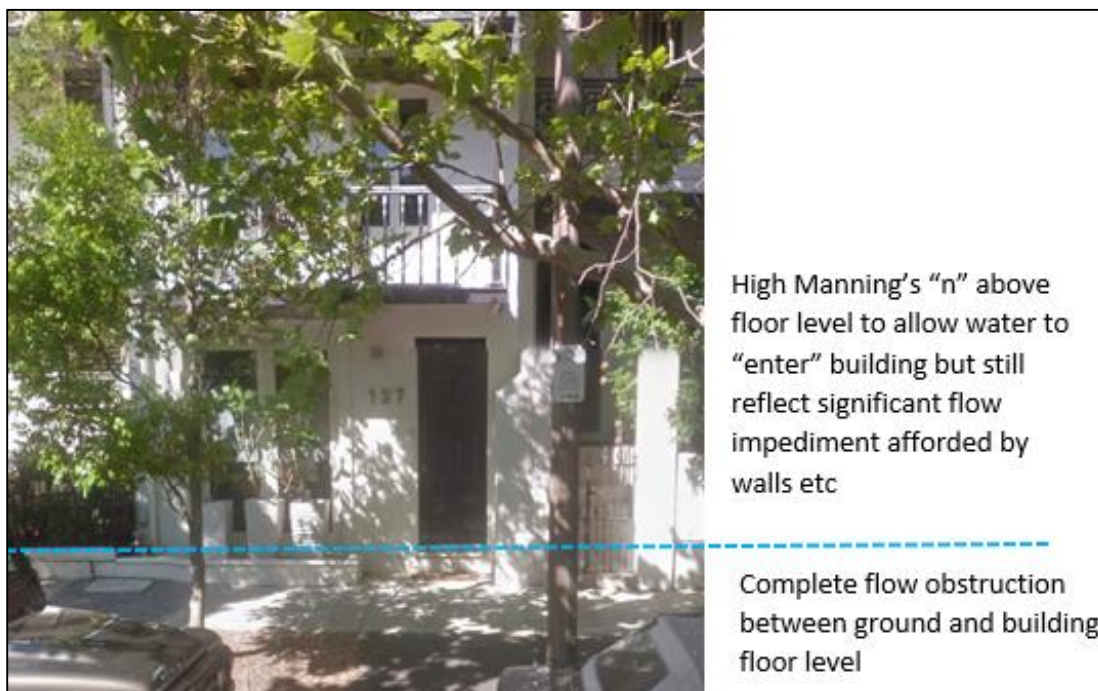
Plate 13 Conceptual representation of buildings in TUFLOW model

The lower part (i.e., the area between the ground surface and the floor level) of each building located within major overland flow paths was represented as a complete flow obstruction. This is shown conceptually in **Plate 13**. Surveyed floor levels were used to define the floor level information, where available. In areas where no surveyed floor level information was available, all elevations contained within the building footprint were raised by 0.3 metres.

Once the water level exceeded the floor level of each building, it was allowed to “enter” the building. However, a high Manning’s “n” value of 1.0 was adopted to reflect the significant impediment to flow afforded by the many flow obstructions contained with a typical house (e.g., walls, furniture etc). This is also shown conceptually in **Plate 13**.

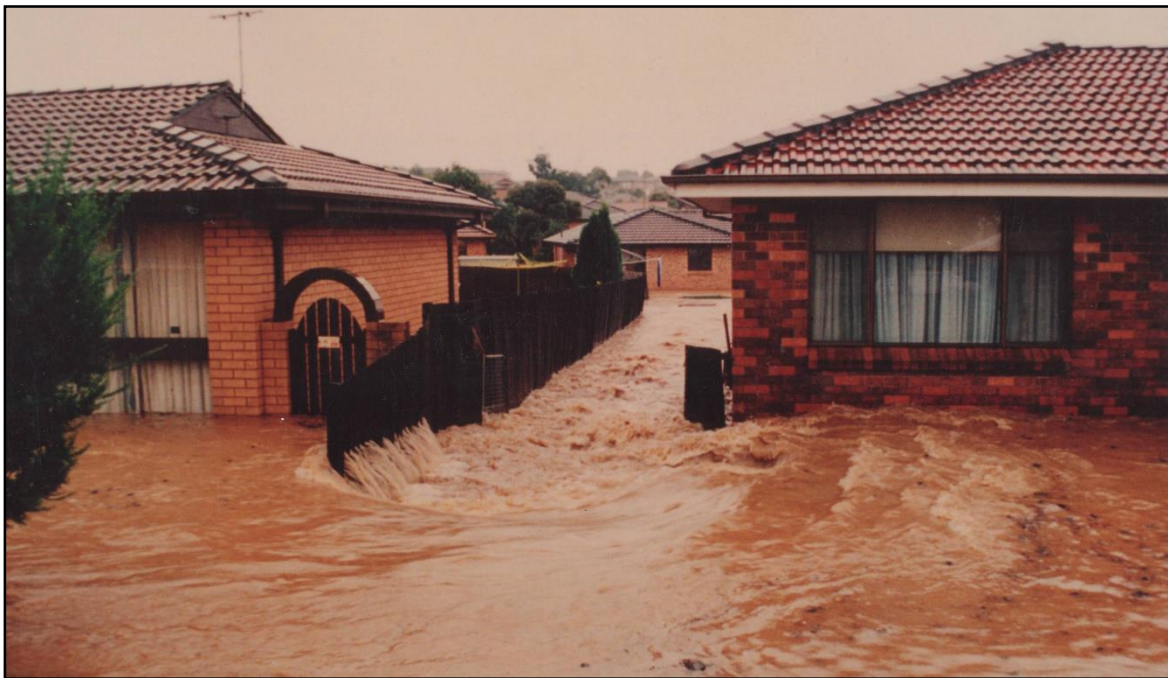
Plate 14 Example of paling fence causing a notable impediment and redistributable of overland flows

Fences can also provide a significant impediment to flow in urbanised catchments (refer **Plate 14**). Therefore, it was also considered important to include a representation of fences within the TUFLOW model. An automated approach was employed to extract approximate fence alignments across urbanised floodplain areas based on information contained in cadastre and LEP GIS layers. This involved using lot boundaries across residential areas as a proxy for fence alignments. The extent of fence lines that were generated based on this approach is shown in **Plate 15**.

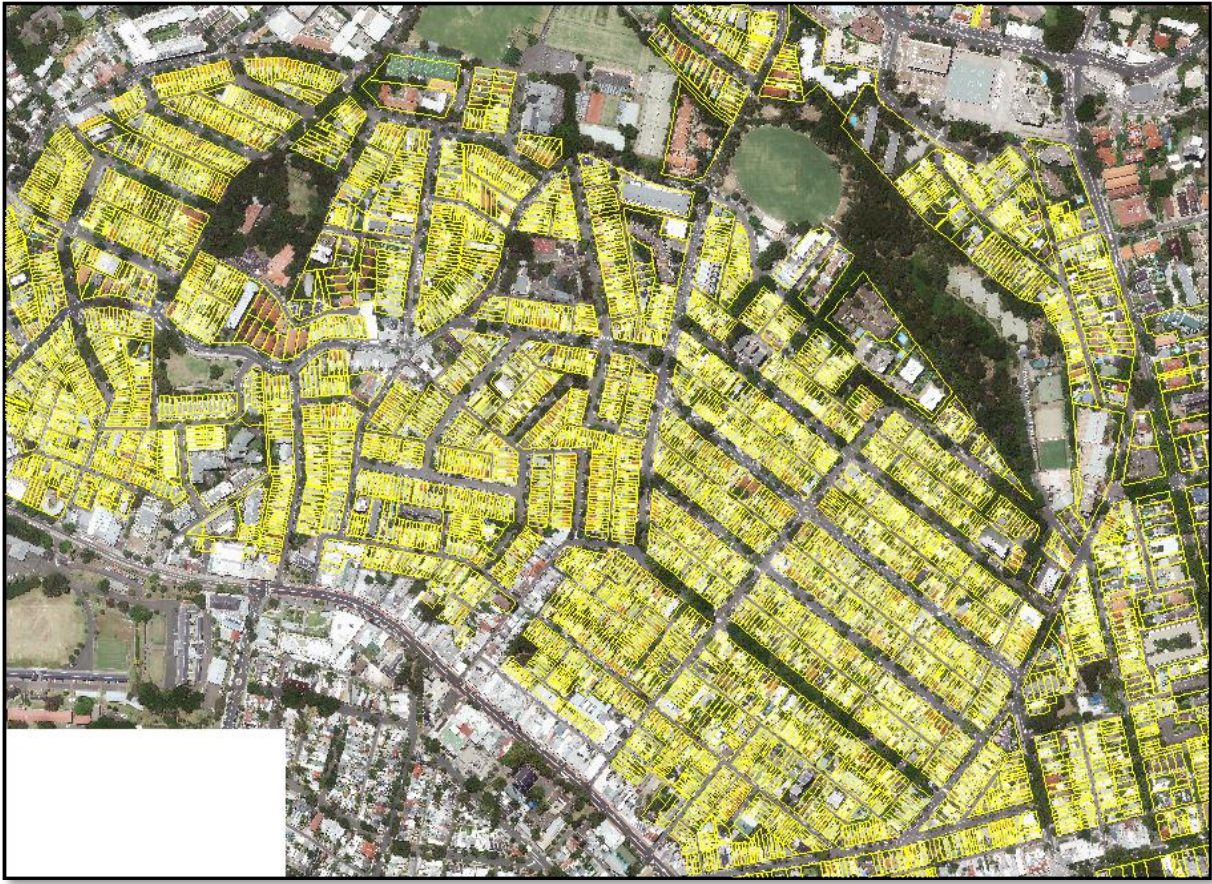
Plate 15 Extent of fences (yellow lines) extracted using cadastre, zoning and roadway GIS layers

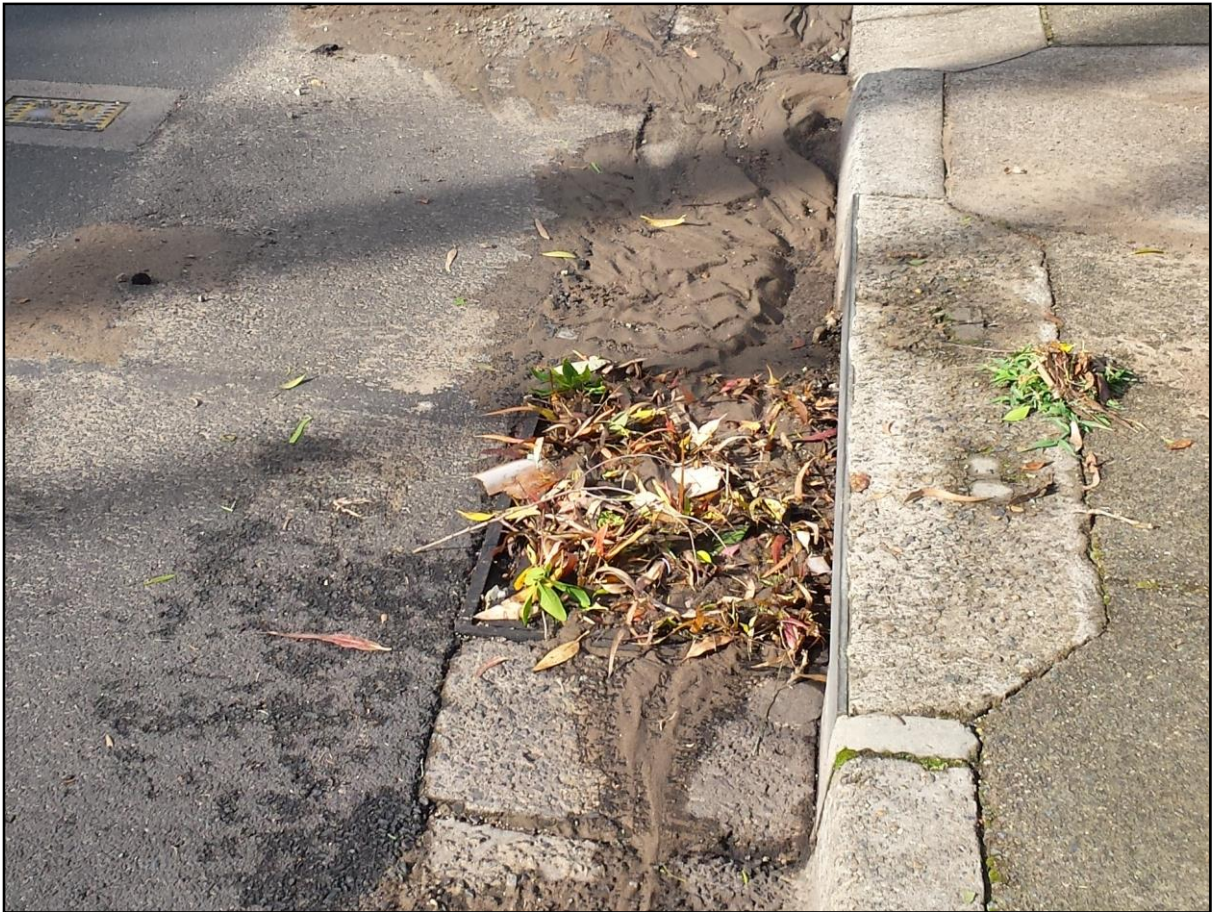
Plate 16 View showing blockage of a stormwater pit located on Glenmore Road following a storm event in 2015

In recognition of this, blockage factors were applied to stormwater pits. The blockage factors were based on the latest available structure blockage information contained in 'Blockage of Hydraulic Structures: Blockage Guidelines' (Engineers Australia, 2015). This resulted in the following blockage factors being adopted for each design flood simulation:

- Sag inlets: 50% blockage
- On-grade inlets: 20% Blockage

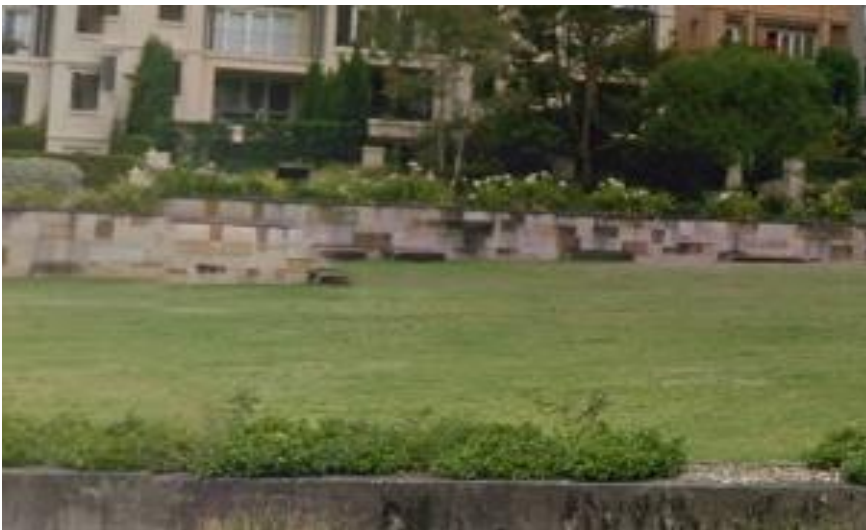
Material Type 5 - Grass
Relatively short grass. Occasional tree or fence post

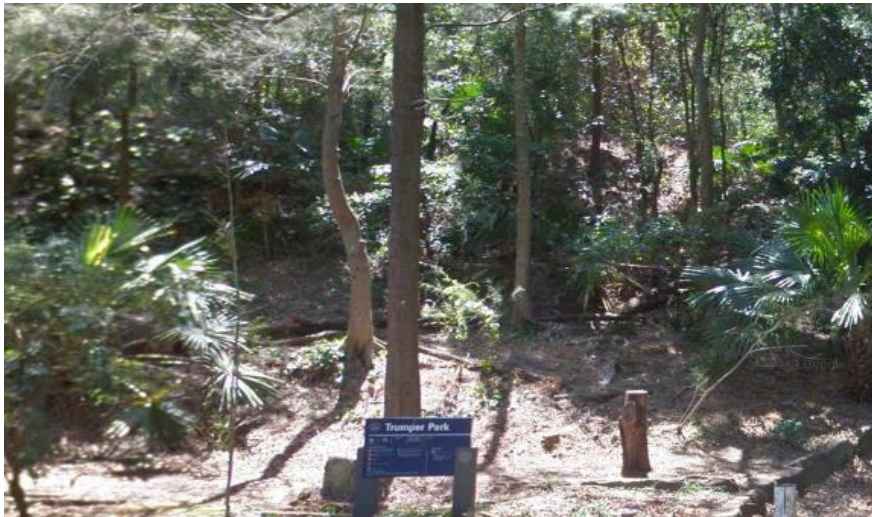
Material Type 3 - Trees
Trees (> 2metres in height) with medium to dense undergrowth

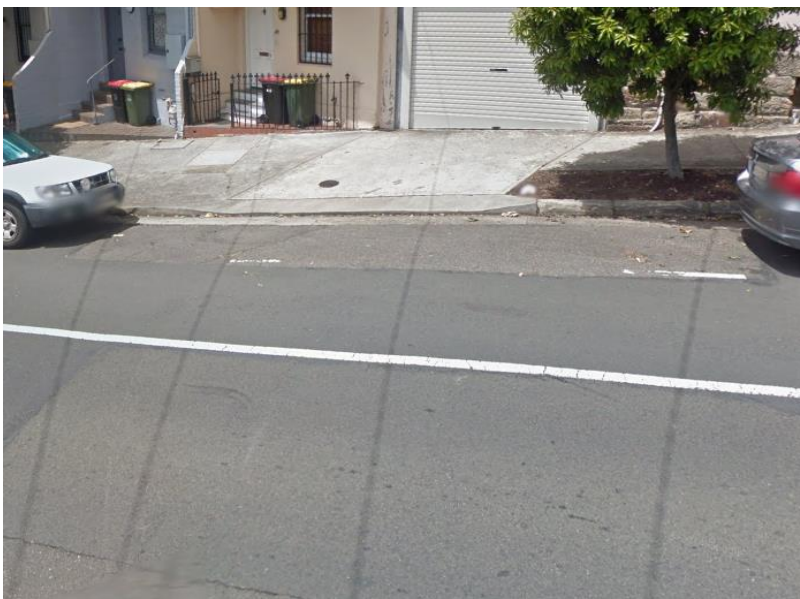
Material Type 2 - Roads

Concrete kerb & gutter for containing low flows with road pavement at higher stages

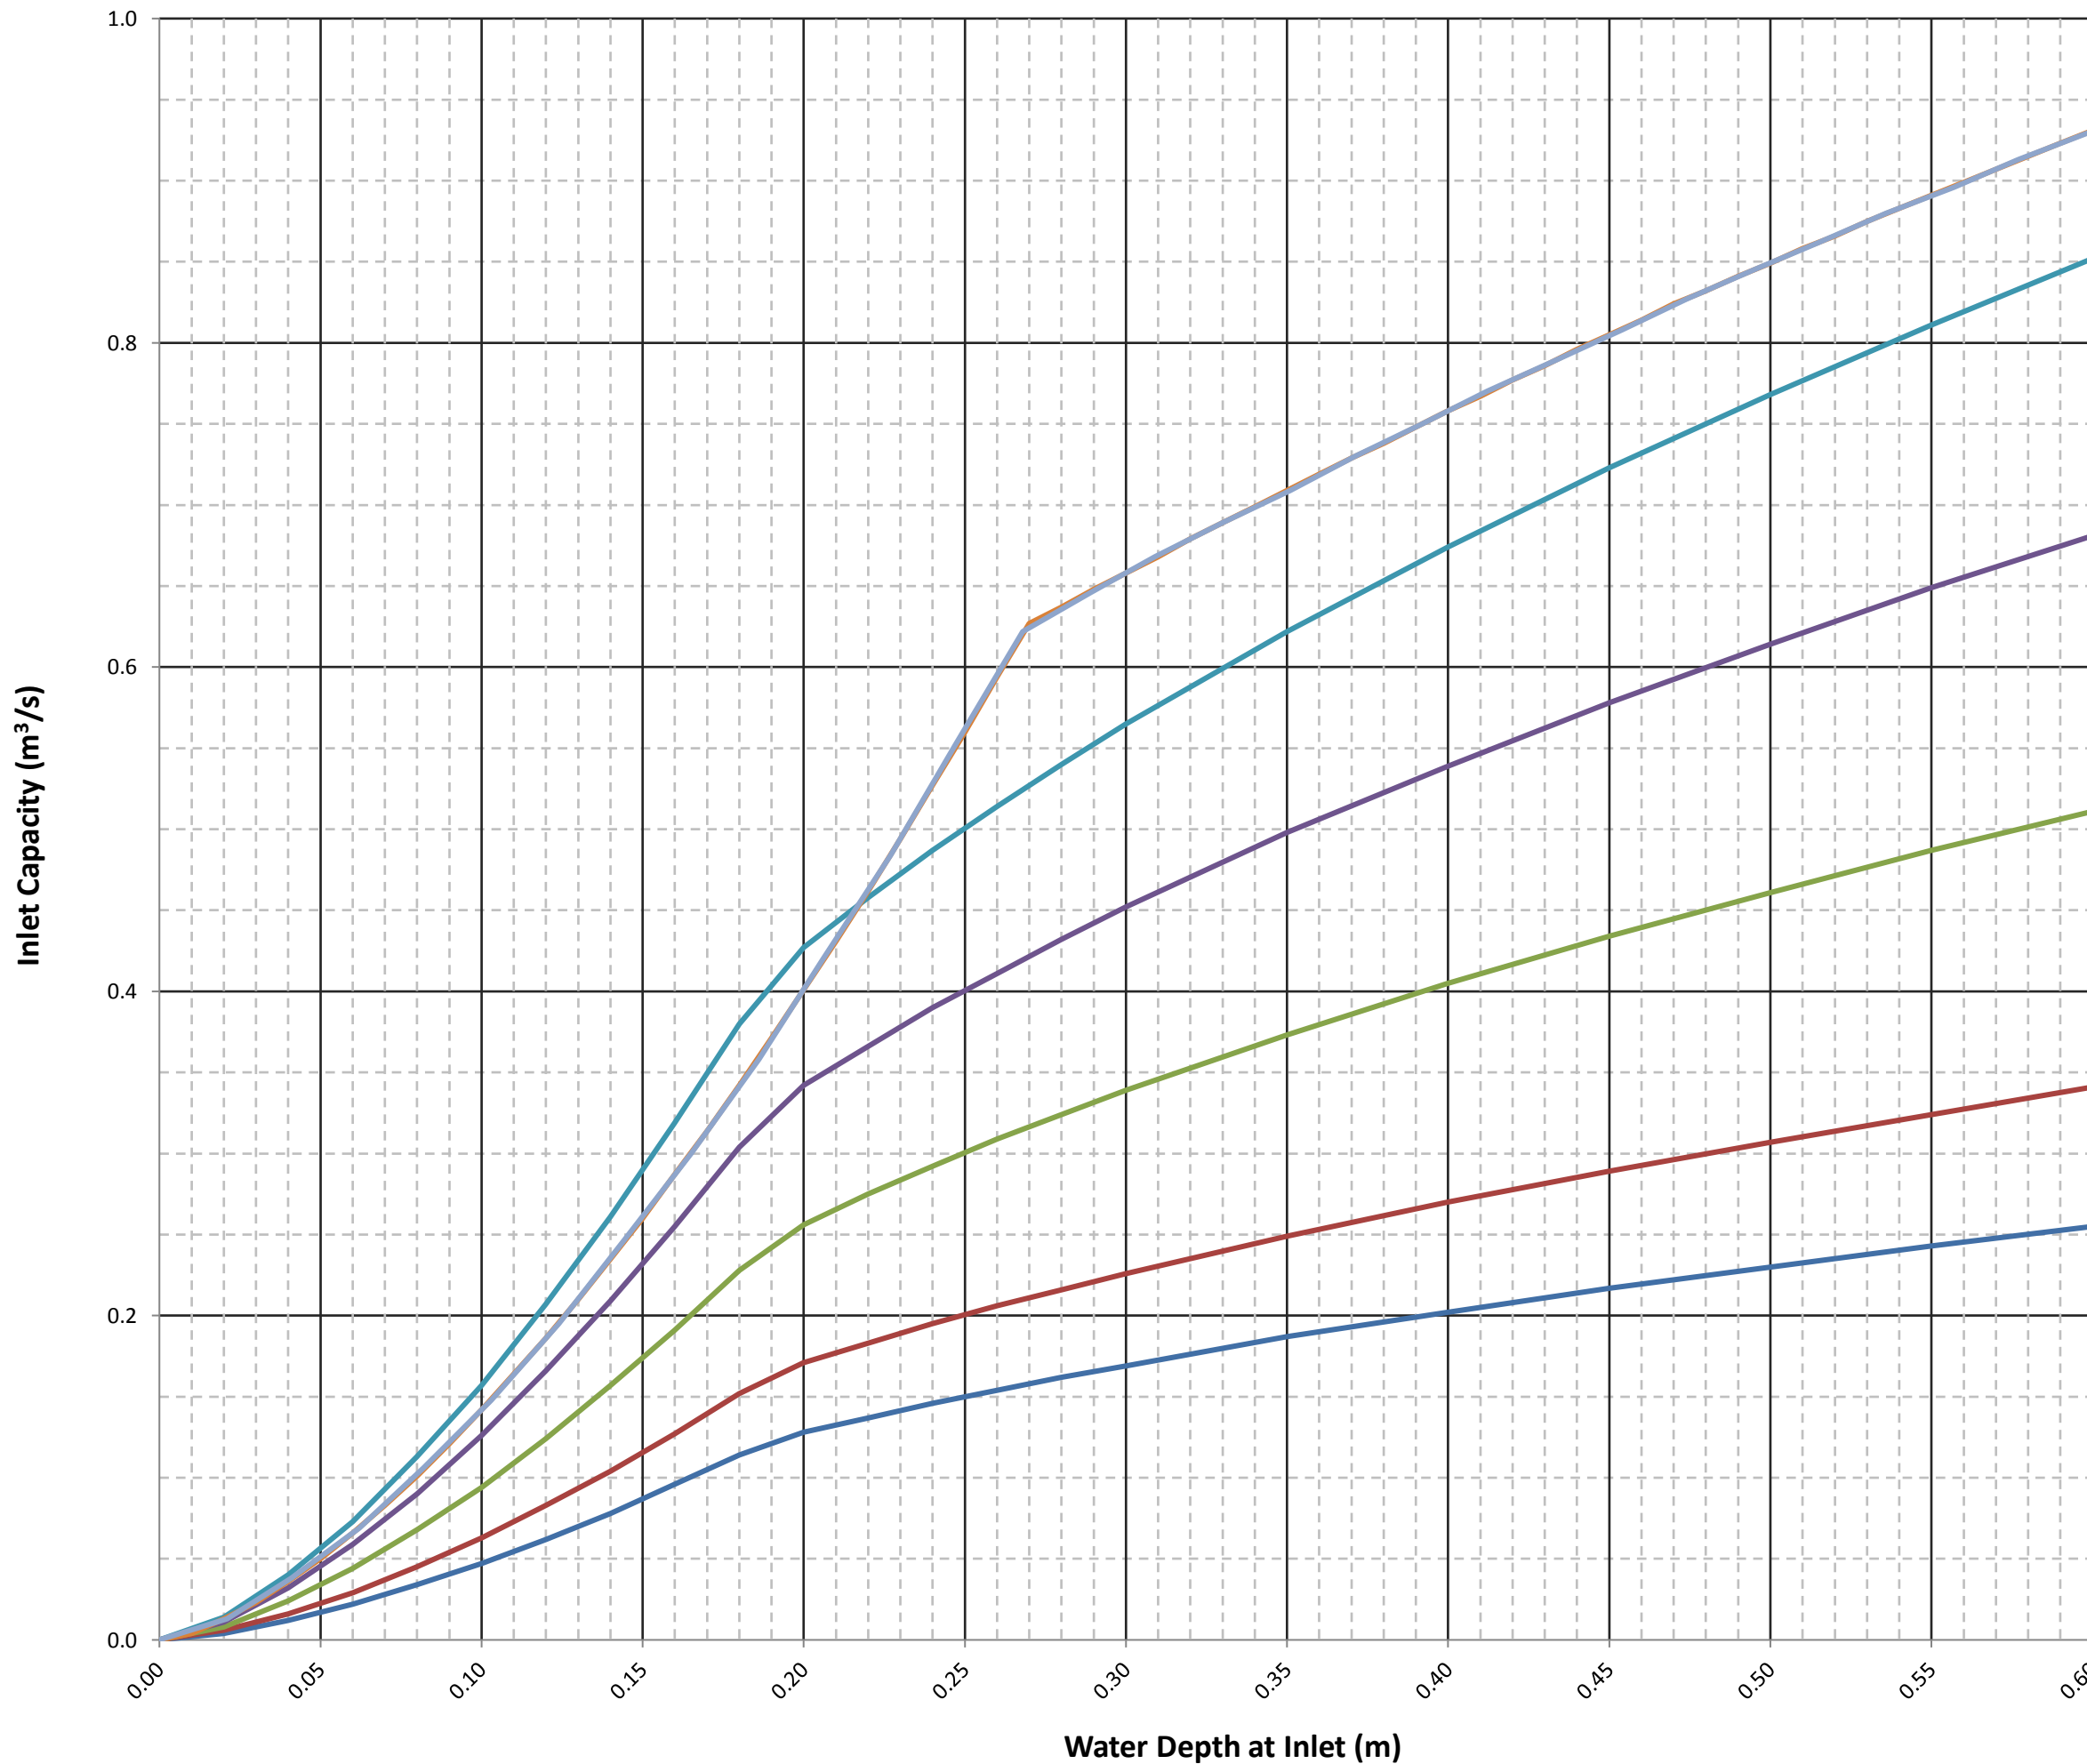
STORMWATER PIT INLET CAPACITY CURVES

- Combination Inlet with 0.9m Lintel
- Combination Inlet with 1.2m Lintel
- Combination Inlet with 1.8m Lintel
- Combination Inlet with 2.4m Lintel
- Combination Inlet with 3m Lintel
- Grate Only Inlet
- Kerb Only Inlet

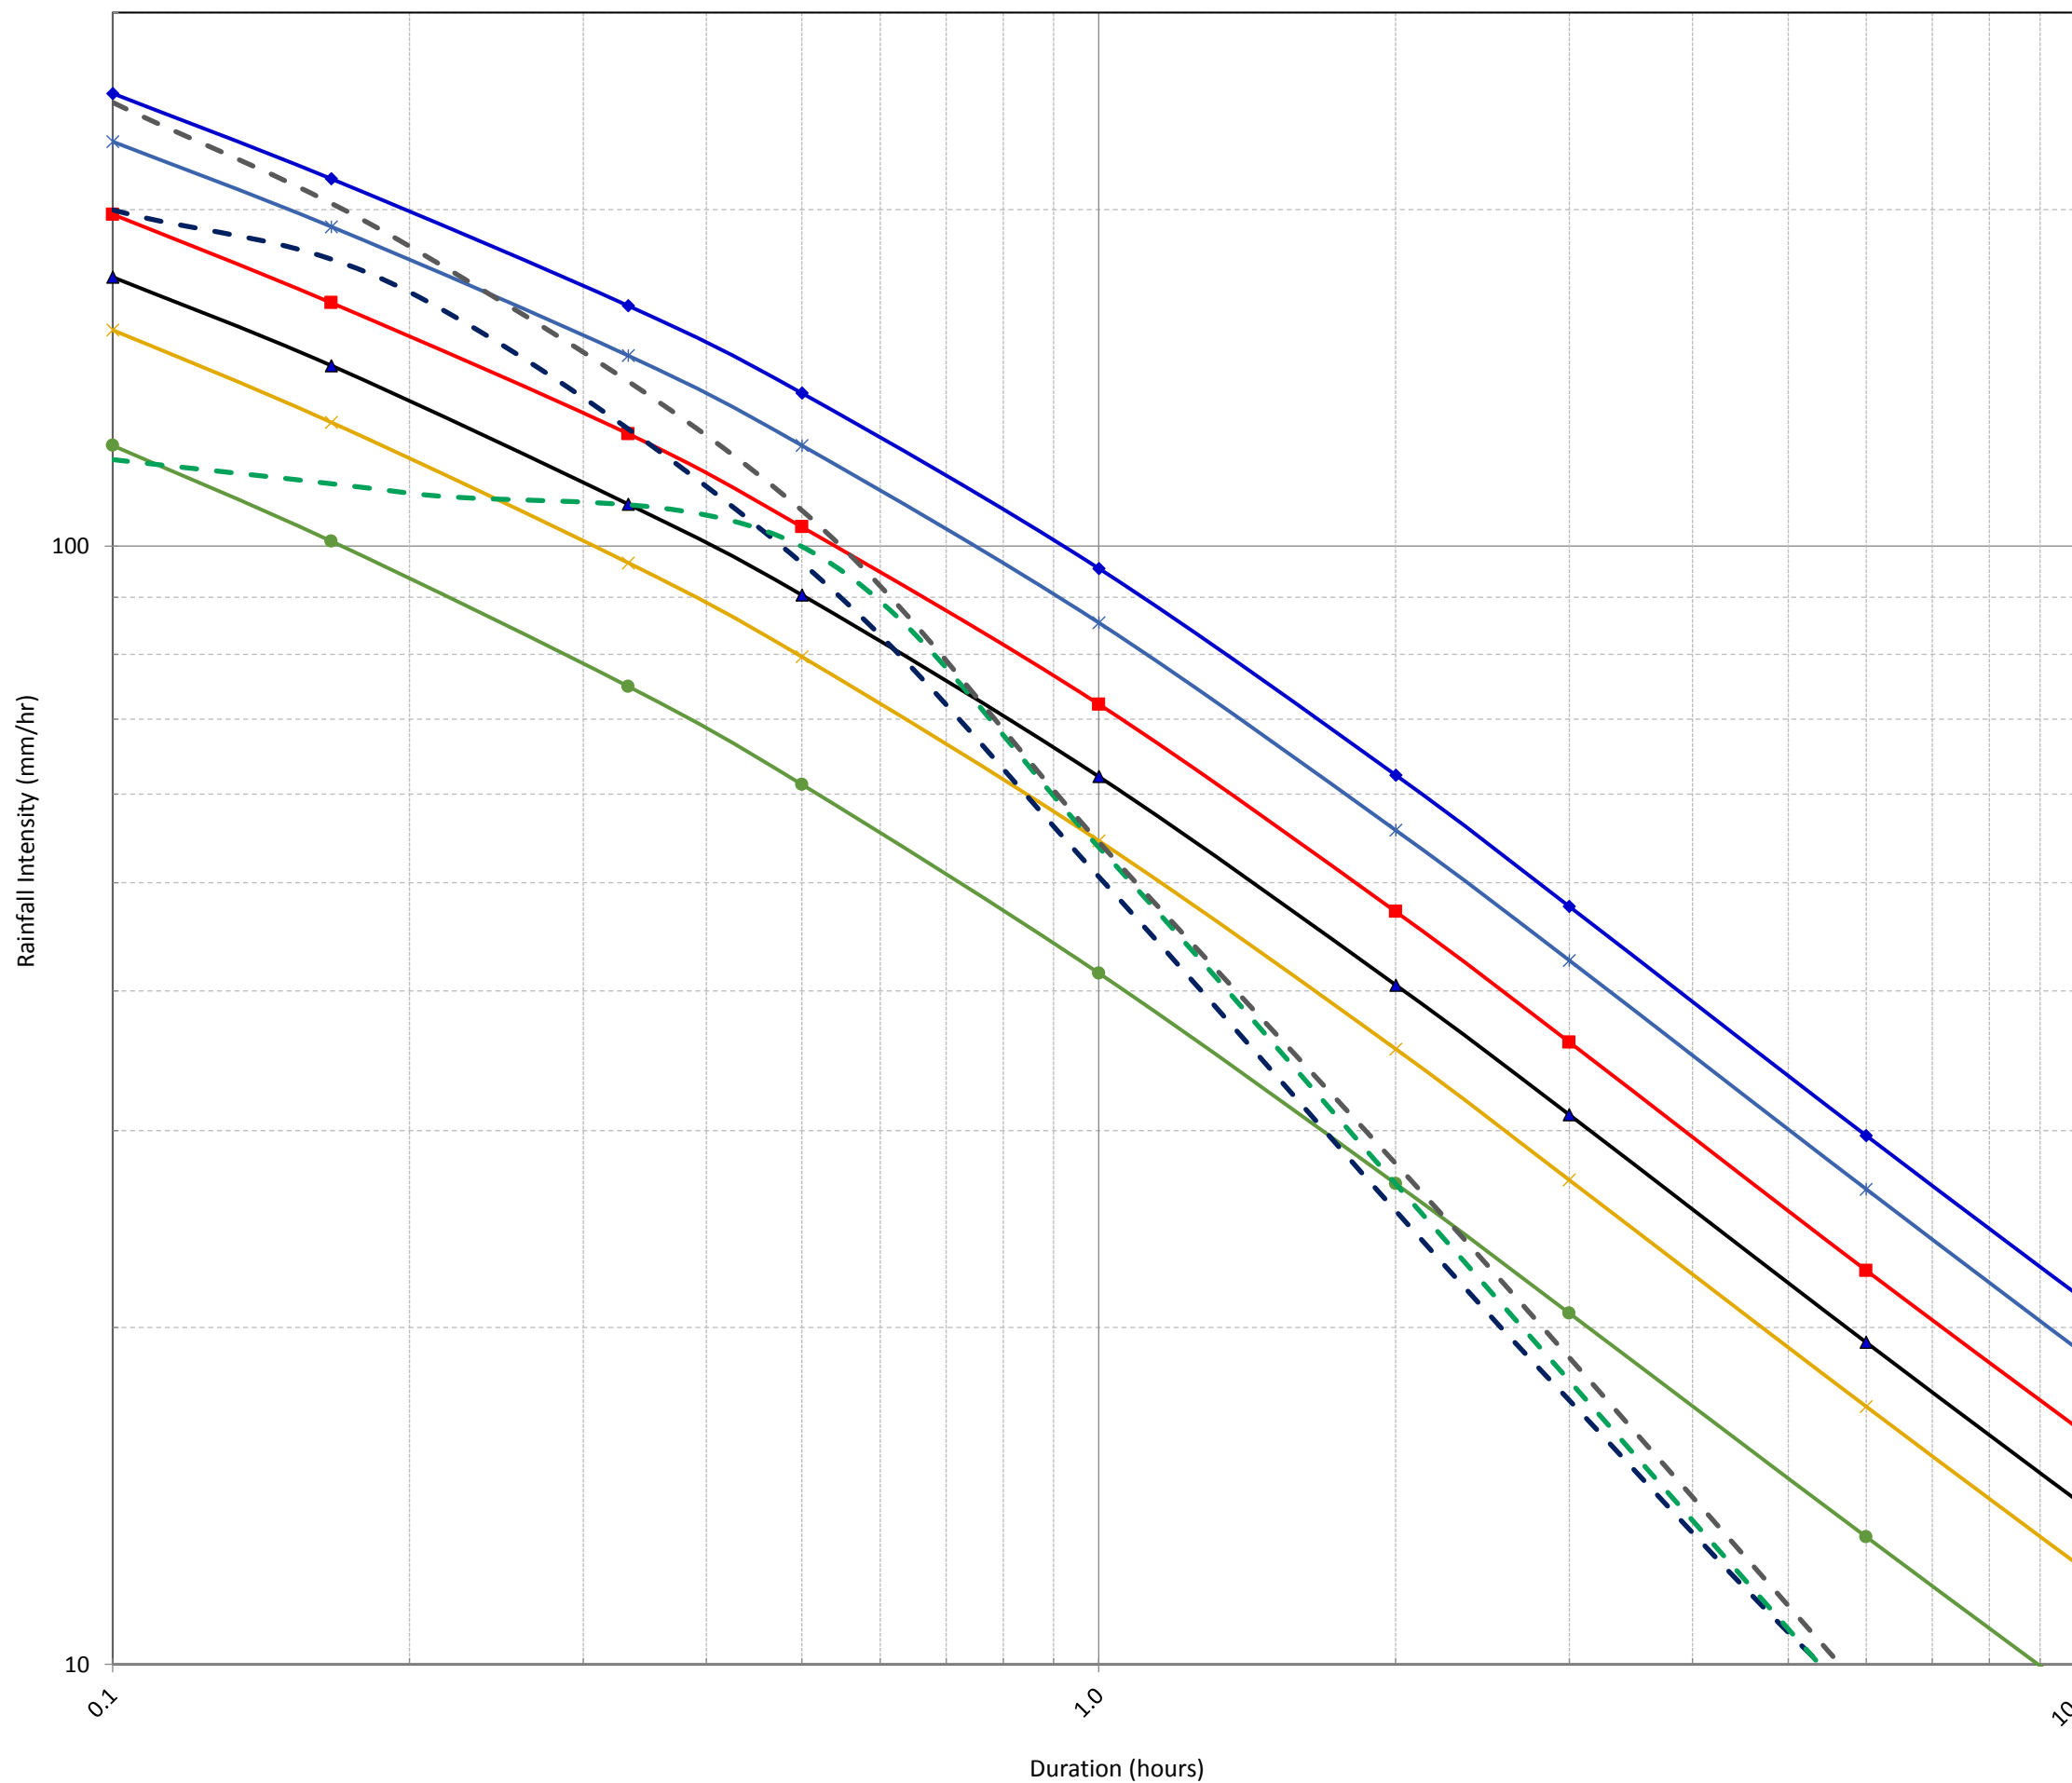
INTENSITY-FREQUENCY-DURATION DATA

- 1% AEP
- 2% AEP
- 5% AEP
- 10% AEP
- 20% AEP
- 50% AEP
- 2015 Rainfall
- 1991 Rainfall
- 1989 Rainfall
