SUMMARY REPORT

Gap Park Masterplan

Thompson Berrill Landscape Design Pty Ltd

MARCH 2008

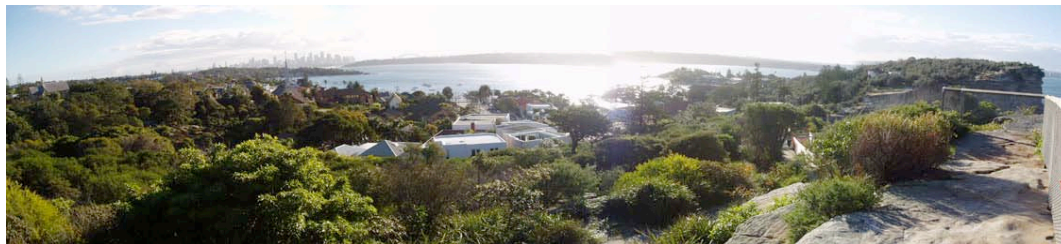
Gap Park escarpment

The cliffs and escarpments along the eastern boundary form the highest part of the site, and are exposed to the coastal winds of the Tasman Sea. From here the park slopes towards Sydney harbour. A level change runs longitudinally through the park, steeper in some areas than others, and separates the western and eastern areas. The western boundary is the lowest part of the site, with greater protection from the elements.

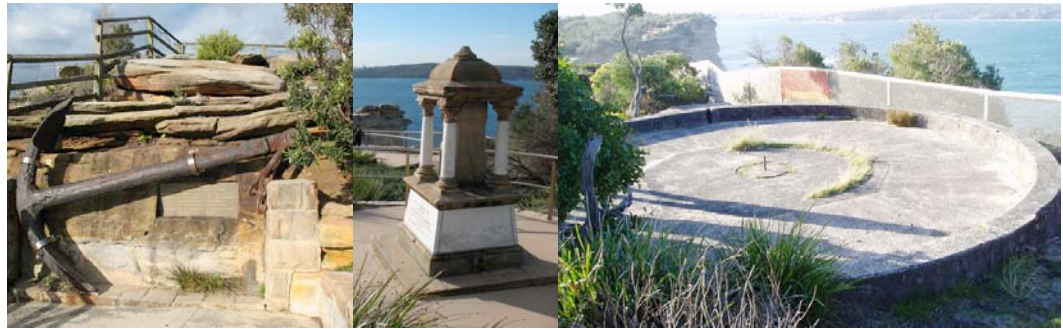
Historic elements

The Dunbar was wrecked to the south of Jacob's Ladder in 1857, with a resulting 121 casualties, and only one survivor. Its Admiralty anchor was retrieved in 1910, and erected as a memorial in 1930.

The World War II gun emplacement was for a small calibre gun, which was never installed.

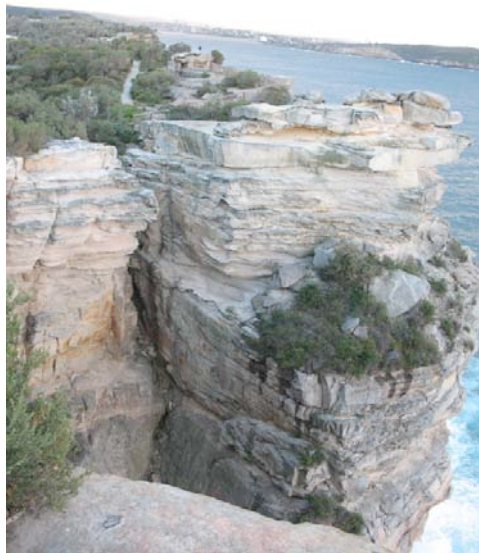
Sandstone cliffs and "Jacob's Ladder"

Sedimentary Hawkesbury sandstone is the underlying bedrock across the park, and is particularly visible along the cliffs and escarpments along the eastern boundary. These cliffs have been shaped by the forces of wind and water acting on them over thousands of years.

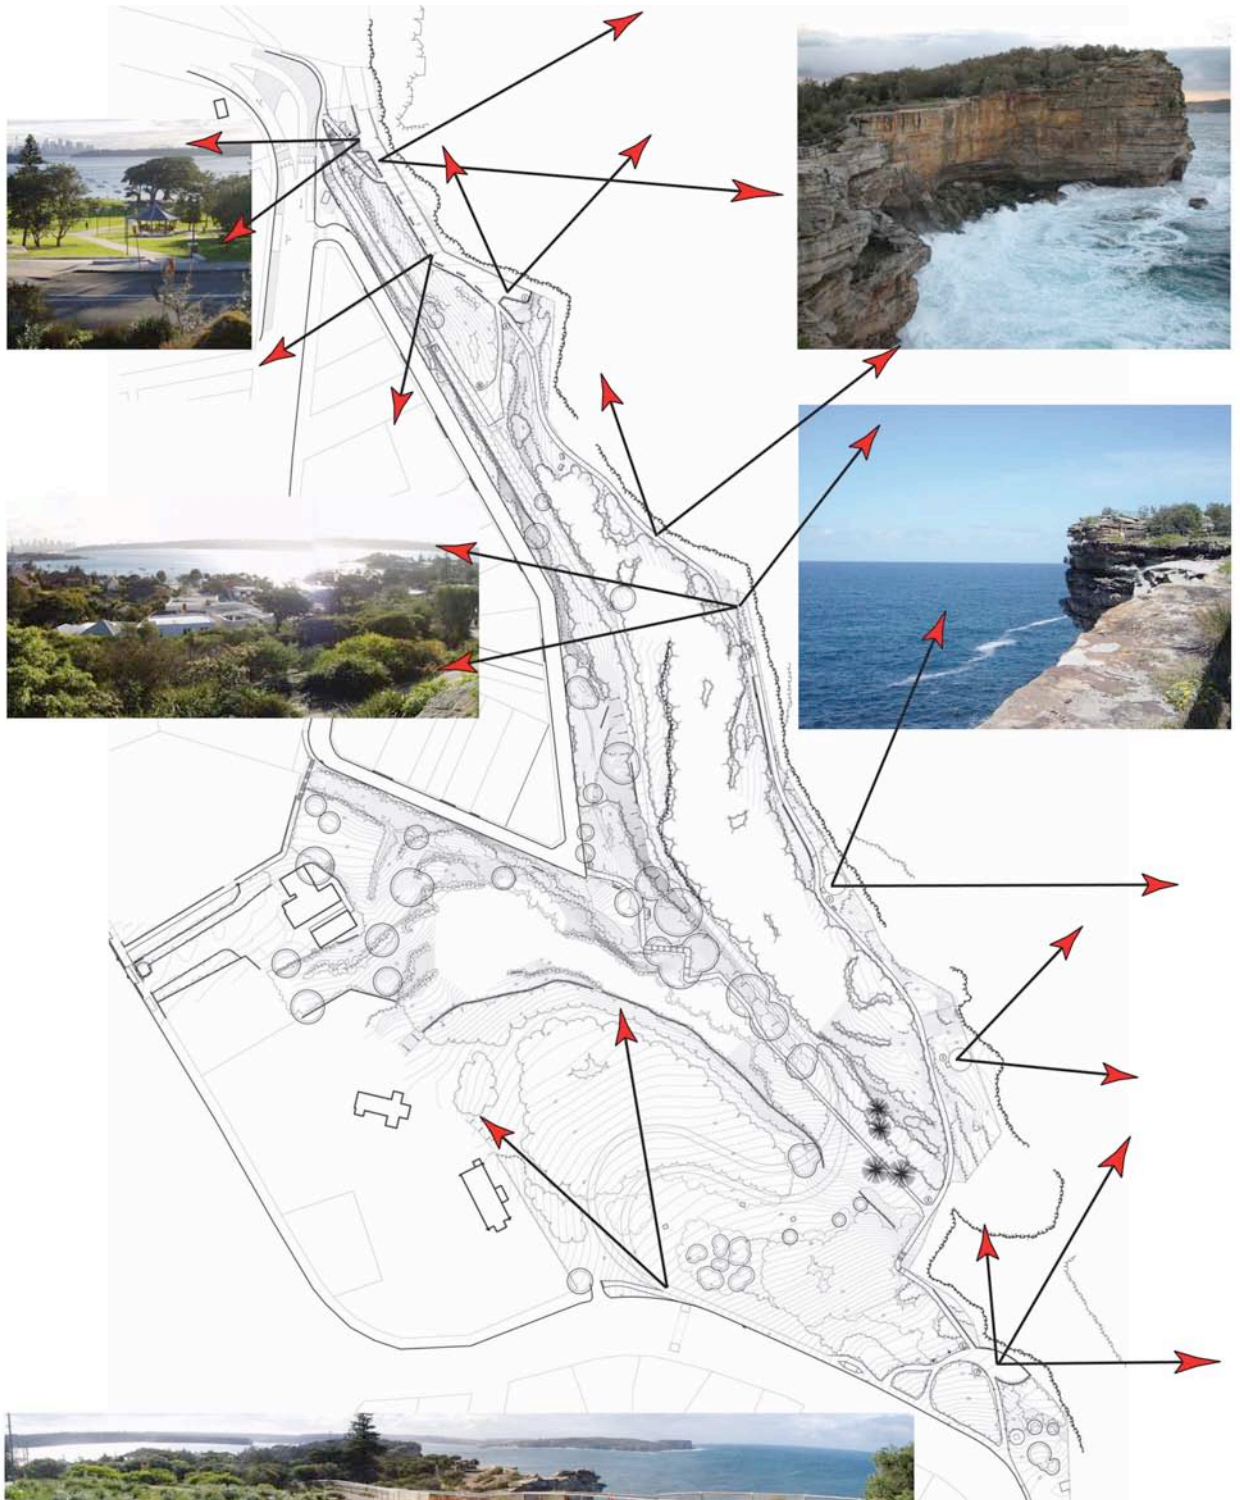
Gap Park view corridors Diagram 02

The southern end of the site also offers expansive views across Gap Park, the ocean, and Sydney harbour. The views from here have been significantly reduced since the 1980s bush regeneration plantings of non-endemic native species, which followed the 1960s landfilling of the area and the existing tramline cutting.

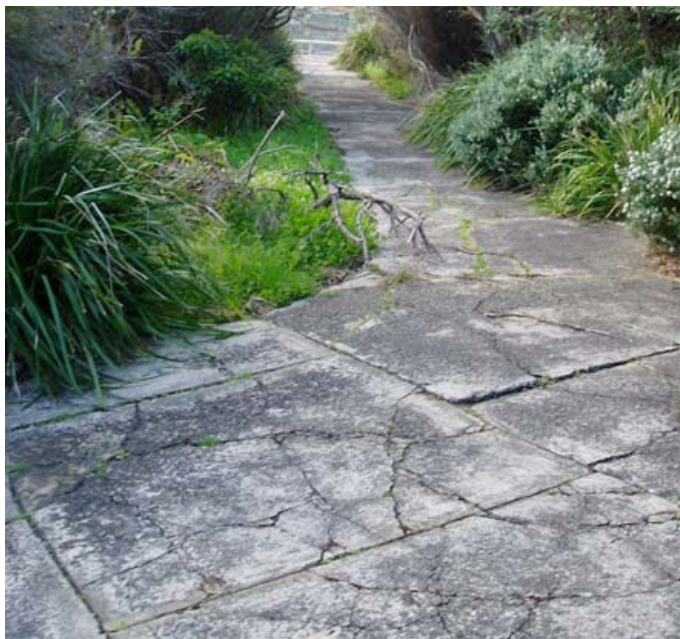
Concrete with exposed aggregate is used throughout the park, and was selected because of its durable nature. The concrete of The Gap viewing area is particularly distinctive, and visually articulate the harsh natural conditions of the site. The remnant original concrete paving from the former “Gap Loop” tram station to The Gap viewing area also tells its own tale of the former access to the site. In other areas, such as the littoral rainforest part of Jacob’s Ladder, the concrete was textured to provide grip. Parts of the existing paving, such as is evident along the coastal path, are lifting and require attention.

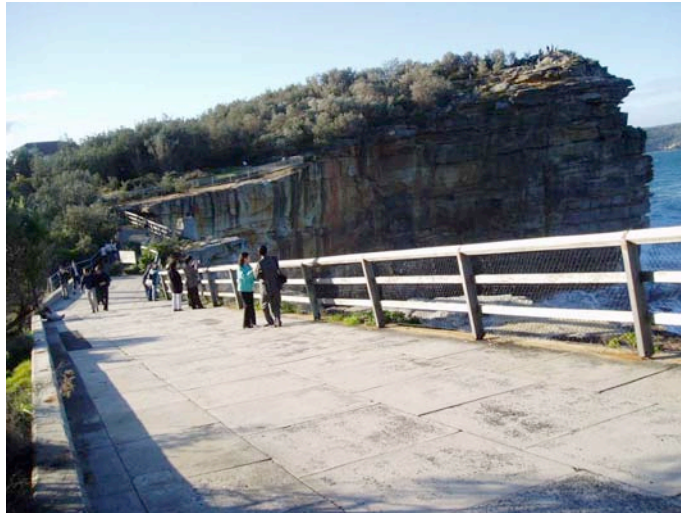
Currently, The Gap viewing area as it is known is in a deteriorated state from a combination of benign neglect and harsh site conditions. This area has been neglected since landscape works in the 1980s, and consequently there is no seating provided, almost no signage, no lighting, the arrival experience is weak, there is no all-ability access, and the railing is outdated and damaged in places.

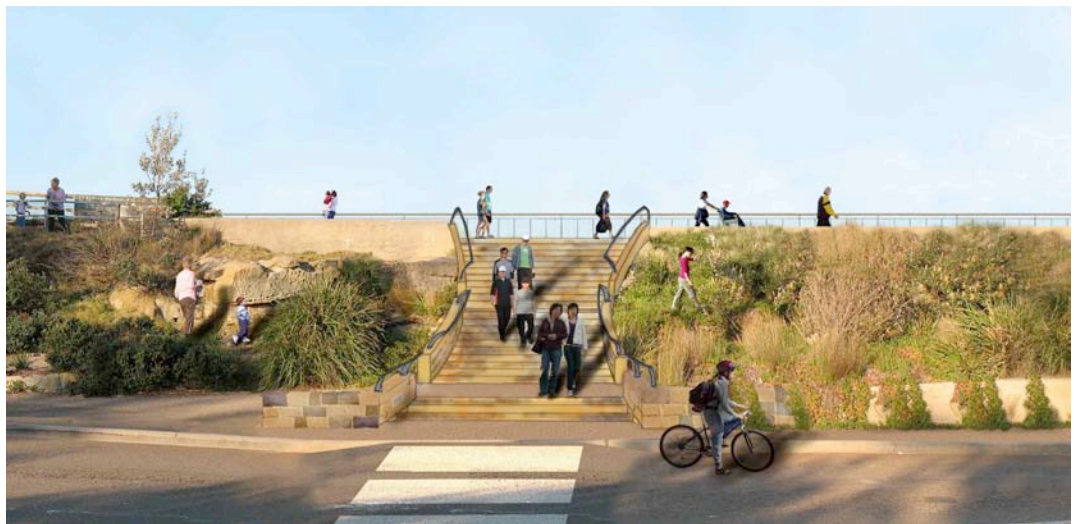
The Gap main entry

450mm high seat and integrated low level lighting will be provided to the back of The Gap promenade. Existing concrete wall will be re-fitted with timber seating (refer GPMP-02 detail 6).

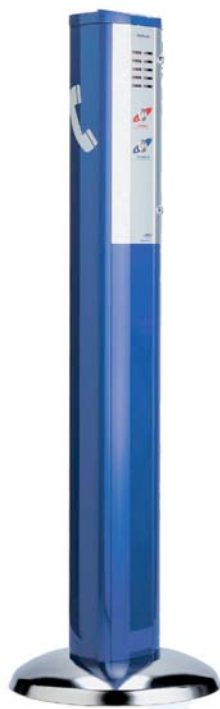
- Programmable send and receive numbers with no charge for call
- One to three push button(s) to programmed numbers (e.g. 000 or local police)
- Hands-free speaker, with built in microphone
- Internal battery with charging options (solar, mains)
- Digitally stored announcements
- Illuminated button option
- Vandal-resistant aluminum housing, with dual high security locks
- All weather protection rating

Recommendations have been made by the Rose Bay Police, mental health counsellors and the Safety Committee for a safety telephone to be installed at the key entries to Gap Park. These cashless phones would allow people considering self-harm to contact a counselling service provider such as “Lifeline”, and also allow people witnessing incidents of potential self harm to contact a support organisation. The phones would be signposted, and positioned in a discreet, but easily accessed location.

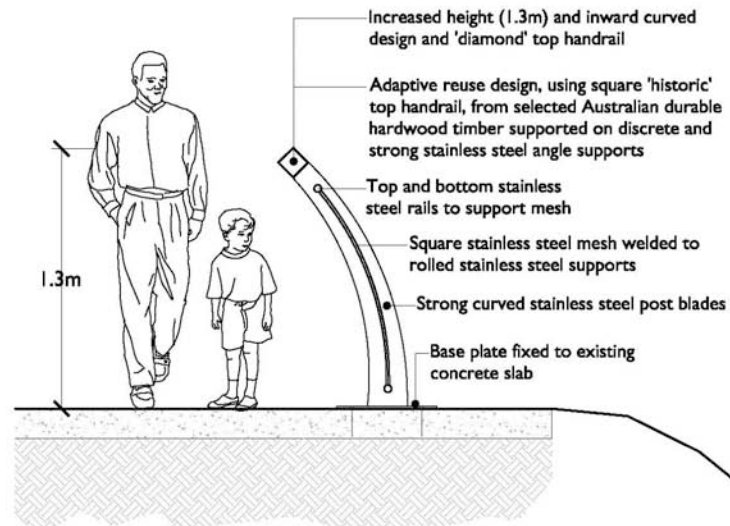
5 New Gap Park Viewing Balustrade Section
1:25

Balustrades are to be installed at the key lookout areas to the north and south of the park, at the main viewing locations. The curved vertical blades reflect nautical symbolism, while allowing for maximum visual transparency. They are curved inwards to deter climbing, but if the fence is scaled, it is possible to climb back over from the sea-cliff side. The diagonal timber top handrail is in keeping with historical Australian coastal handrail theme. In addition, the fence will be in-filled with welded stainless steel square mesh, to further deter climbing.

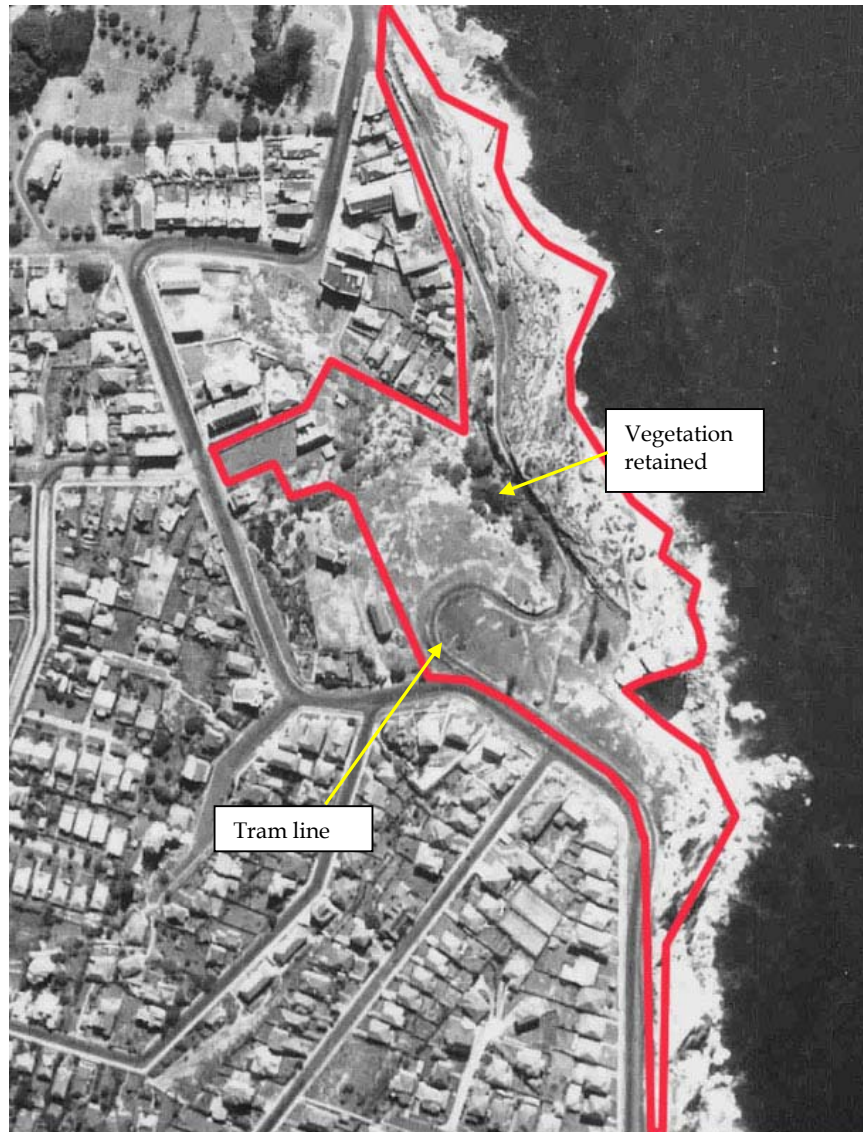
Figure 3 - 1943 Aerial Photograph of the Gap Park (outlined in red) showing vegetation removal in the Gap Park during World War II. Note also the position of the tram line. Source: Roads and Traffic Authority NSW.

The vegetation within the site included both native and non-native plantings, some of which were the result of recent re-vegetation (refer Figure 4). A 1943 aerial photograph of the site (Figure 3) indicates that some original vegetation is likely to have been retained. This may be supported by a Council Engineering report stating that Park improvement works in 1965 retained both 'the natural rock surfaces and the few remaining specimens of [coastal] tea tree (*Leptospermum laevigatum*)'²⁰. The area shown in the 1943 aerial photograph as retaining vegetation was steeply graded and contained several large fig trees (*Ficus rubiginosa*).

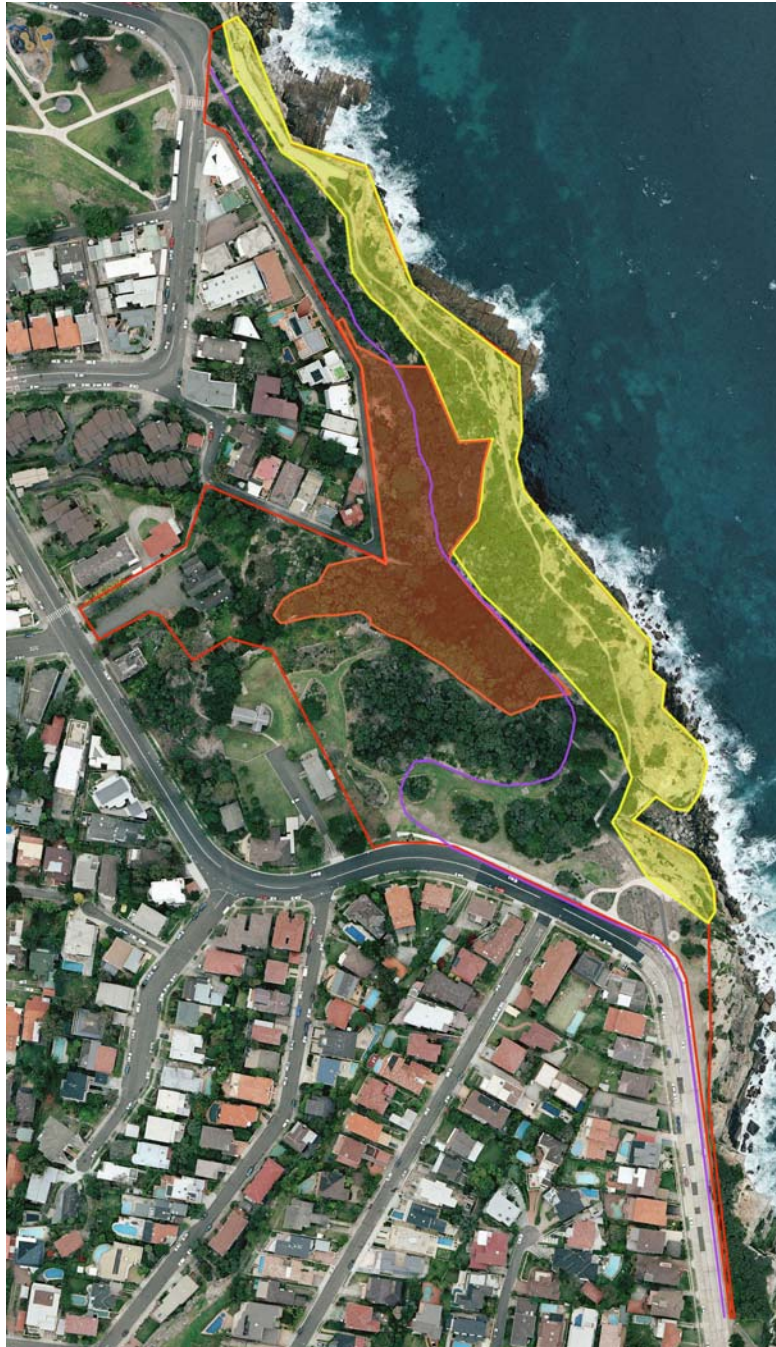
Figure 5 - Aerial photograph of the study area showing zones of archaeological potential (yellow and orange) and the old tram alignment (purple).

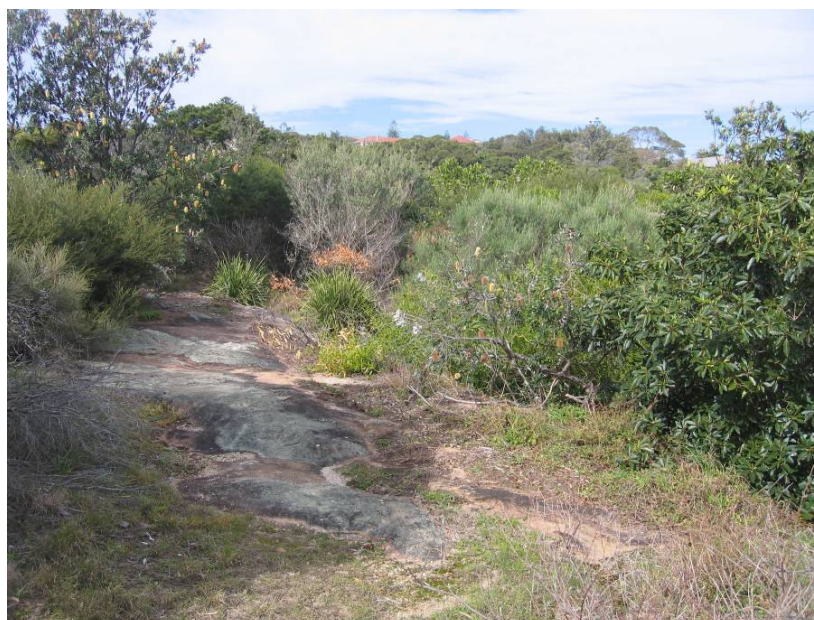
Figure 2: Coastal heath community with exposed Hawkesbury sandstone, Gap Park.

The vegetation communities in Gap Park were mostly coastal heath and low scrub communities (Figure 2), although there was also a small area of low forest in the east of the Park along Gap Road (Figure 3), which contained rainforest elements. Norfolk pine (*Araucaria heterophylla*) was present in Gap Park, which is likely to have provided habitat for fauna, but did not form a distinct vegetation community with the other native plant species. None of the vegetation communities occurring on Gap Park are considered to be endangered ecological communities.

ground-dwelling mammals, reptiles and birds for shelter and foraging. As well, there were many areas of exposed Hawkesbury sandstone in all vegetation communities. The sandstone varied from flat horizontal slabs (Figure 2) to boulders and steep cliff faces with caves (Figures 4 and 5). These provided areas for lizards to bask on, for ground-dwelling fauna to shelter and forage in, and for mammals such as bats to roost in. No hollow-bearing trees were observed on Gap Park.

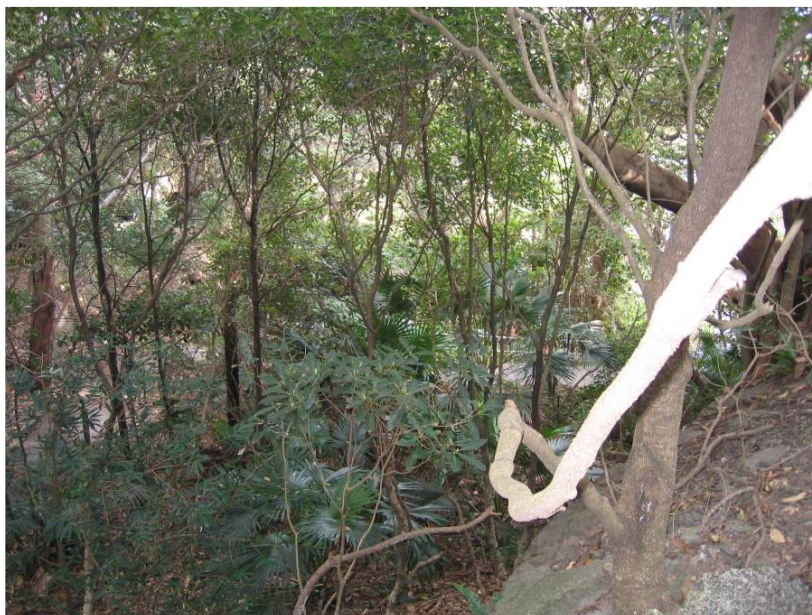
Figure 3: Low forest community with rainforest elements, Gap Park.

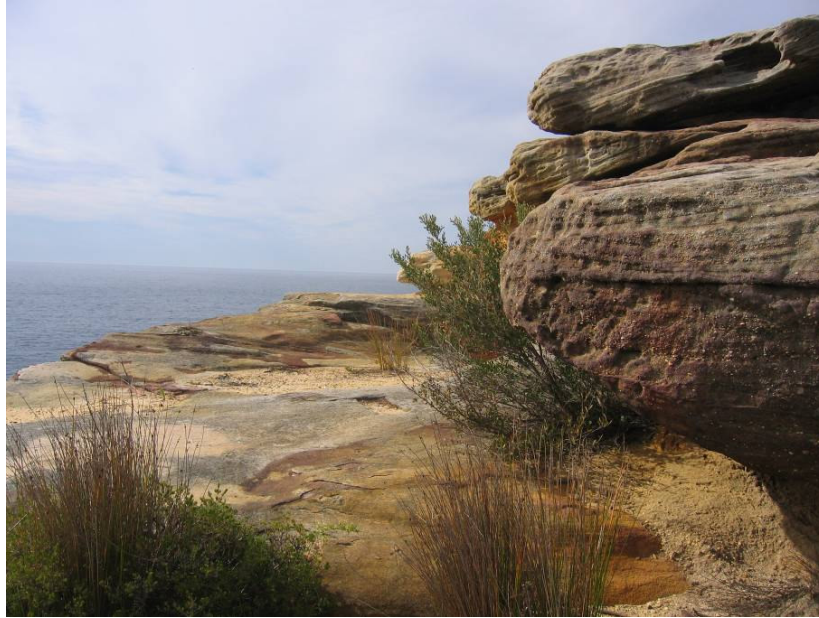
Figure 4: Exposed Hawkesbury sandstone, Gap Park.

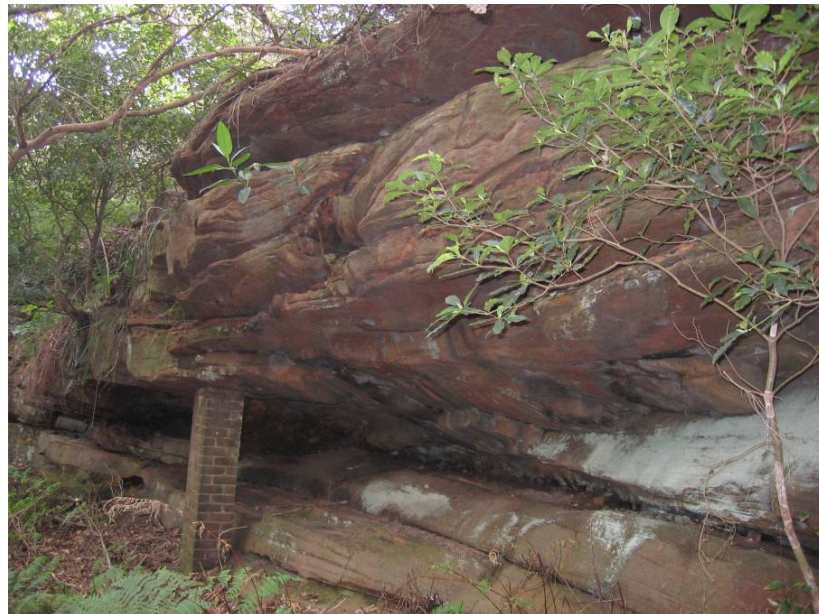
Figure 5: Exposed Hawkesbury sandstone with caves, Gap Park.

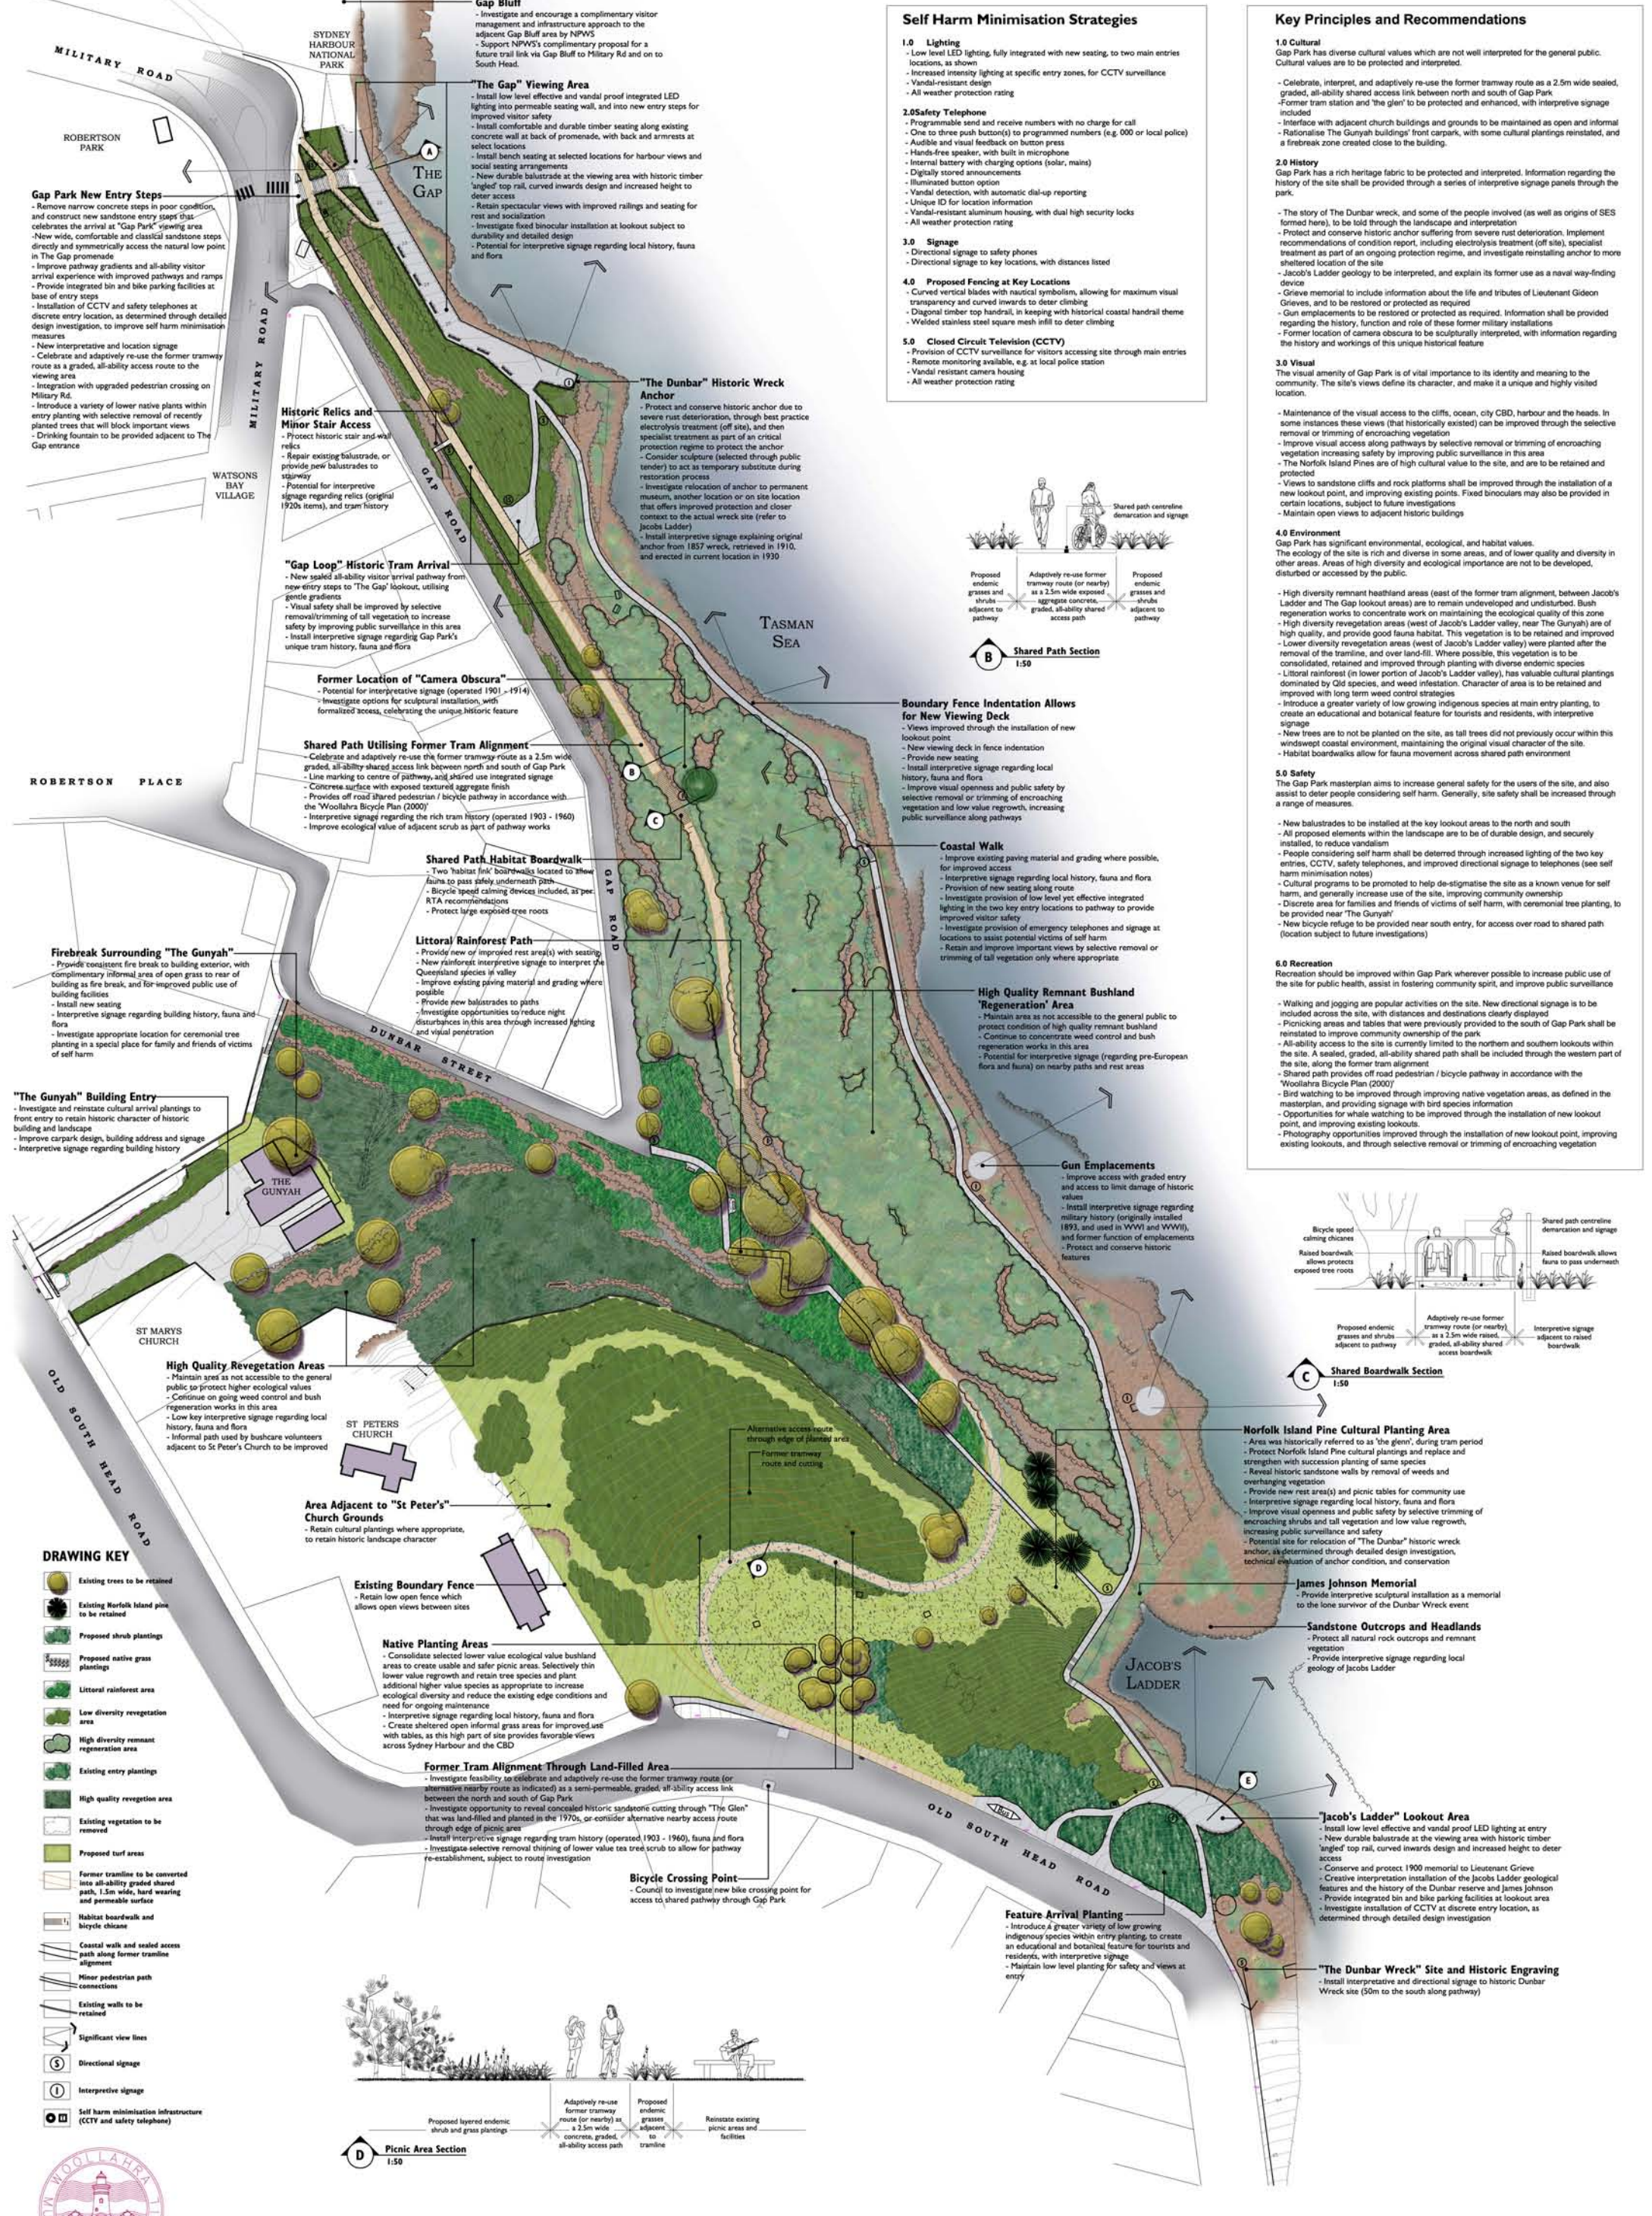
GPMP-03 Gap Park Masterplan: Self Harm Minimisation Plan March 2008

- ### Self Harm Minimisation Strategies
- Lighting**
 - Low level LED lighting, fully integrated with new seating, to two main entries locations, as shown

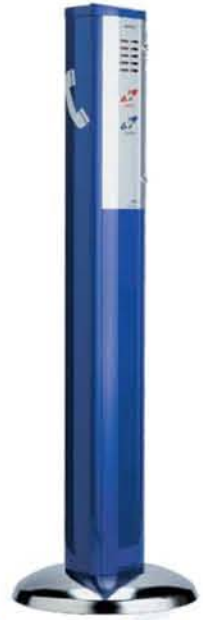
2 Safety Telephone Example

- 2.0 Safety Telephone**
- Programmable send and receive numbers
 - One to three push button(s)
 - Audible and visual feedback on button press
 - Handsfree speaker, with built in microphone
 - Accessible locally or remotely
 - Internal battery with charging options (solar, mains)
 - Digitally stored announcements
 - Illuminated button option
 - Vandal detection, with automatic dial-up reporting
 - Unique ID for location information
 - Vandal-resistant aluminium housing, with dual high security locks
 - All weather protection rating

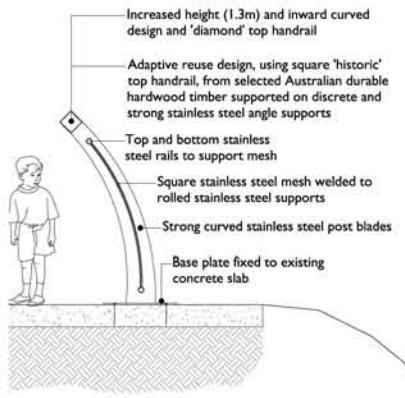
3 New Gap Park Viewing Balustrade Elevation
1:25

- 3.0 Proposed Fencing at Key Locations**
- Curved vertical blades with nautical symbolism, also allowing for maximum frontal transparency
 - Diagonal top handrail, in keeping with coastal theme
 - Welded, stainless steel square mesh
 - Curved inwards to deter climbing

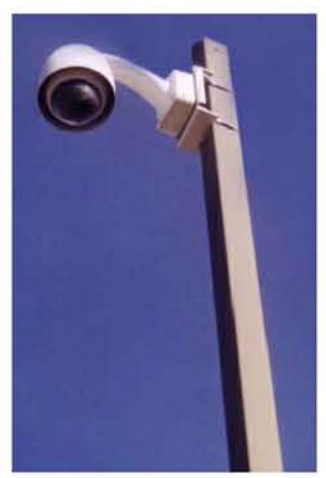
5 CCTV Example

- 5.0 Closed Circuit Television (CCTV)**
- Provides CCTV surveillance for visitors accessing site through main entries
 - Accessible locally or remotely
 - Vandal resistant camera housing
 - All weather protection rating
