Water Savings Action Plan

2006

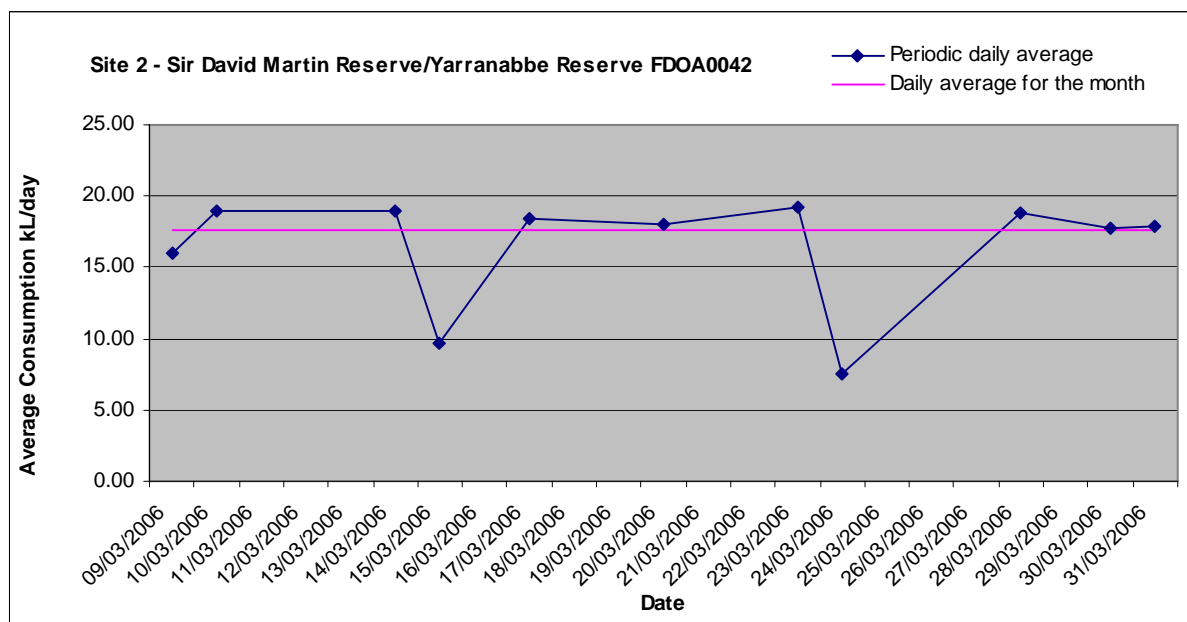
Figure 1: Average daily water use (kL) water meter FDOA0042, March 2006.

The Olympic legacy berths have three taps and two fire hoses connected to this water meter. The berths are open to the public 24 hours a day, seven days a week. Use of these facilities is difficult to monitor as access by the public is required 24 hours a day. To reduce uncontrolled water use from this facility it is recommended that the taps on the berth pontoon be kept locked for use by the sub-lessee. Further investigation is required to determine water use patterns and the source of water used at the site over night.

Figure 1 represents graphically the average daily water use recorded in kL during the monitoring period from the Olympic legacy berths and hardstand. The water meter readings recorded during the four week monitoring period have been included as Annexure D.

1. Enforce the sub-lessee requirement of keeping the taps on the Olympic legacy berths locked at all times.
2. Replace existing water meter FDOA0042 with a pulse emitting water meter.
3. Install a data logger to further monitor water use.

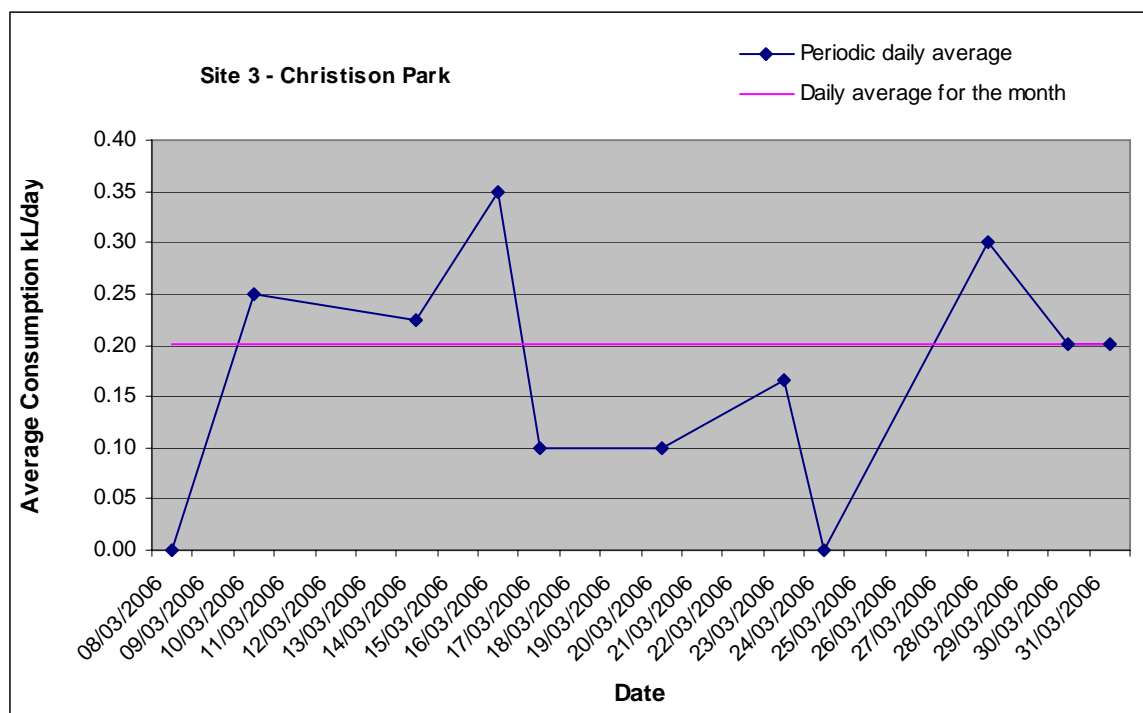
Figure 2: Average daily water use (kL) Christison Park, March 2006.

A comparison of the monitoring results and base year usage concludes that the irrigation system, when functional, is the main source of water used at the site. Therefore, it is recommended that when the irrigation system is upgraded, the most water efficient system suitable for the parks active recreational uses is installed.

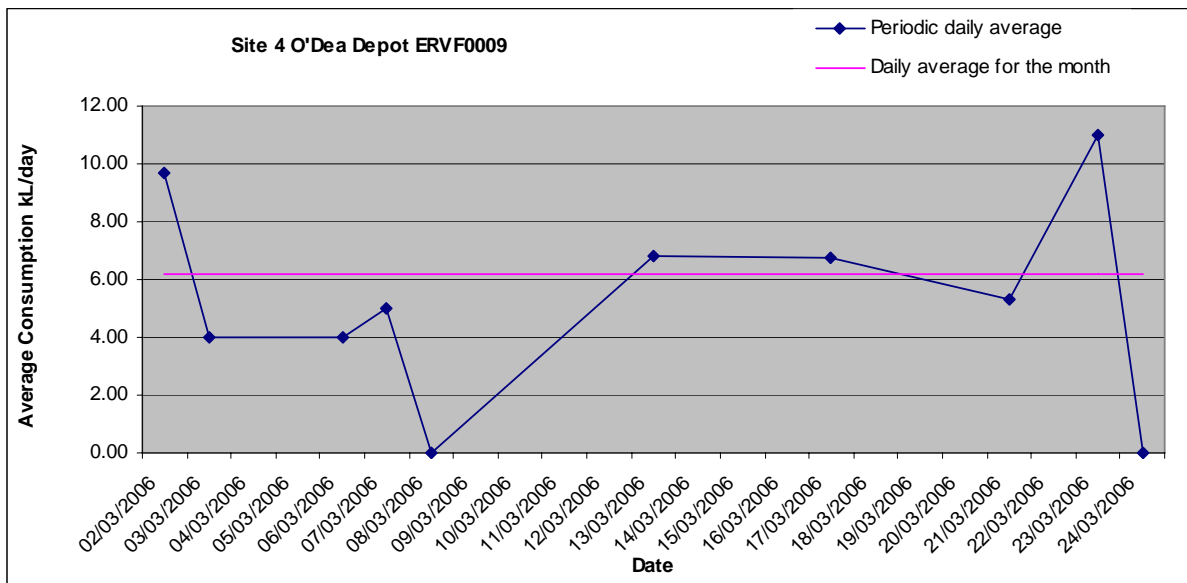
Figure 3: Average daily water use (kL) water meter ERVF0009, February - March 2006.

The readings taken outside of normal working hours to detect leaks recorded that no water was being used at the Schindler Lift Australia property overnight.

1. Replace existing 11 litre toilet cisterns with dual 6/3 flush cisterns at Council’s depot.
2. Install cistern valves to reduce water flow on the urinals at Council’s depot.
3. Install flow restrictors on existing bathroom, kitchen and workshop area taps at Council’s depot.
4. Replace existing showerheads with AAA rated showerheads at Council’s depot.
5. Replace existing 11 litre toilet cisterns with dual 6/3 flush cisterns at Schindler Lift Australia.
6. Reduce urinal flushing cycles at Schindler Lift Australia.
7. Install flow restrictors on existing bathroom and kitchen taps at Schindler Lift Australia.
8. Replace existing showerheads with AAA rated showerheads at Schindler Lift Australia.

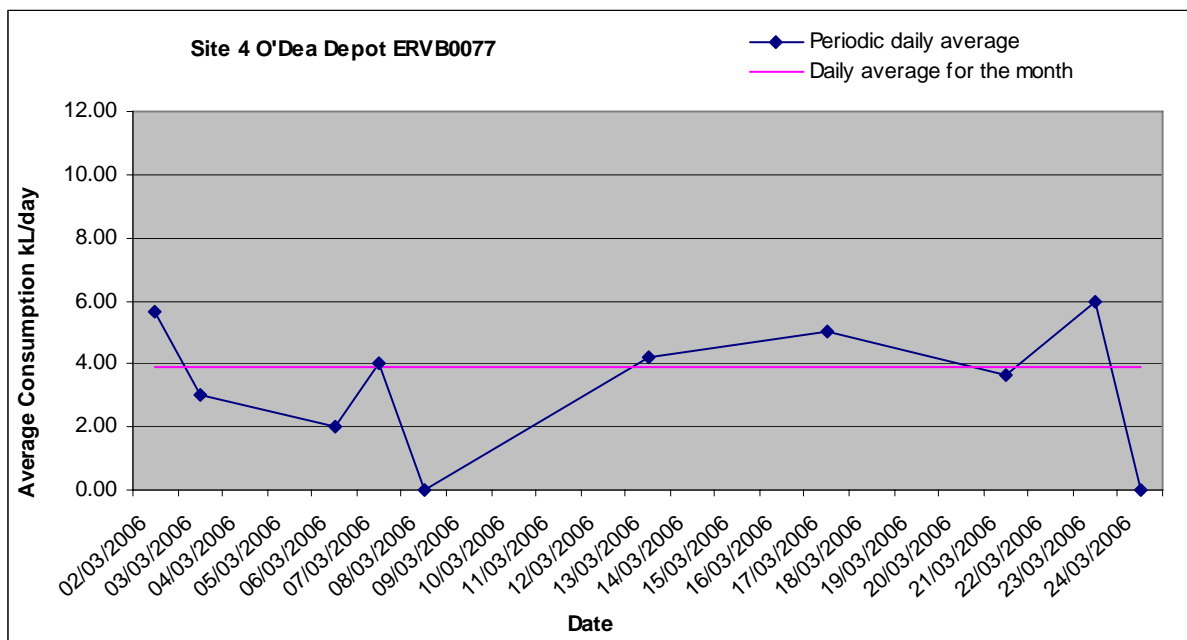
Figure 4: Average daily water use (kL) water meter ERVB0077, February - March 2006.

Figure 4 represents graphically the average daily water use recorded in kL during the monitoring period from water meter ERVB0077. The water meter readings recorded during the four week monitoring period have been included as Annexure D.

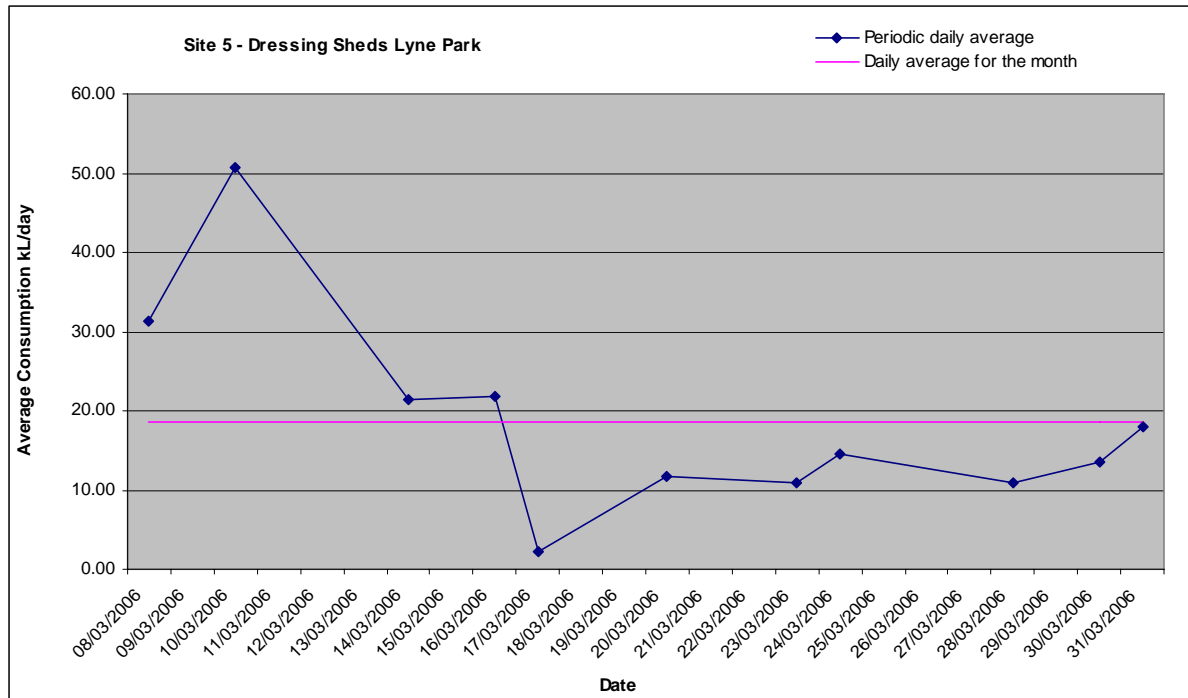
Figure 5: Average daily water use (kL) Lyne Park, March 2006.

Two sets of readings were taken outside of normal working hours to detect leaks, with each set recording different usage rates. The first set taken on the evening of Thursday 16 March and the morning of Friday 17 March, recorded that 2.17kL of water was used over night. The second set, taken on the evening of Thursday 23 March and the morning of Friday 24 March, recorded that 14.49 kL of water was used over night. Due to the large volume of water used, it is assumed that the park was irrigated on the evening of the 23 March.

No leaks were detected during the walk through site review. The base flow may be attributed to a leak from the irrigation network in the park. It is recommended that the irrigation network be checked for leaks.

Figure 5 represents graphically the average daily water used in kilo litres (kL) during the monitoring period. The water meter readings recorded during the four week monitoring period have been included as Annexure D.

1. Replace existing taps with time flow taps in the amenities block.
2. Check the irrigation network for leaks.
3. Replace existing water meter FDOA0042 with a pulse emitting water meter.
4. Install a data logger to further monitor water use.

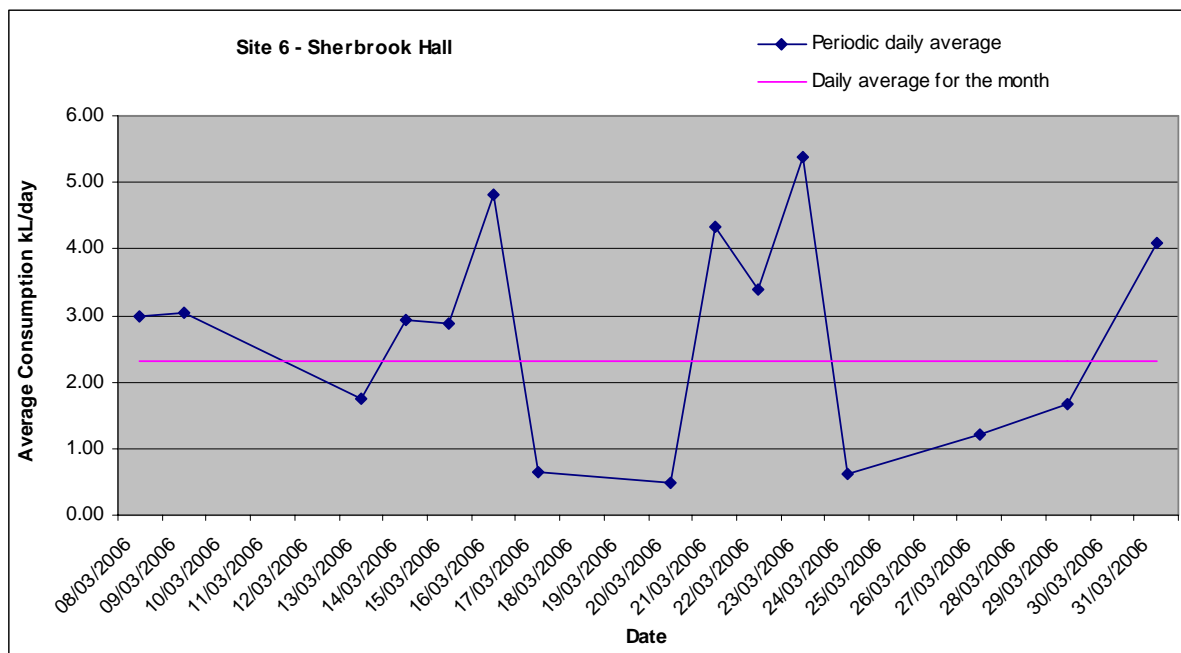
Figure 6: Average daily water use kL at Sherbrooke Hall, March 2006.

The over night usage may be attributed to the use of the fixtures in the outdoor areas that do not have tap locks and are open to use 24 hours a day, seven days a week. The base flow may also be attributed to a leak from the fixtures on the site. No leaks were detected during the walk through site review. The base flow requires further investigation.

Figure 6 represents graphically the average daily water used in kL during the monitoring period. The water meter readings recorded during the four week monitoring period have been included as Annexure D.

1. Install tap flow restrictors and dual flush toilet cistern into the Regulatory Office.
2. Install cistern valves and flow valves into the Local History Library.
3. Install dual flush toilet cisterns, low flow taps and tap locks into the Woollahra Preschool, including the outdoor areas.
4. Install a dual flush toilet cistern and tap flow restrictors into the Meals on Wheels office.
5. Investigate possible causes for the increase in water use at the site.

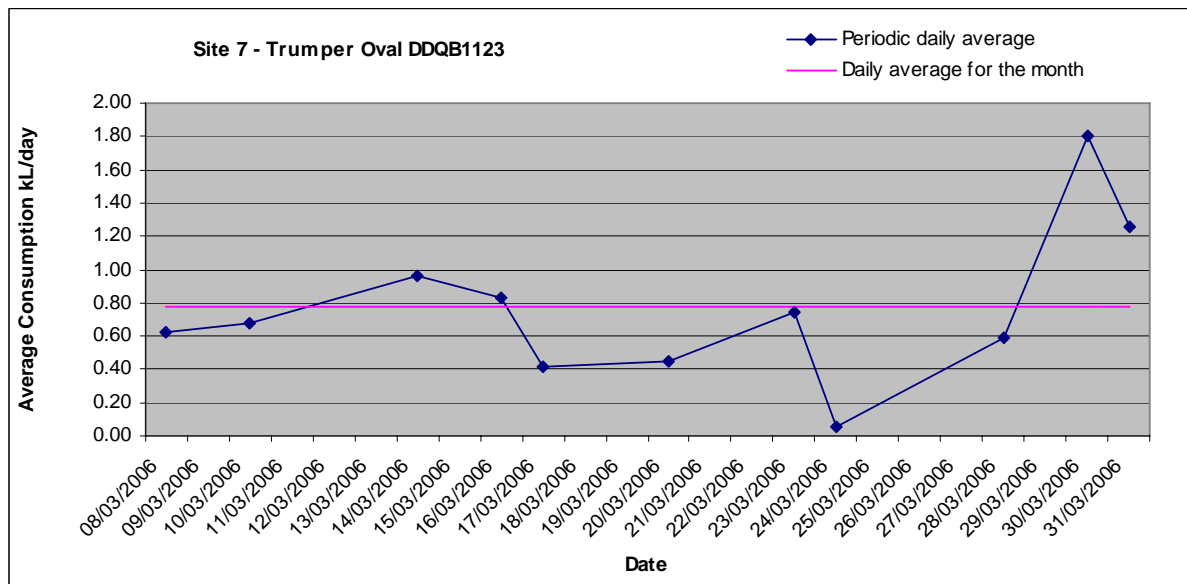
Figure 7: Average daily water use (kL) water meter DDQB1123, March 2006.

Figure 7 represents graphically the average daily water used in kilo litres (kL) during the monitoring period. The water meter readings recorded during the four week monitoring period have been included as Annexure D.

Water usage of the site recorded during the monitoring period was compared to the oval's booking schedule during this time. The peak in water use corresponds to a peak in park sports bookings, where over the two day period, there were six bookings. The most the oval was booked during the monitoring period.

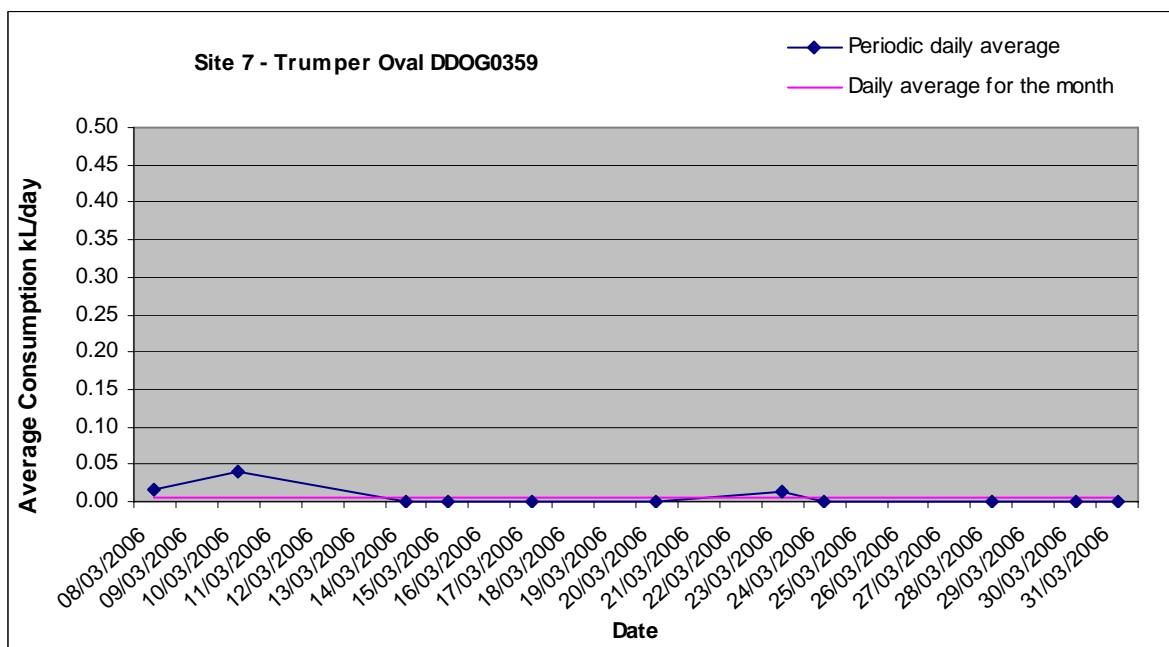
Figure 8: Average daily water use (kL) water meter DDOG0359, March 2006.

The water used from this meter is negligible. It is recommended that tap locks be installed on the taps located around the oval to reduce the potential for future over use.

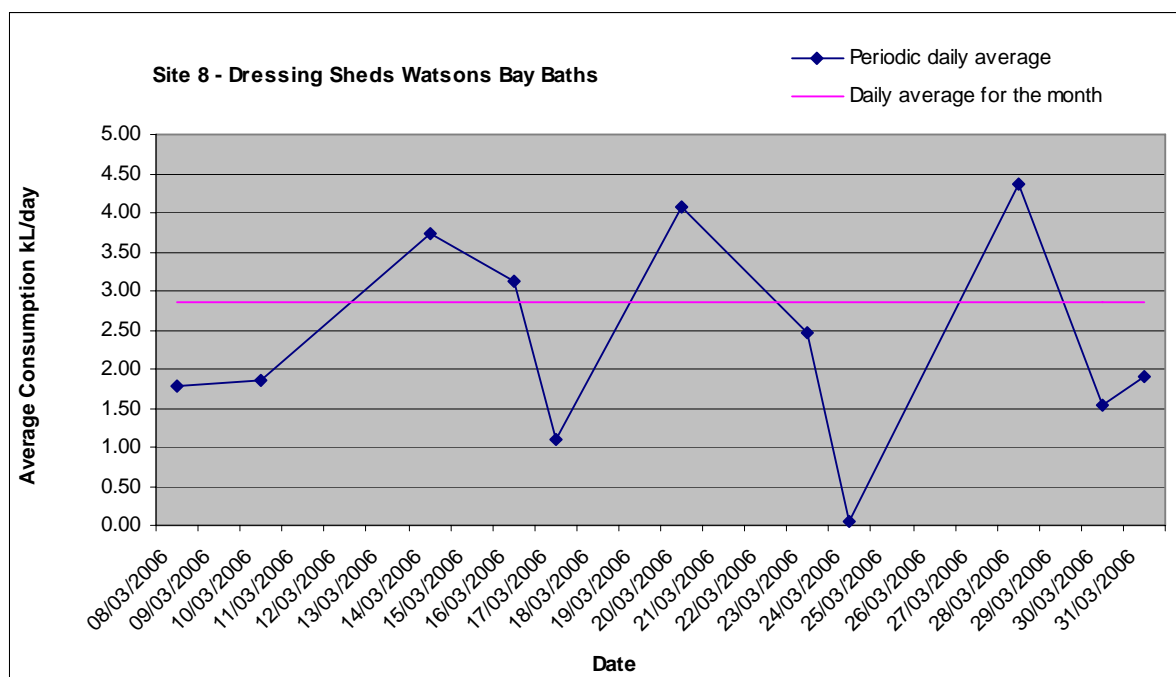
Figure 9: Average daily water use (kL) Watsons Bay Baths, March 2006.

The readings taken outside of normal working hours to detect leaks recorded that 60 litres of water was used at the site overnight. This may be attributed to the shower and tap located in the baths enclosure and the tap and bubbler located in the grounds of the café that do not have tap locks and are open to use 24 hours a day, seven days a week. The base flow may also be attributed to a low flow leak from the fixtures on the site (approximately 0.5 L/hour). As no leaks were detected during the walk through site review, the base flow was not investigated further.

Figure 9 represents graphically the average daily water used in kilo litres (kL) during the monitoring period. The water meter readings recorded during the four week monitoring period have been included as Annexure D.

1. Replace existing toilet cisterns with dual flush (6/3 litre) cisterns.
2. Install low flow taps in the amenities block.
3. Install a tap lock on the outdoor tap located in the baths area.
4. Install urinal flush valve.

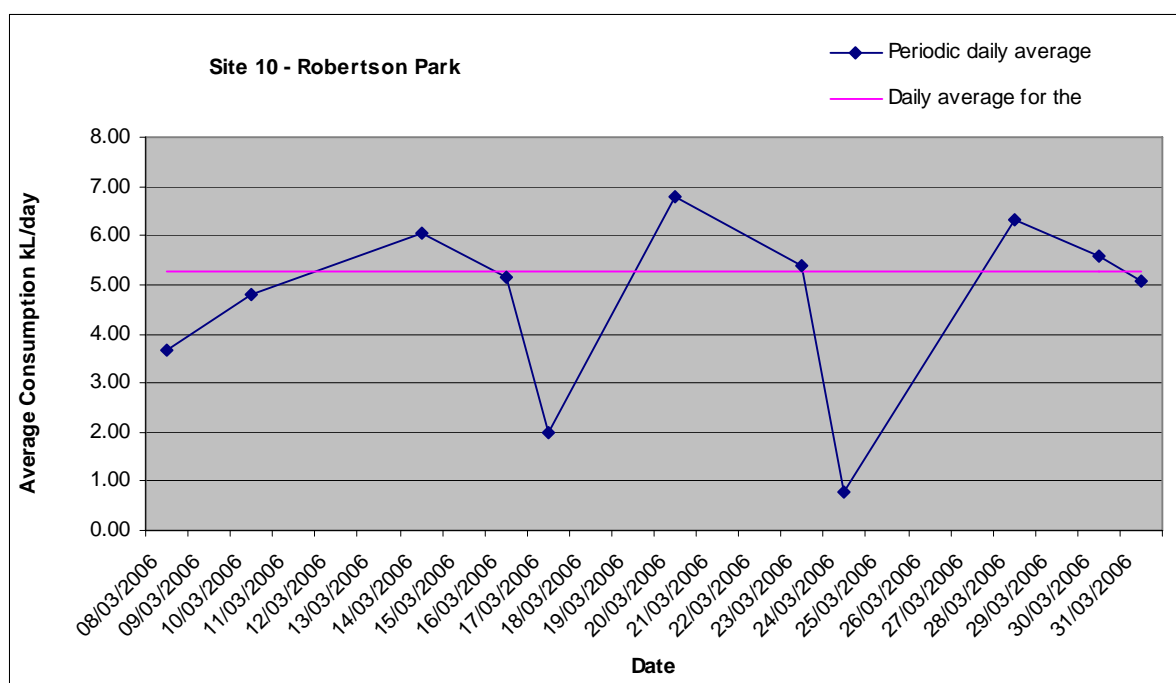
Figure 10: Average daily water use (kL) Robertson Park, March 2006.

The readings taken outside of normal working hours to detect leaks, recorded that 0.78 kL or 780 litres of water was used at the site overnight. This equates to an approximate 55 litre/hour base flow rate.

The overnight water usage or base flow may be attributed to the use of the taps located in the park that do not have tap locks. It was observed on a number of occasions that the taps located in the reserve were regularly used by park users and no leaks were detected during the walk through review of the site.

Figure 10 represents graphically the average daily water used in kilo litres (kL) during the monitoring period. The water meter readings recorded during the four week monitoring period have been included as Annexure D.
