ARBORICULTURAL IMPACT ASSESSMENT (CONCEPT)

The Edgecliff Centre-New South Head Rd, Edgecliff.

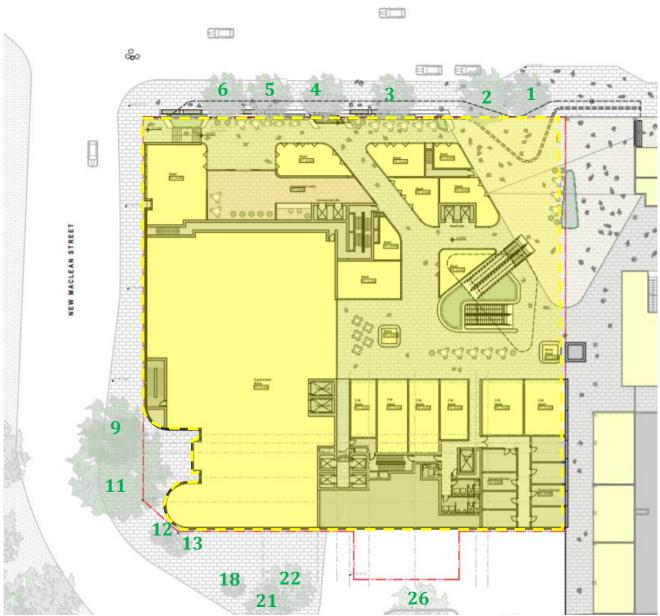
Figure 2- The proposed development footprint shown in yellow with the existing footprint shown in red dotted line, the trees proposed for retention are also shown and numbered. Image provided by the client.

The proposed development seeks to demolish the existing building shown with red dotted line. The trees proposed for retention are shown on the drawing and numbered in accordance with the tree schedule located in section 6 of this report. There will be discussion provided within section 8 of this report which will discuss the potential impacts upon these trees and also whether the trees are worthy of retention or whether in the interest of design or site functionality, they should be removed and replaced.

- Trees 1-2-3-4-5-6-11 & 30 should be retained and protected throughout development, the remaining trees should not be considered as a constraint to development.
