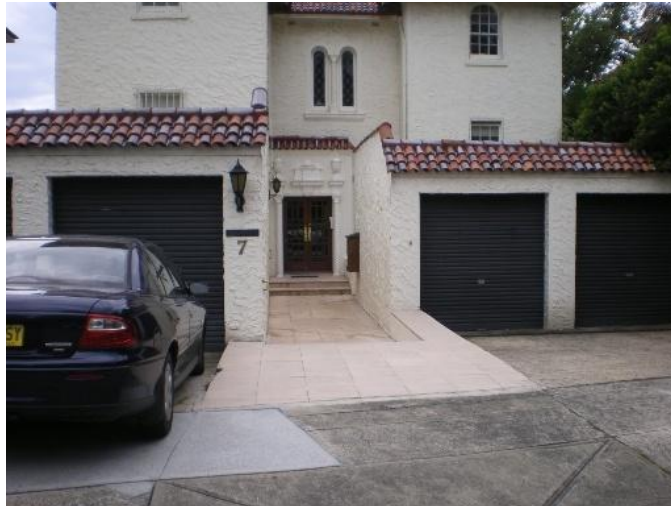
0. 7 Aston PL Problem identified by Reference 4, field trip results show: Floor below road, Ponding on street, Flooding due to overland flow from road above property

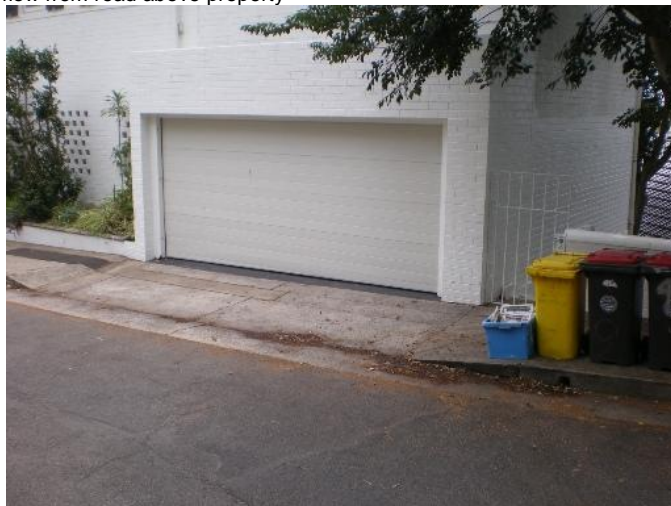
6. 9 Cranbrook Lane Problem identified by Reference 4, field trip results show: Floor below road, Garage below road, Main flow channel bordering residence, Ponding on street, Flooding due to overland flow from road above property

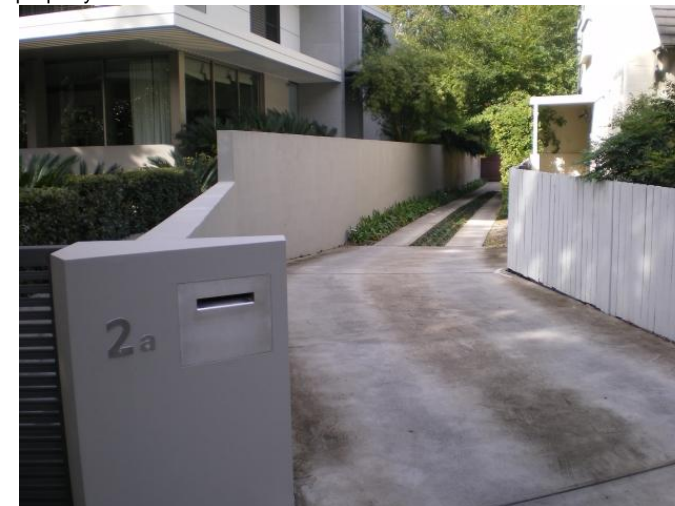
8. 2A Cranbrook Road Problem identified by Reference 2, field trip results show: No problem identified

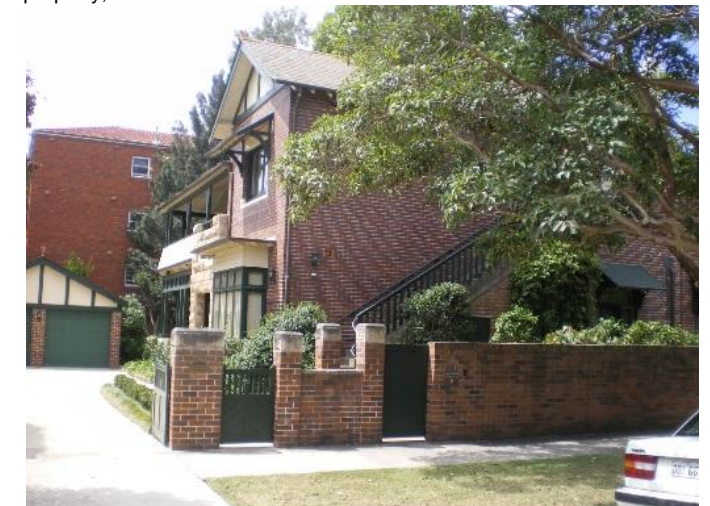
15. 3 Balfour Road Problem identified by Reference 2, field trip results show: No problem identified

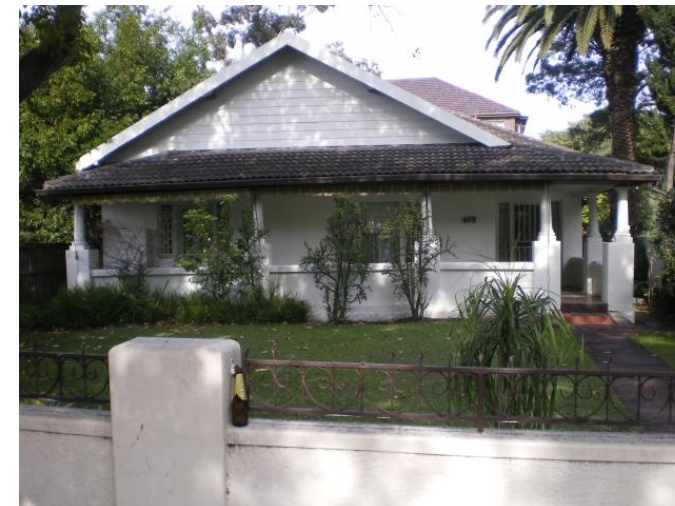
20. 673 New South Head Road Problem identified by Reference 2, field trip results show: Very high flow and water level in nearby channel

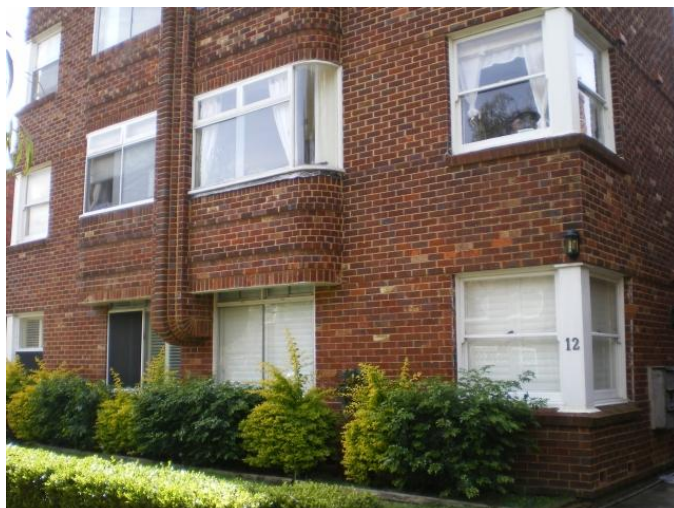
22. 12 Manion Avenue Problem identified by Reference 3, field trip results show: Street flooding reported, no problem identified

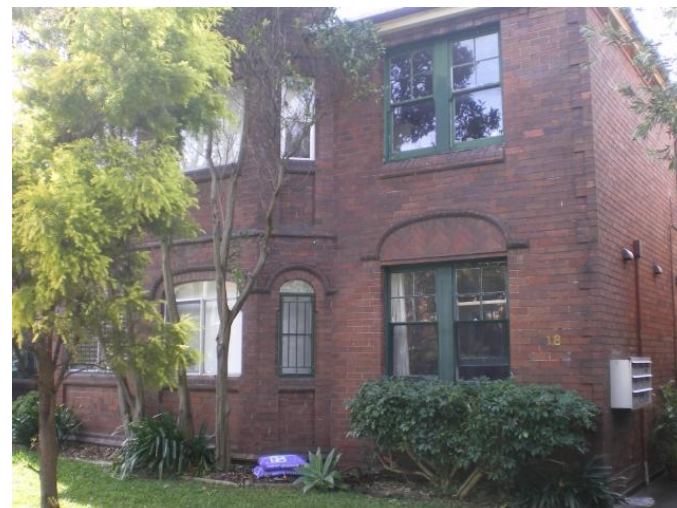
23. 18 Manion Avenue Problem identified by Reference 3, field trip results show: Street flooding reported, no problem identified

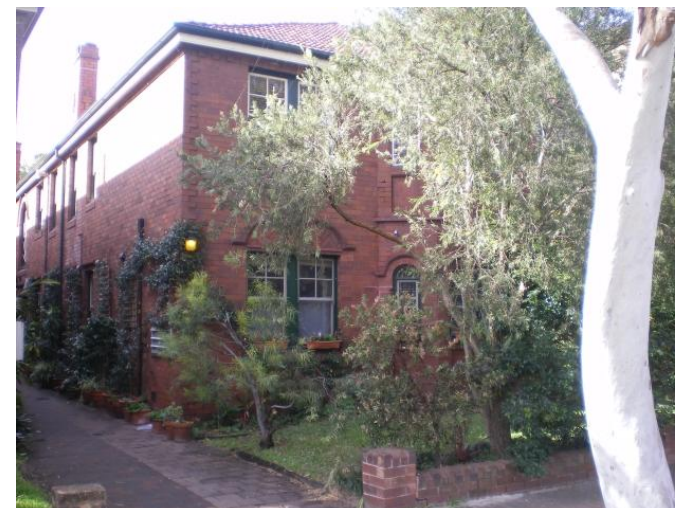
24. 20 Manion Avenue Problem identified by Reference 2, field trip results show: Street flooding reported, no problem identified

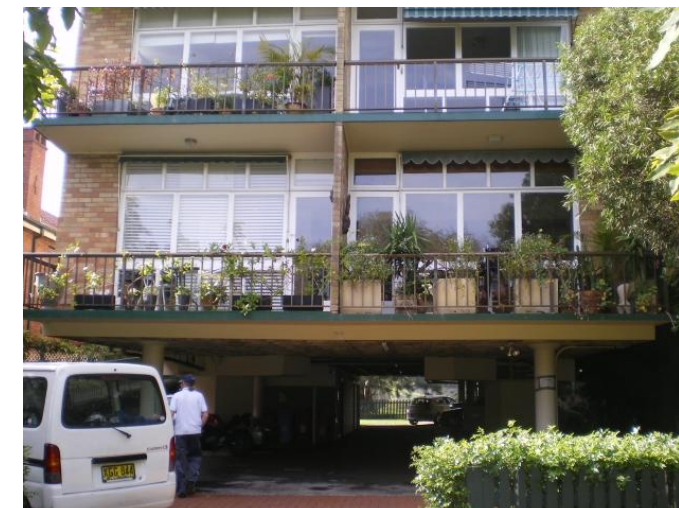
25. 22 Manion Avenue Problem identified by Reference 3, field trip results show: Street flooding reported, no problem identified

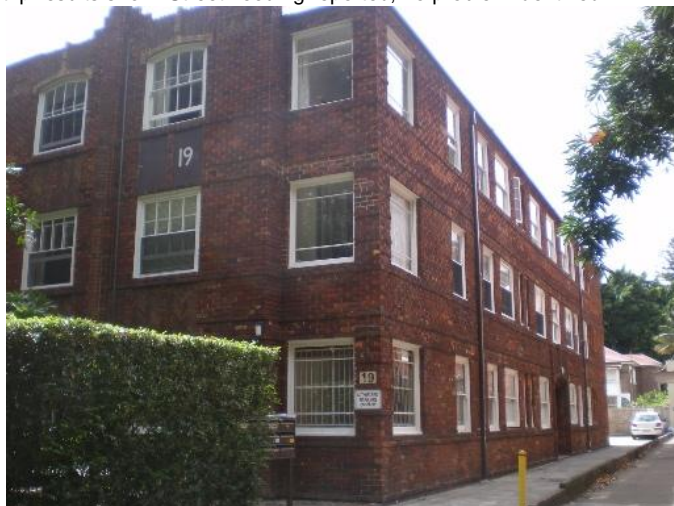
33. 19 Balfour Road Problem identified by Reference 4, field trip results show: No problem identified

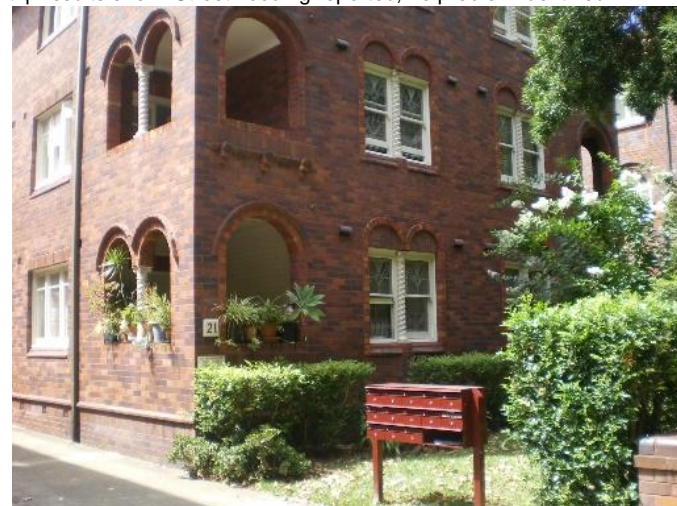
34. 21 Balfour Road Problem identified by Reference 4, field trip results show: No problem identified

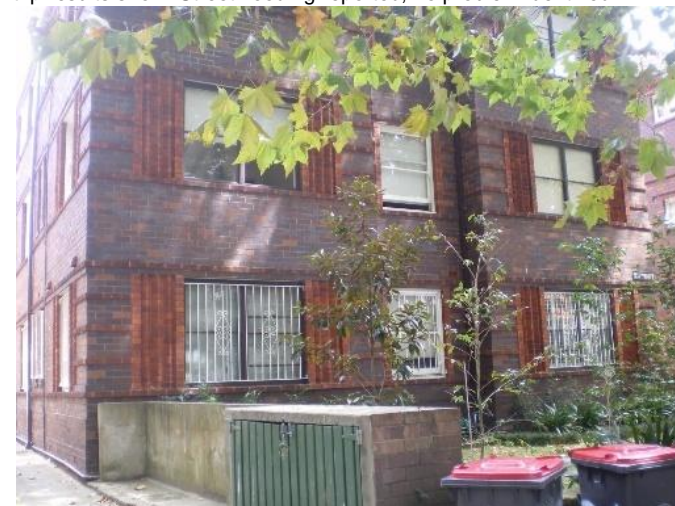
35. 26 Balfour Road Problem identified by Reference 4, field trip results show: No problem identified

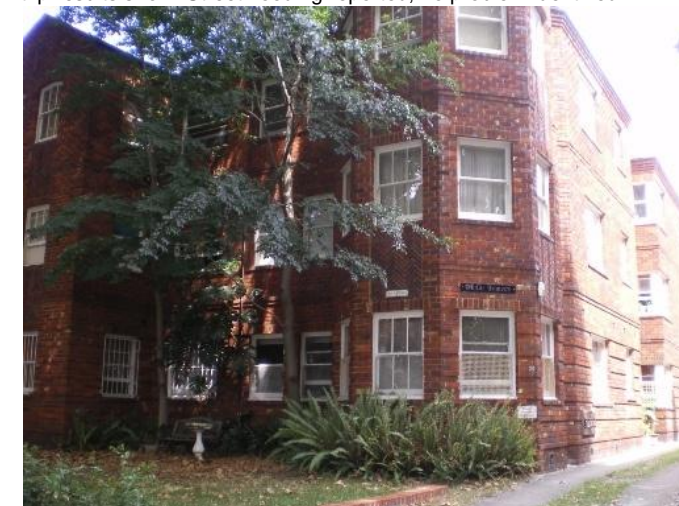
36. 24 Balfour Road Problem identified by Reference 2, field trip results show: No problem identified

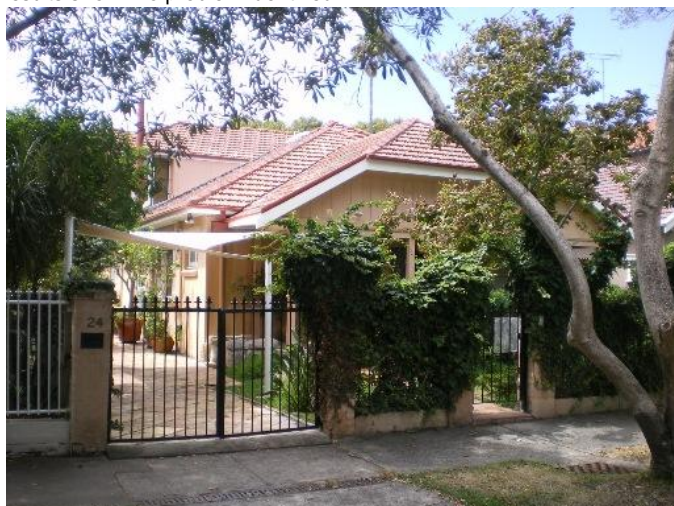
38. 24 Salisbury Road Problem identified by Reference 2, field trip results show: No problem identified

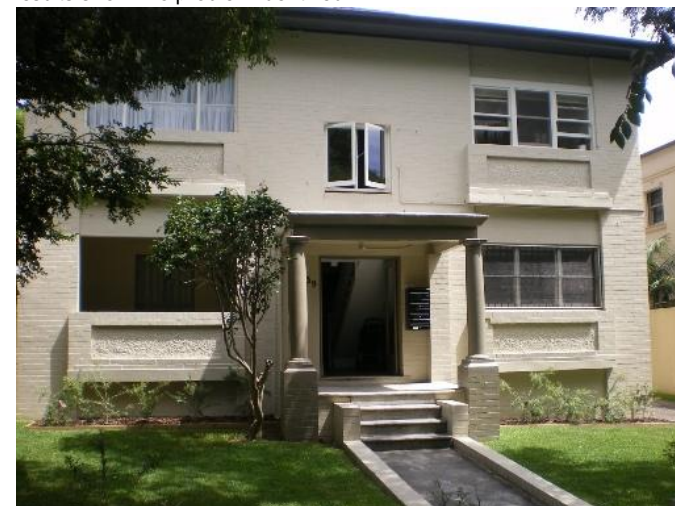
42. 39 Salisbury Road Problem identified by Reference 2, field trip results show: No problem identified

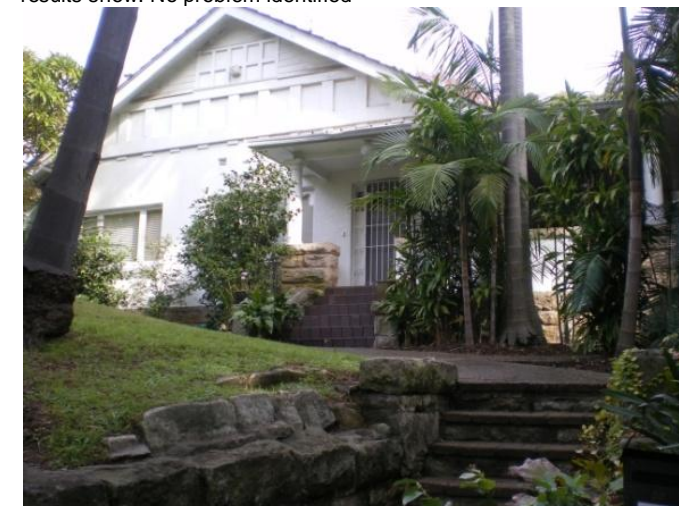
44. 50 Beresford Road Problem identified by Reference 4, field trip results show: Flooding due to overland flow from road above property

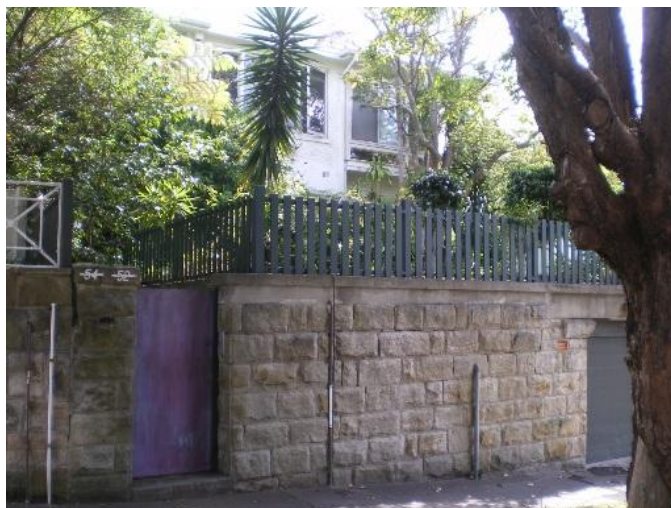
45. 52 Beresford Road Problem identified by Reference 4, field trip results show: Flooding due to overland flow from road above property

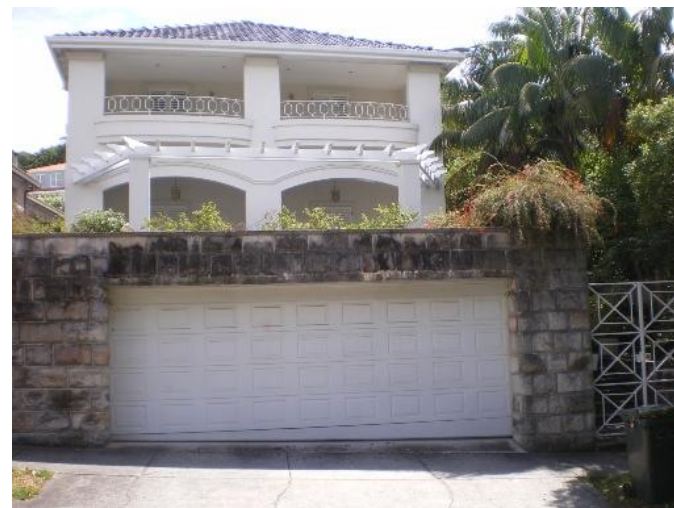
46. 56 Beresford Road Problem identified by Reference 4, field trip results show: Flooding due to overland flow from road above property

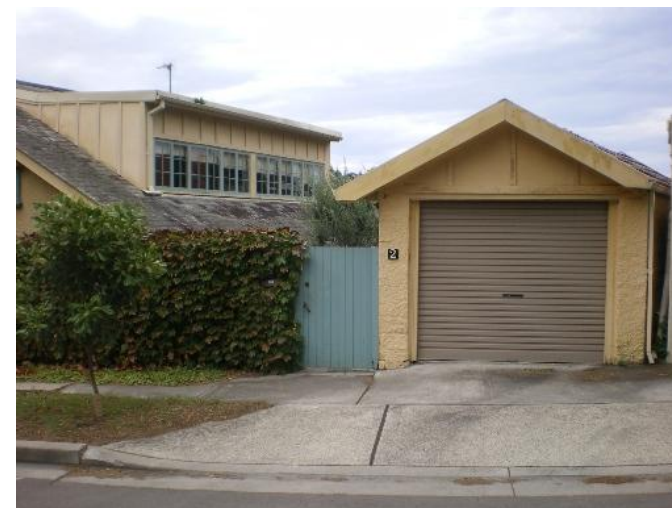
47. 2 Beresford Crescent Problem identified by Reference 4, field trip results show: Floor below road, Garage below road, Ponding on street

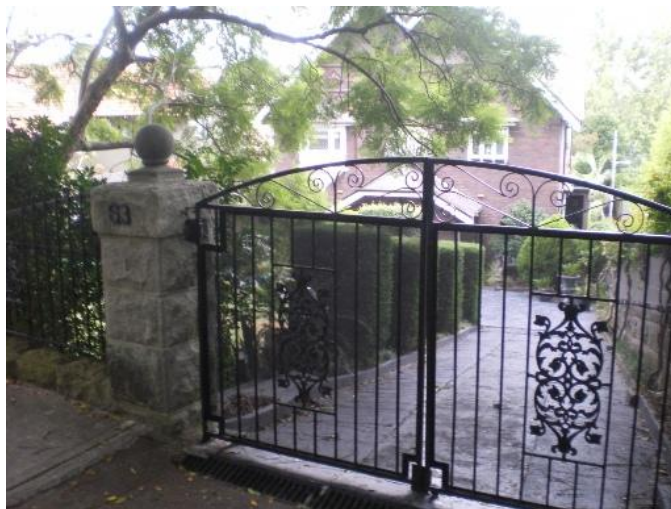
54. 63 Victoria Road Problem identified by Reference 4, field trip results show: Floor below road, Ponding on street, No flow path

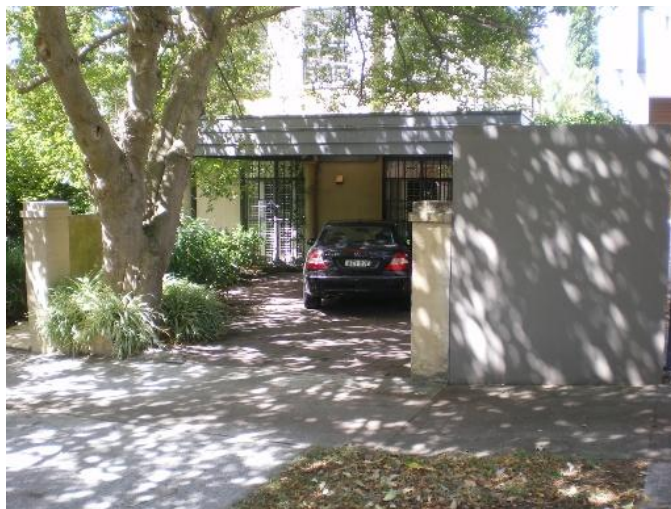
76. 60 Salisbury Road Problem identified by Reference 3, field trip results show: Floor below road, Garage below road, Main flow channel bordering residence

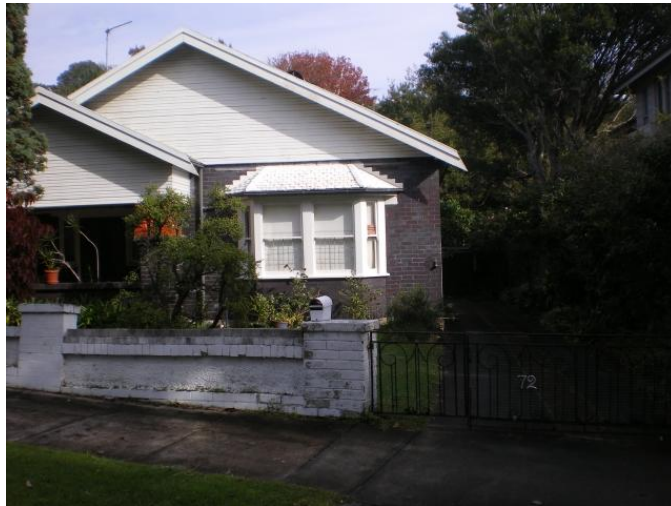
86. 72 Balfour Road Problem identified by Reference 3, field trip results show: No problem identified

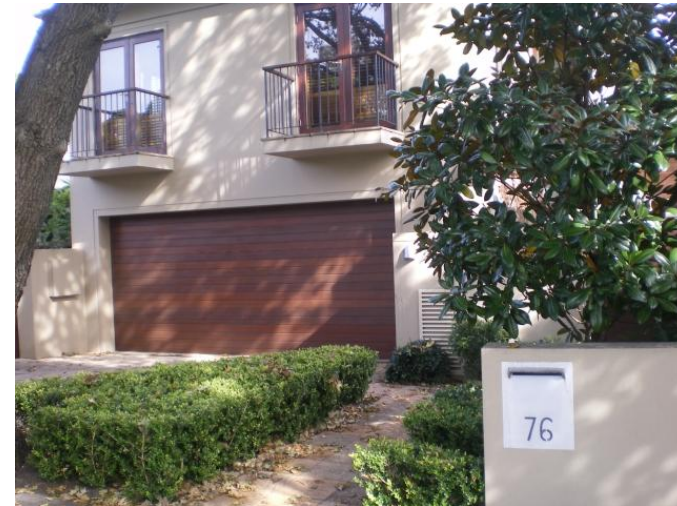
88. 76 Balfour Road Problem identified by Reference 2, field trip results show: Flooding due to overland flow from road above property

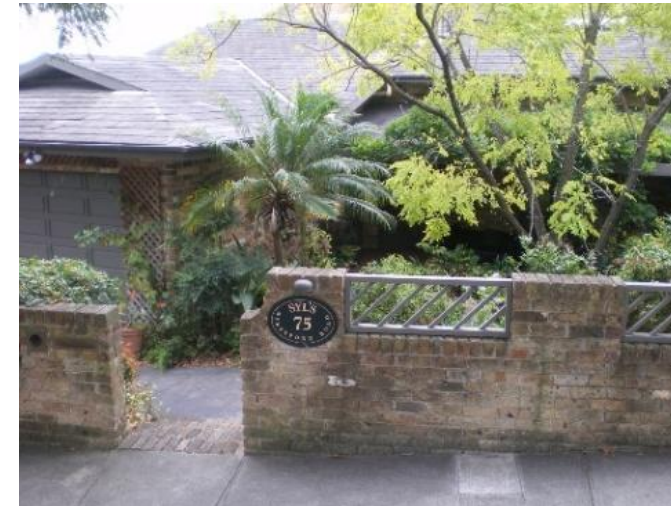
91. 75 Beresford Road Problem identified by Reference 2, field trip results show: Floor below road, Garage below road, Main flow channel bordering residence

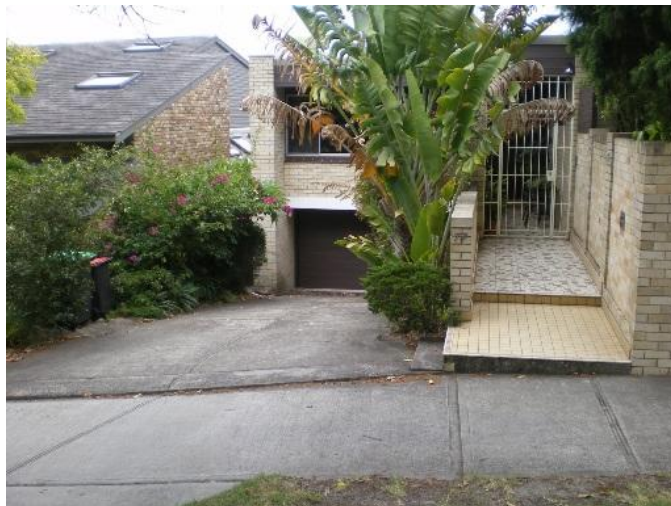
93. 77 Beresford Road Problem identified by Reference 2, field trip results show: Garage below road, Main flow channel bordering residence

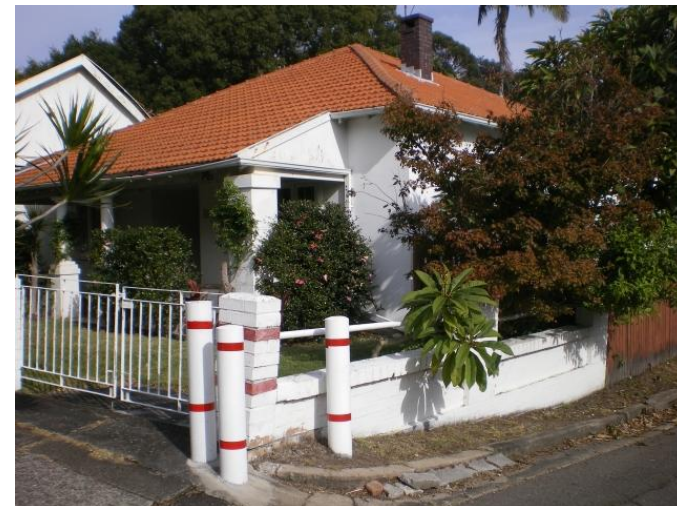
99. 96 Balfour Road Problem identified by Reference 2, field trip results show: Yard flooding and flooding due to ponding in Balfour Lane

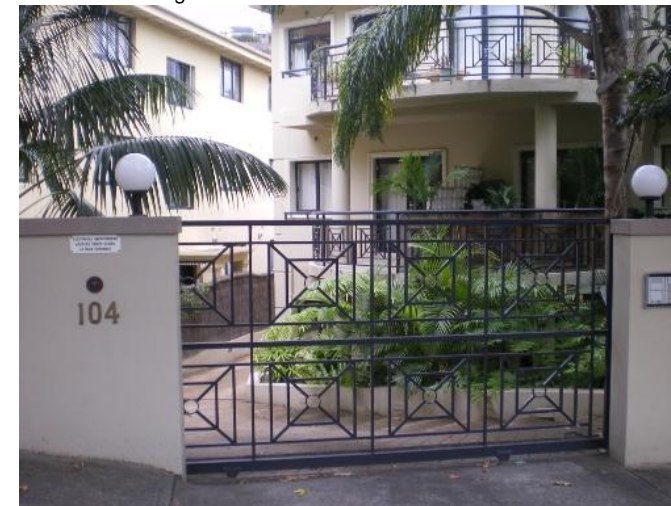
102. 104 Balfour Road Problem identified by Reference 3, field trip results show: Floor below road, Yard flooding likely

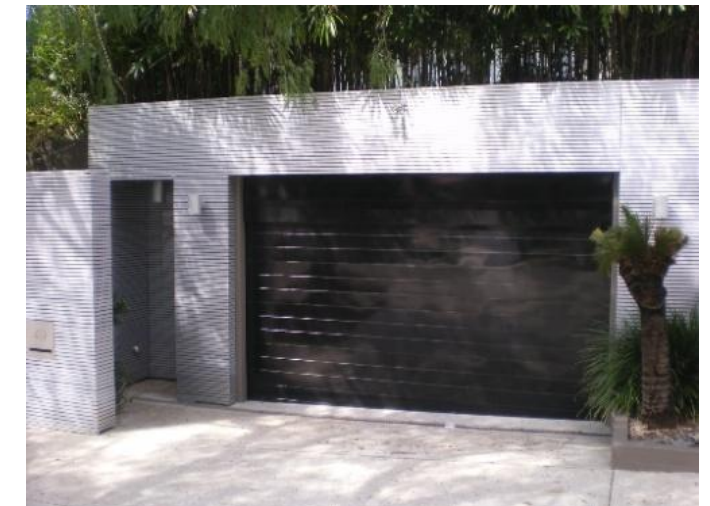
118. 49 Balfour Road Problem identified by Reference 3, field trip results show: Floor below road, Garage below road, Main flow channel bordering residence

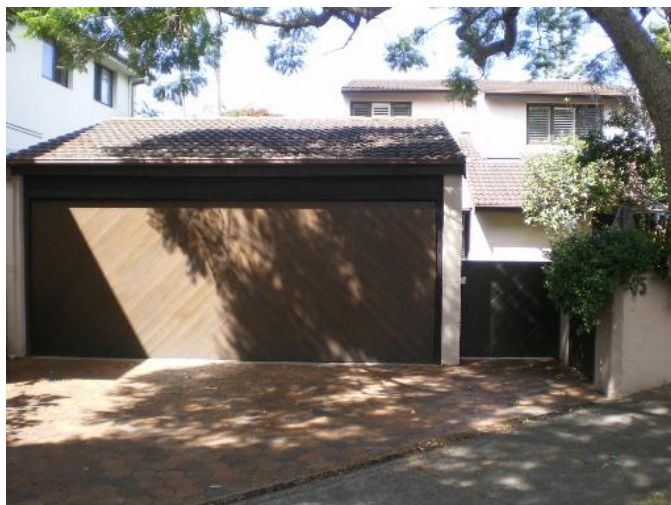
122. 75 Balfour Road Problem identified by Reference 3, field trip results show: Floor below road, Garage below road, Main flow channel bordering residence

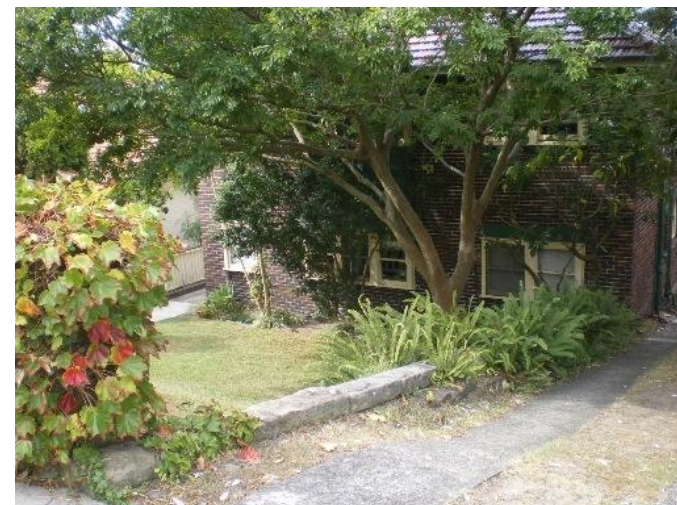
129. 55 Latimer Road Problem identified by Reference 3, field trip results show: Flooding due to overland flow from road above property

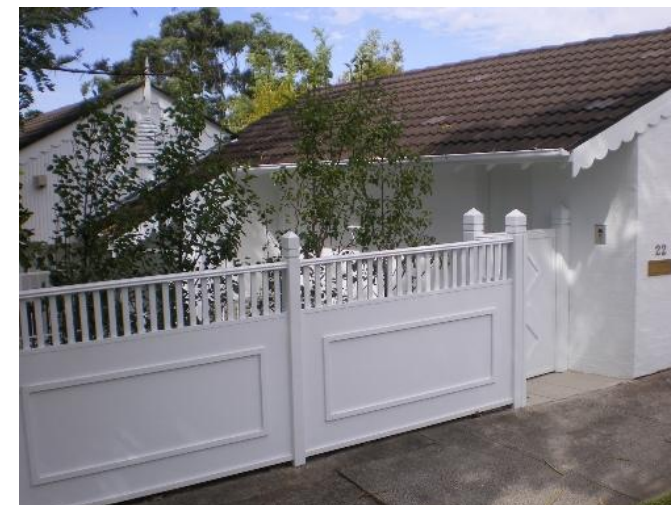
142. 22 Latimer Road Problem identified by Reference 3, field trip results show: Floor below road, Garage below road, Main flow channel bordering residence

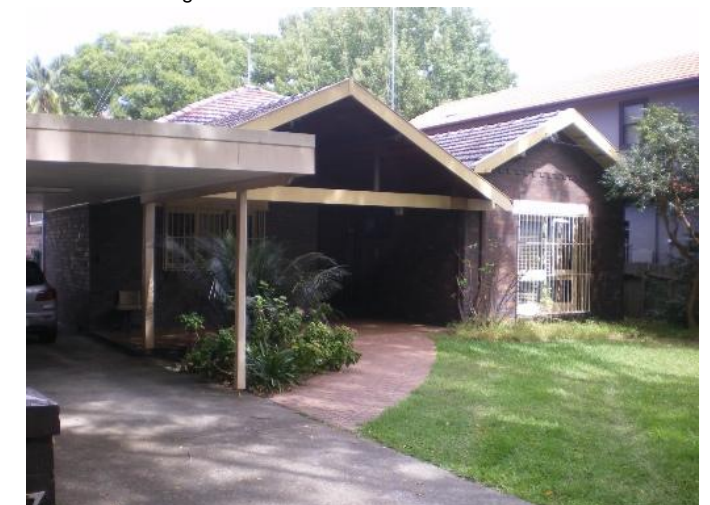
148. 177 O'Sullivan Road Problem identified by Reference 4, field trip results show: Floor below road, Flooding due to overland flow from road above property

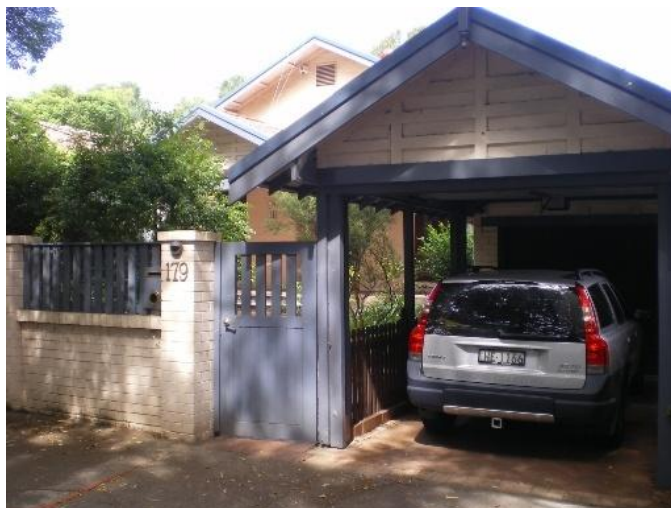
149. 179 O'Sullivan Road Problem identified by Reference 4, field trip results show: Flooding due to overland flow from road above property

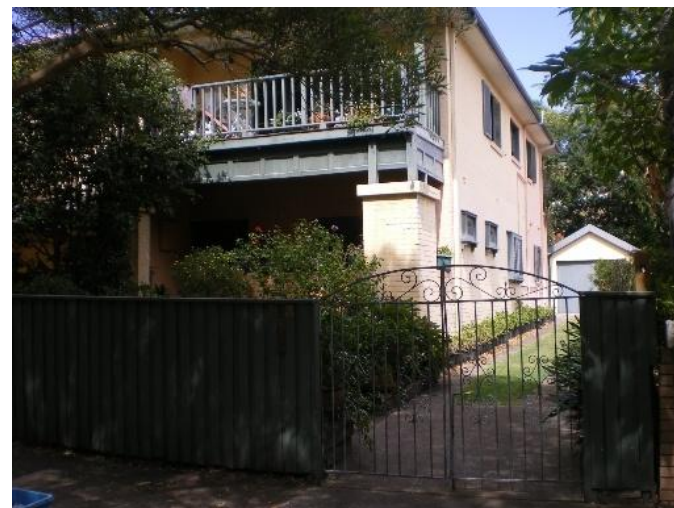
151. 183 O'Sullivan Road Problem identified by Reference 2, field trip results show: Flooding due to overland flow from road above property

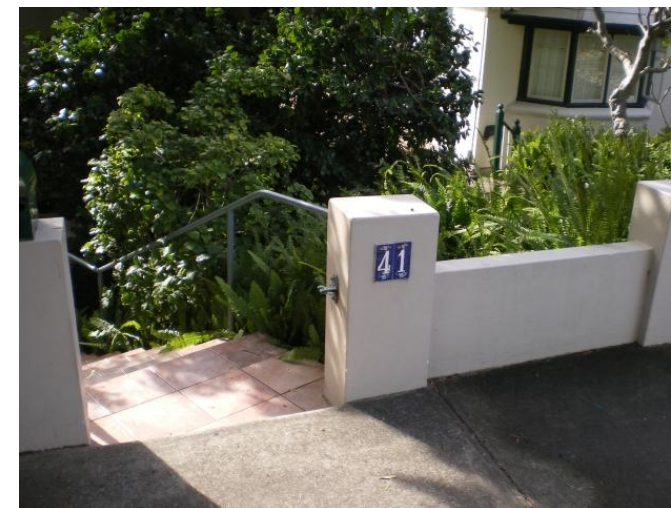
155. 41 Boronia Road Problem identified by Reference 2, field trip results show: Ponding on street

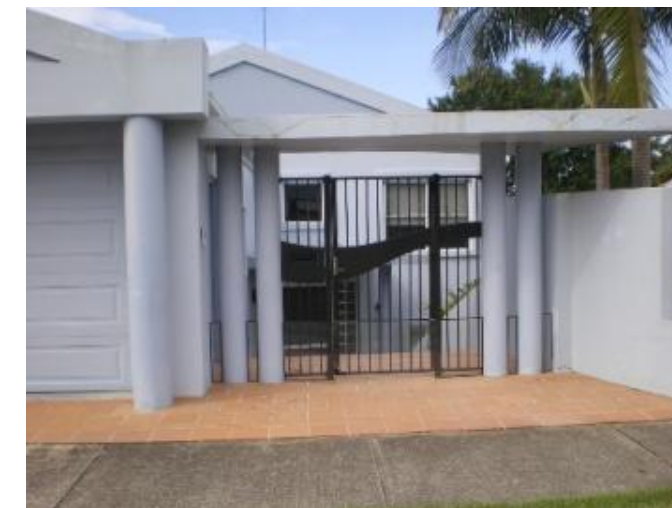
158. 49 Boronia Road Problem identified by Reference 2, field trip results show: Floor below road, Ponding on street, Flooding due to overland flow from road above property

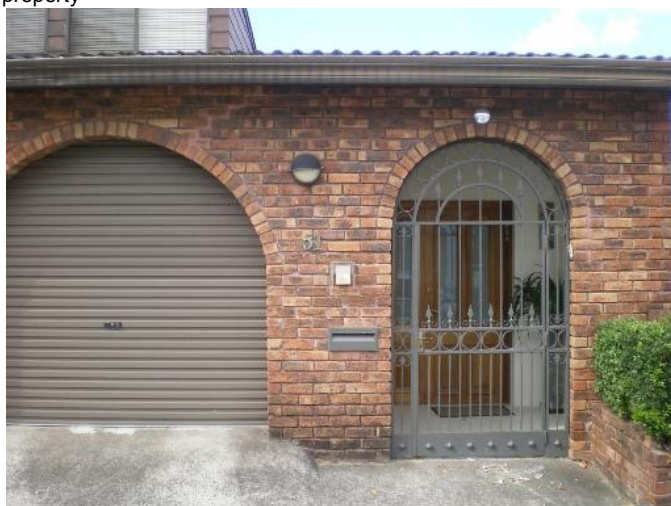
159. 51 Boronia Road Problem identified by Reference 2, field trip results show: Floor below road, Ponding on street, Flooding due to overland flow from road above property

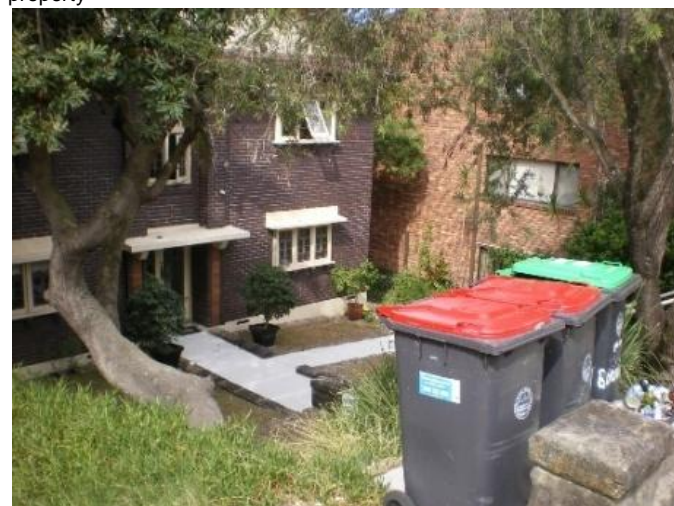
160. 53 Boronia Road Problem identified by Reference 2, field trip results show: Floor below road, Ponding on street, Flooding due to overland flow from road above property

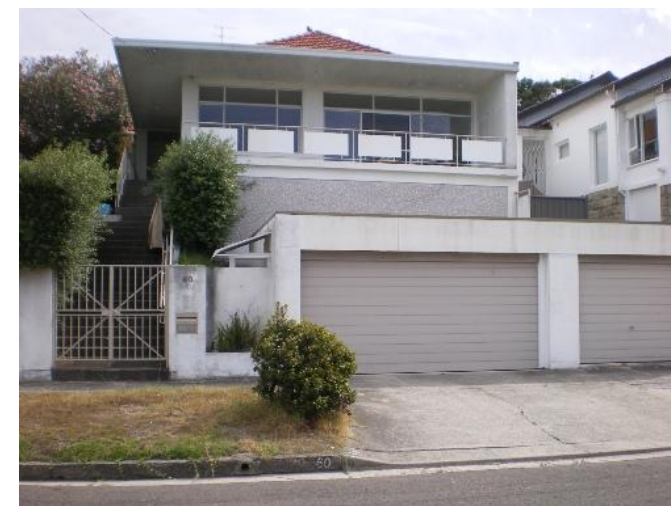
164. 60 Boronia Road Problem identified by Reference 4, field trip results show: Garage below road, Ponding on street, Flooding due to overland flow from road above property

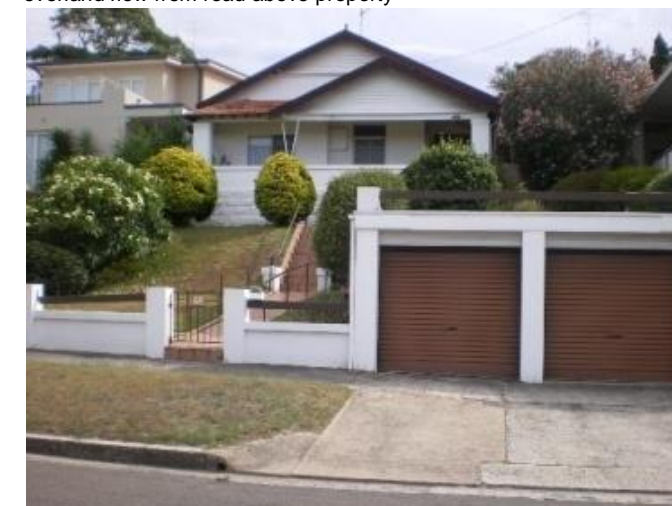
165. 58 Boronia Road Problem identified by Reference 4, field trip results show: Garage below road, Ponding on street, Flooding due to overland flow from road above property

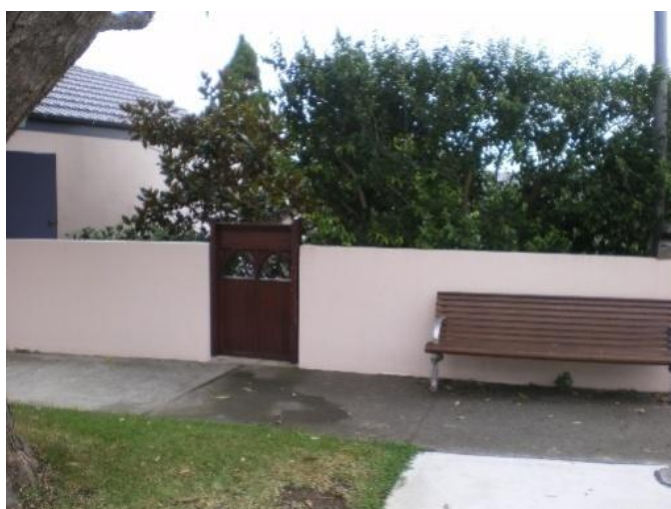
169. 19 Bunyula Road Problem identified by Reference 4, field trip results show: No problem identified

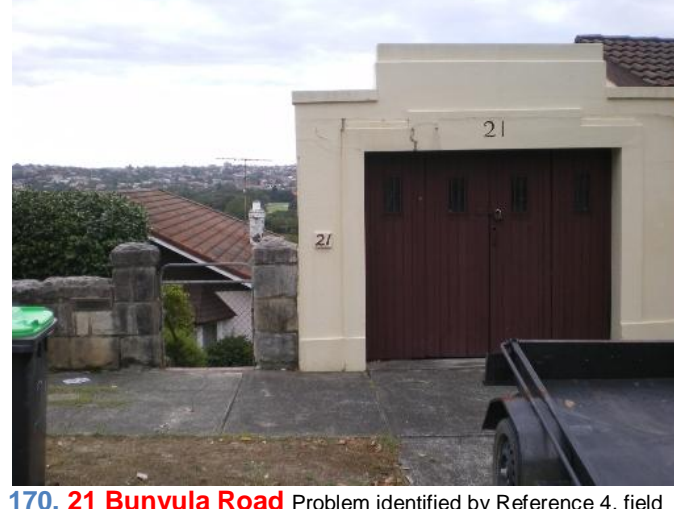
170. 21 Bunyula Road Problem identified by Reference 4, field trip results show: No problem identified

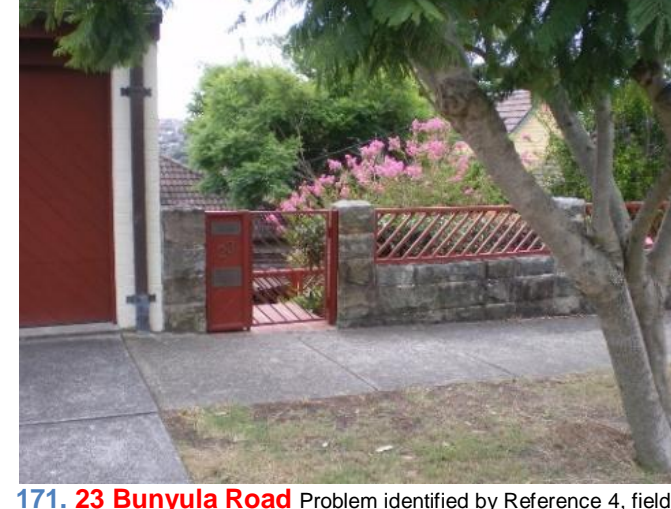
171. 23 Bunyula Road Problem identified by Reference 4, field trip results show: No problem identified

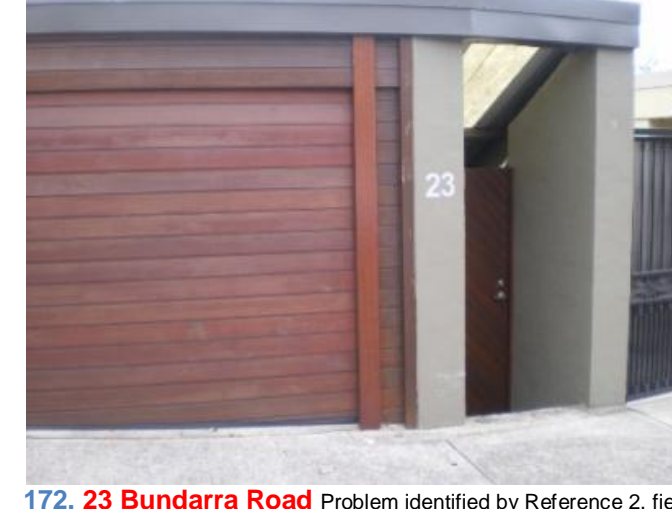
172. 23 Bundarra Road Problem identified by Reference 2, field trip results show: Floor below road, Garage below road

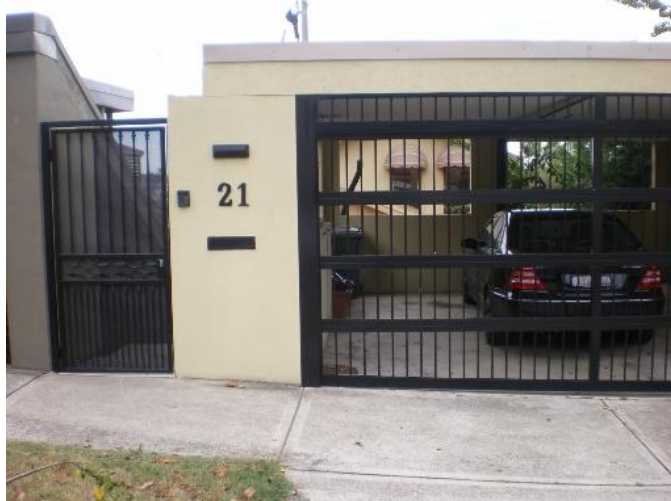
173. 21 Bundarra Road Problem identified by Reference 4, field trip results show: Floor below road, Garage below road, Flooding due to overland flow from road above property

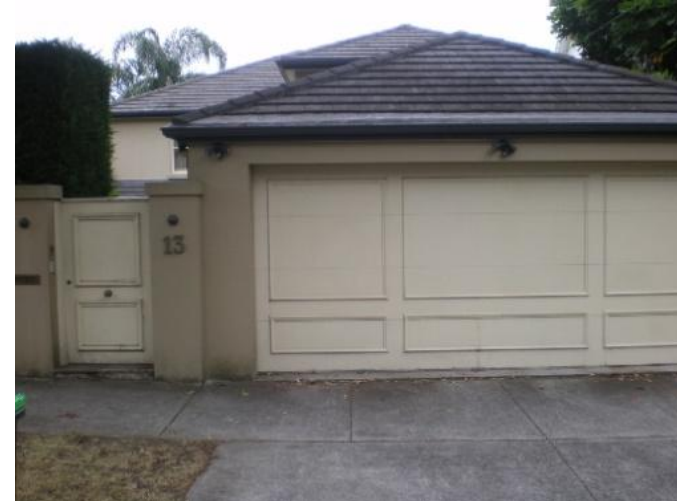
177. 13 Bundarra Road Problem identified by Reference 2, field trip results show: Floor below road, Garage below road, Ponding on street, Flooding due to overland flow from road above property

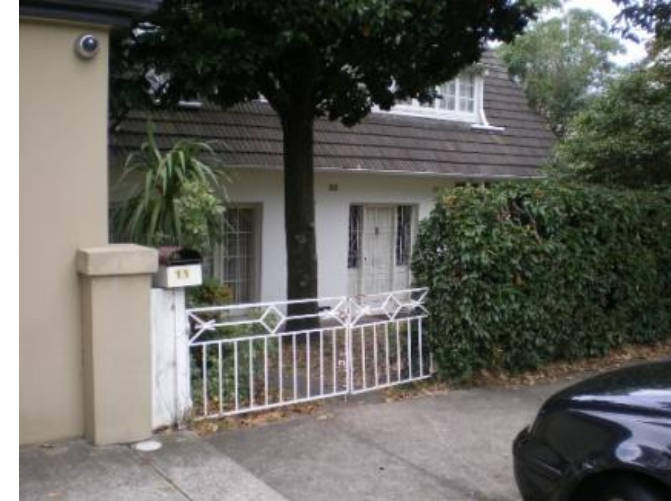
178. 11 Bundarra Road Problem identified by Reference 2, field trip results show: Floor below road, Garage below road, Ponding on street, Flooding due to overland flow from road above property

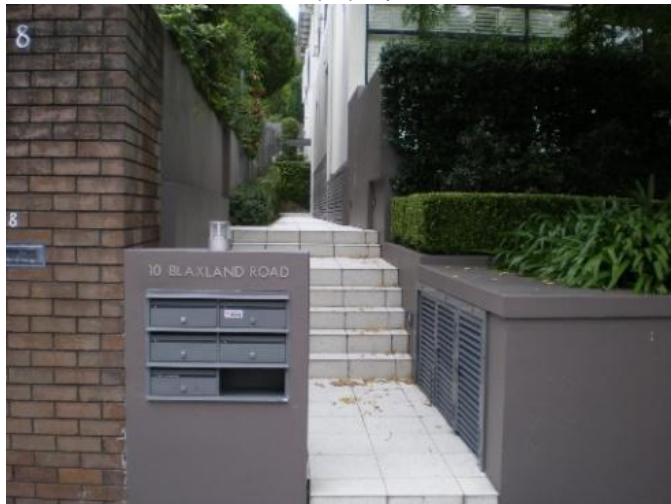
182. 10 Blaxland Road Problem identified by Reference 4, field trip results show: Floor below road, Garage below road, High velocity flow, Flooding due to overland flow path from adjacent street

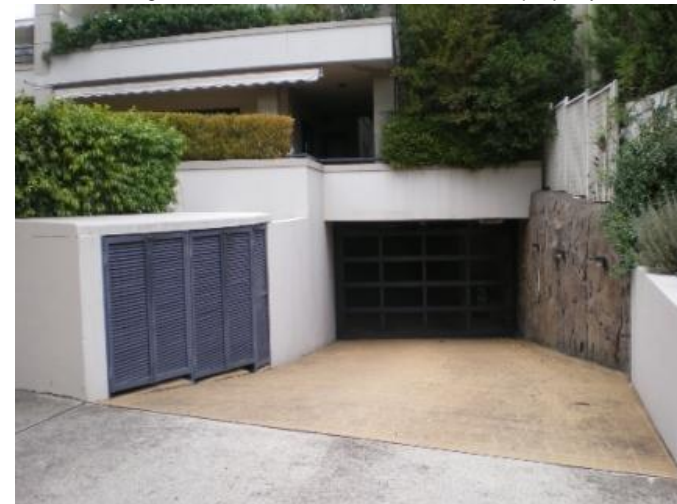
183. 12 Blaxland Road Problem identified by Reference 4, field trip results show: Floor below road, Garage below road, High velocity flow, Flooding due to overland flow path from adjacent street

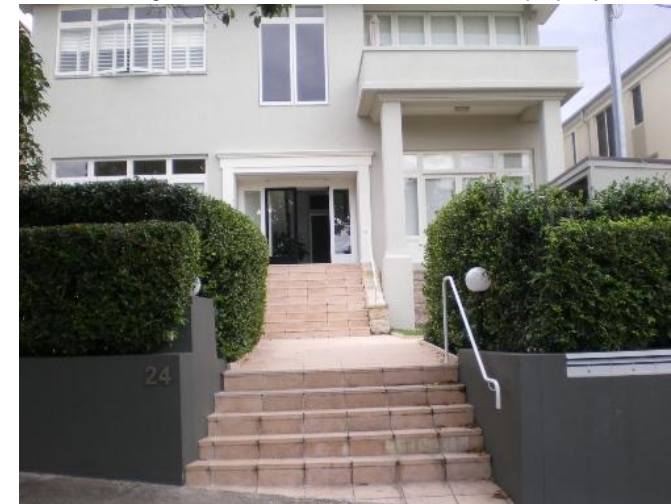
184. 22 Blaxland Road Problem identified by Reference 2, field trip results show: Flooding due to overland flow from road above property

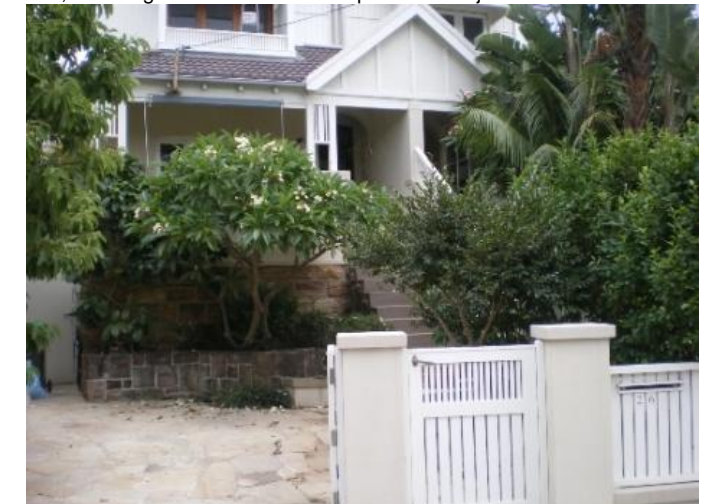
185. 26 Blaxland Road Problem identified by Reference 2, field trip results show: Flooding due to overland flow from road above property

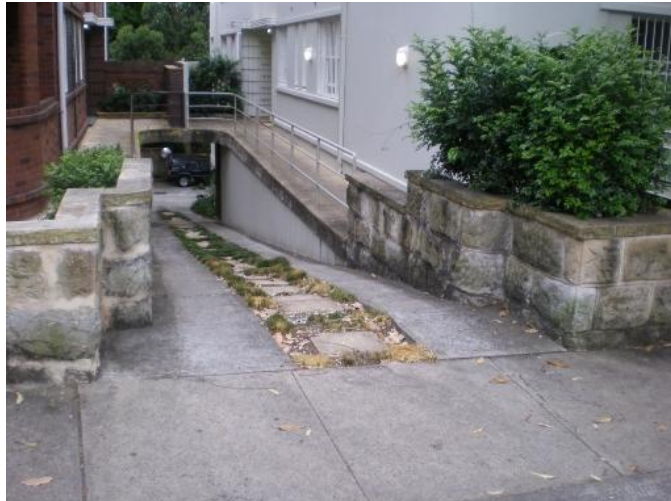
193. 78 Birriga Road Problem identified by Reference 2, field trip results show: Floor below road, Garage below road, Road and footpath graded towards residence, Main flow channel bordering residence

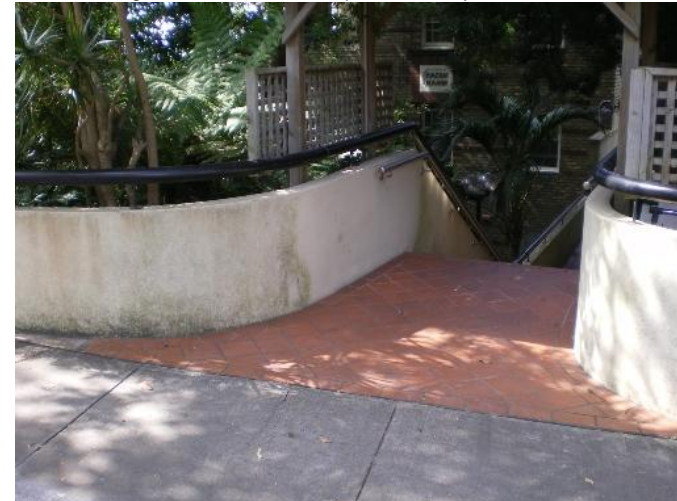
196. 94 Birriga Road Problem identified by Reference 2, field trip results show: Floor below road, Main flow channel bordering residence

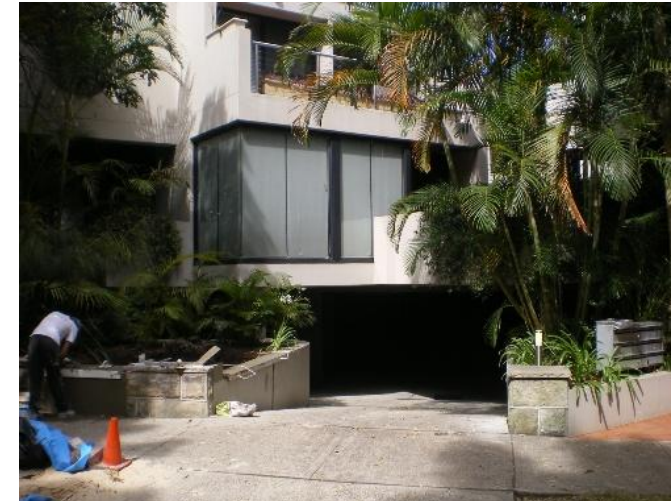
198. 271 O'Sullivan Road Problem identified by Reference 2, field trip results show: Garage below road

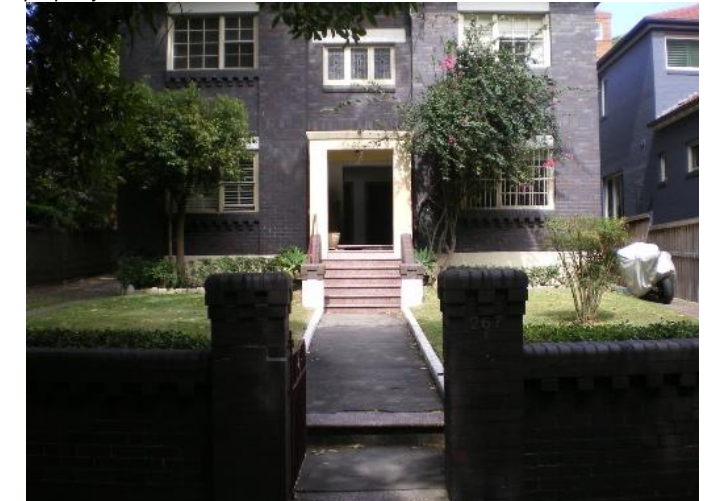
199. 267 O'Sullivan Road Problem identified by Reference 2, field trip results show: No problem identified

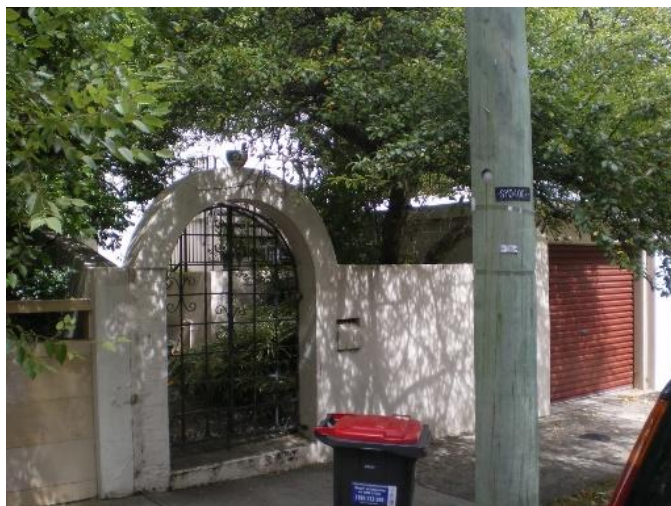
202. 245 O'Sullivan Road Problem identified by Reference 2, field trip results show: Flooding due to overland flow from road above property

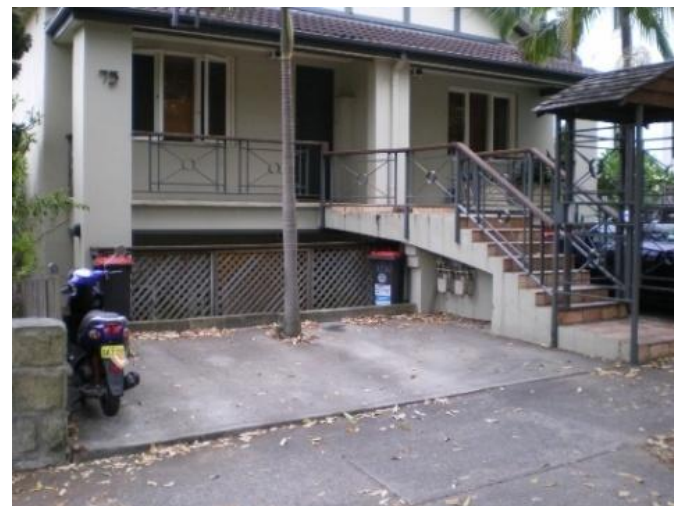
205. 75 Birriga Road Problem identified by Reference 2, field trip results show: Floor below road, Road and footpath graded towards residence

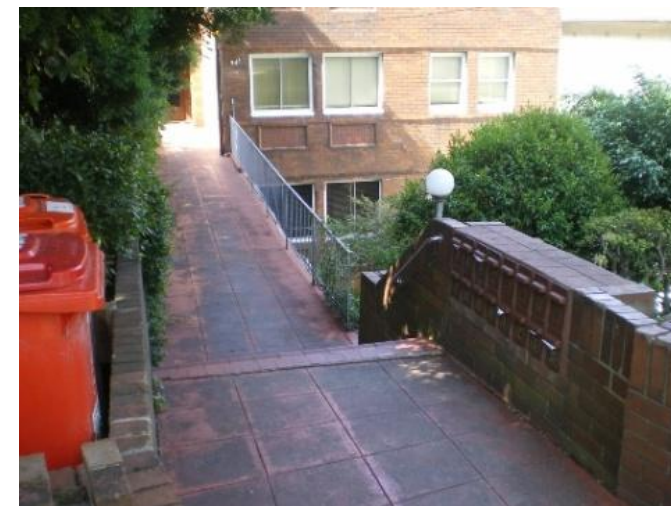
217. 103A Birriga Road Problem identified by Reference 2, field trip results show: Garage below road, Flooding due to overland flow from road above property

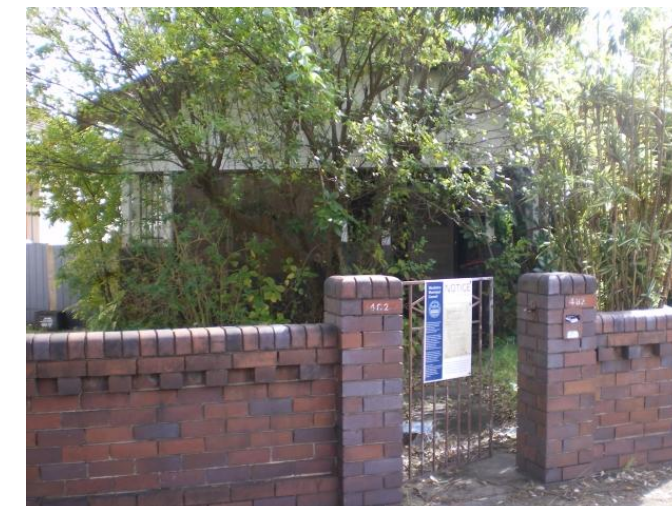
219. 482 Old South Head Road Problem identified by Reference 4, field trip results show: Very high flow and water level in nearby channel

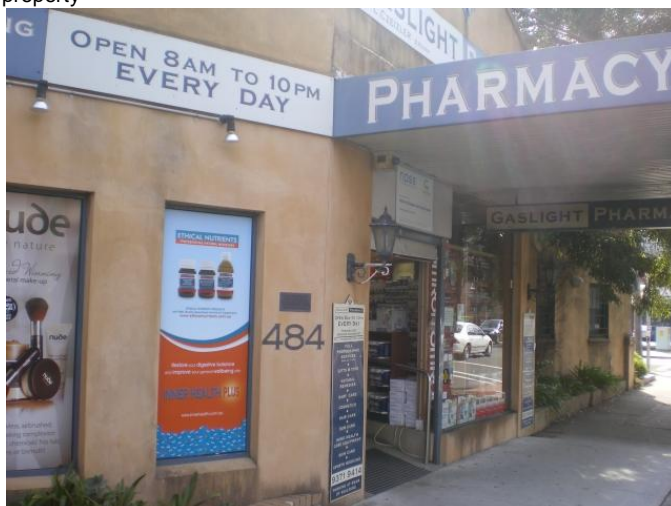
220. 484 Old South Head Road Problem identified by Reference 4, field trip results show: Very high flow and water level in nearby channel
