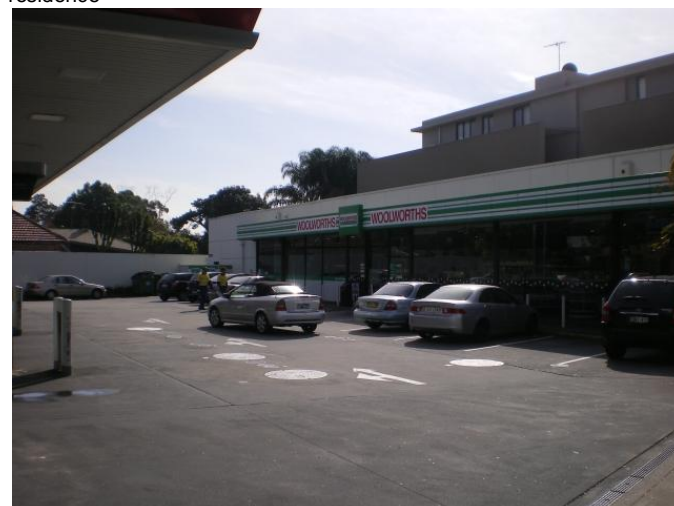
221. 488 Old South Head Road Problem identified by Reference 4, field trip results show: Very high flow and water level in nearby channel

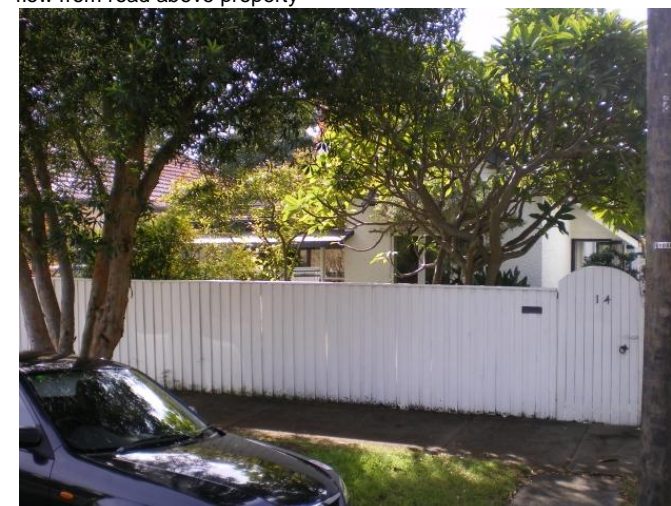
222. 14 Albemarle Avenue Problem identified by Reference 2, field trip results show: Very high flow and water level

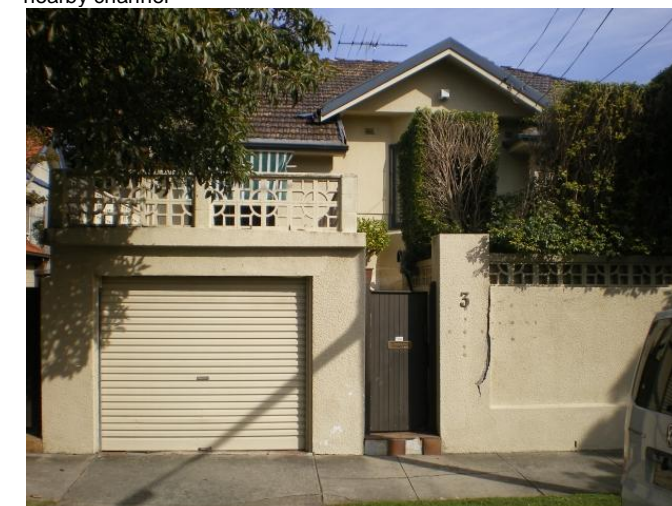
223. 3 Albemarle Avenue Problem identified by Reference 2, field trip results show: Constricted flow path with deep water

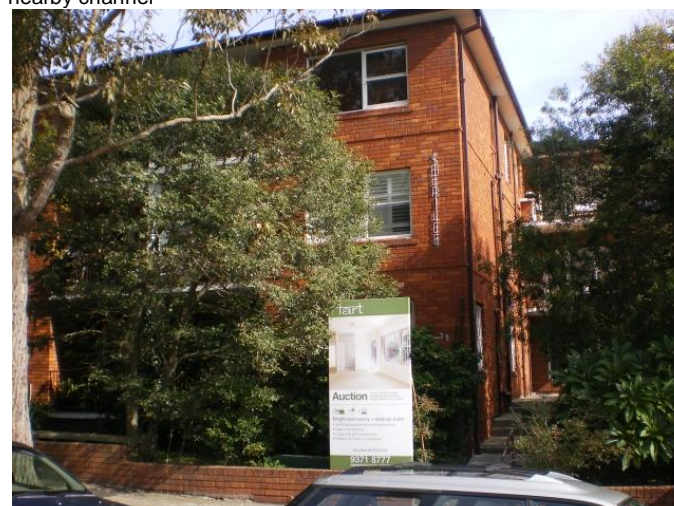
227. 39 Newcastle Street Problem identified by Reference 2, field trip results show: Garage below road

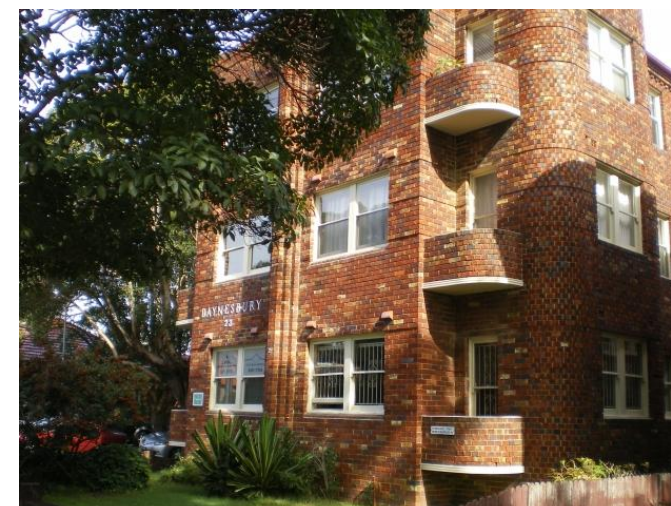
228. 23 Newcastle Street Problem identified by Reference 2, field trip results show: Very high flow and water level in nearby channel

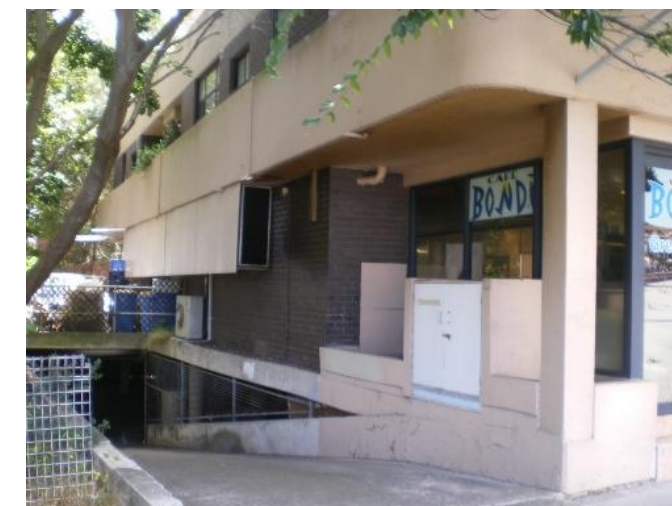
233. 624B New South Head Road Problem identified by Reference 2, field trip results show: Floor below road

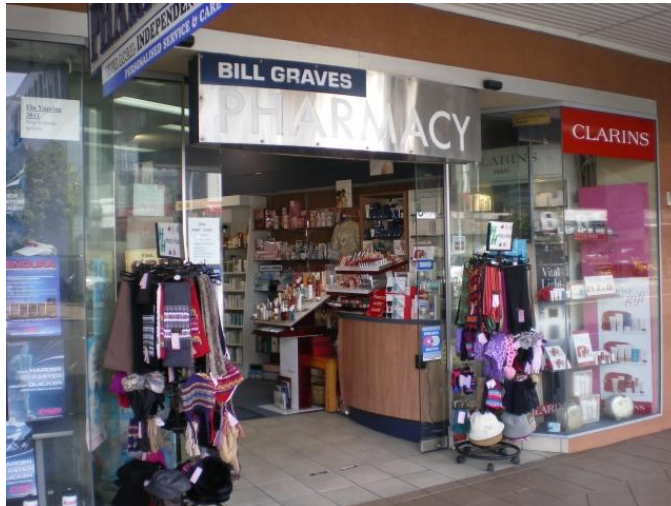
236. 692 New South Head Road Problem identified by Reference 2, field trip results show: Very high flow and water level

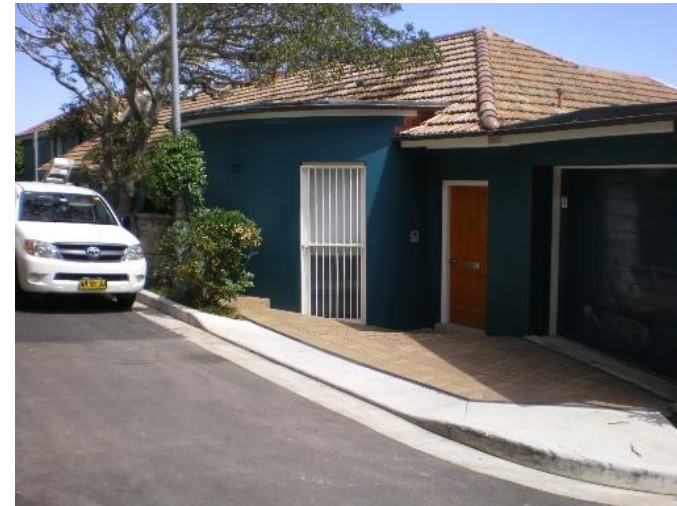
248. 8 Bayview Hill Road Problem identified by Reference 2, field trip results show: Floor below road, Road and footpath graded towards residence, Main flow channel bordering residence

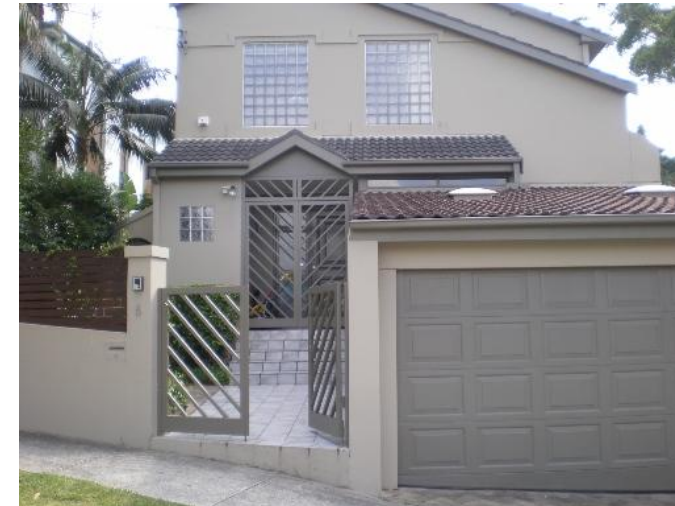
259. 6 Mitchell Road Problem identified by Reference 2, field trip results show: Flooding due to overland flow from road above property

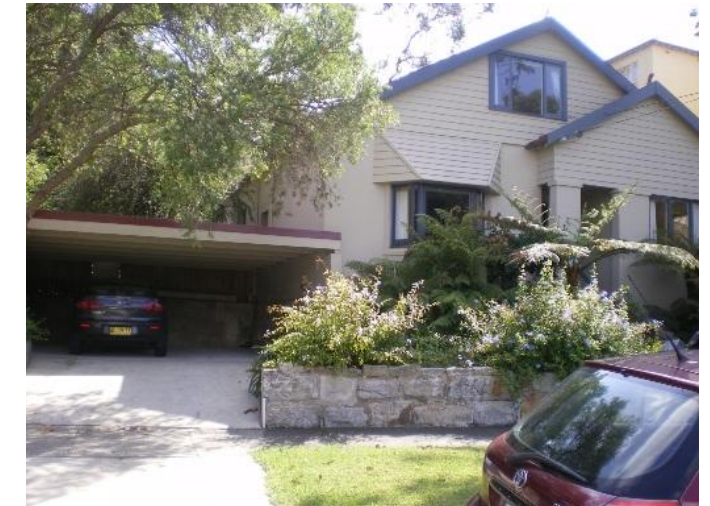
261. 14 Mitchell Road Problem identified by Reference 2, field trip results show: Flooding due to overland flow from road above property

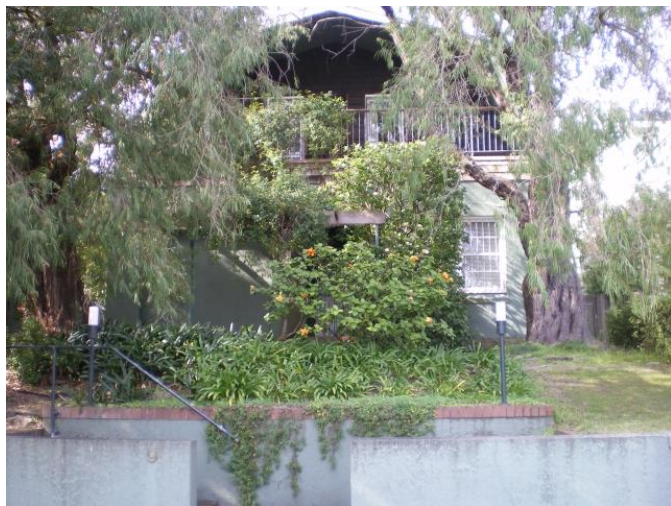
264. 9 Ebsworth Road Problem identified by Reference 2, field trip results show: Flooding reported not at this address

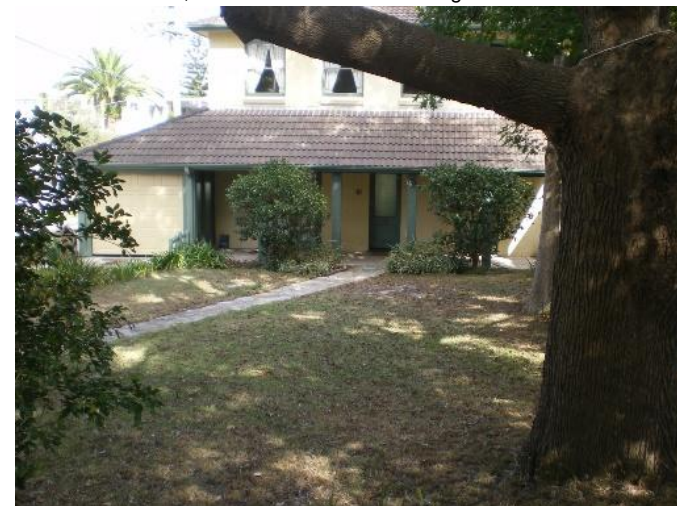
265. 2 Ebsworth Road Problem identified by Reference 2, field trip results show: Floor below road, Road and footpath graded towards residence, Main flow channel bordering residence

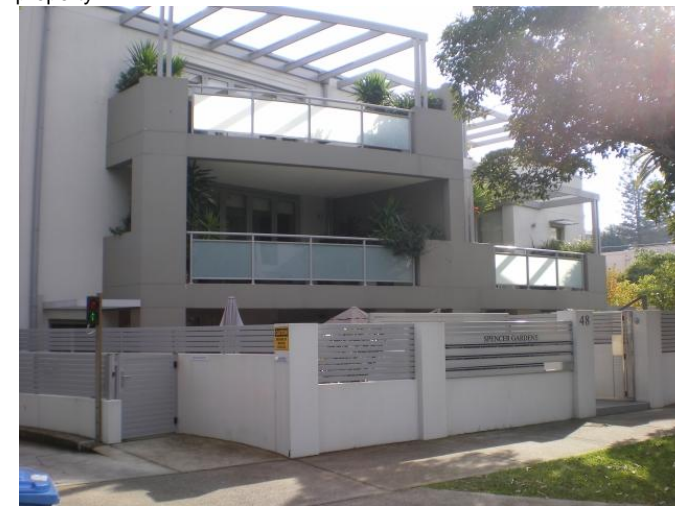
266. 48 Spencer Street Problem identified by Reference 4, field trip results show: High Flow along Spencer Street

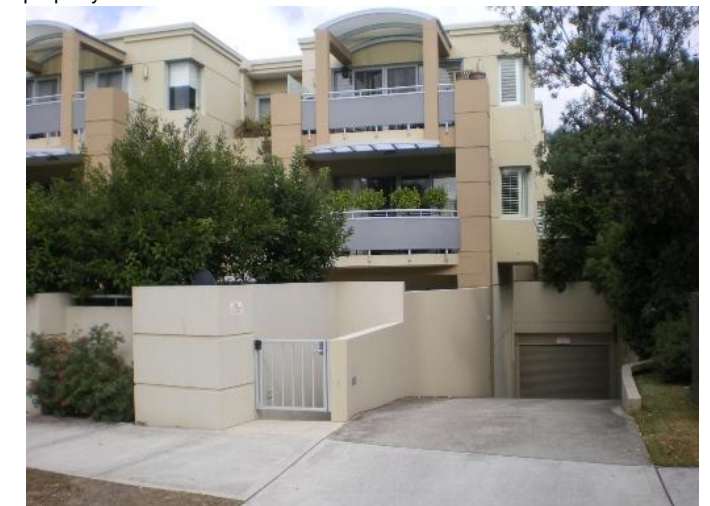
267. 44 Spencer Street Problem identified by Reference 4, field trip results show: High Flow along Spencer Street

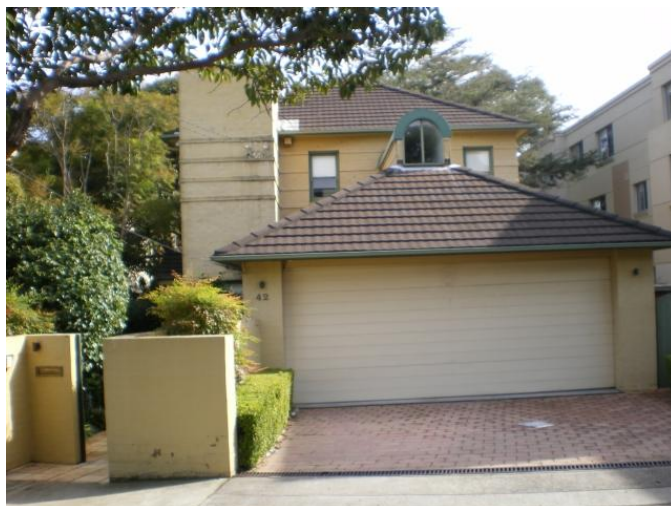
268. 42 Spencer Street Problem identified by Reference 4, field trip results show: High Flow along Spencer Street

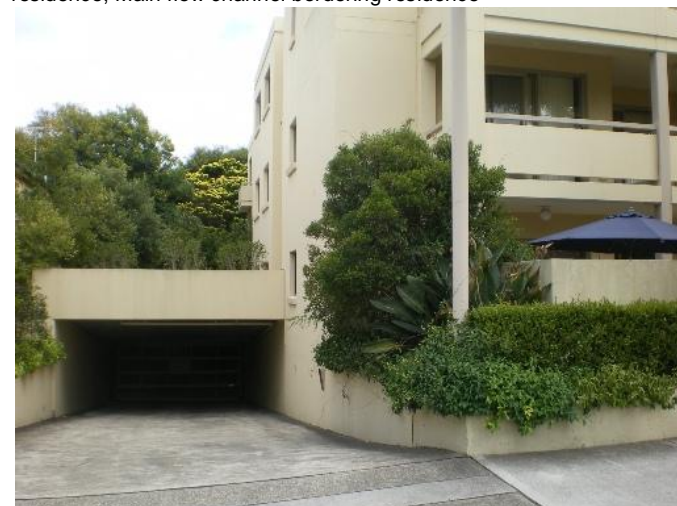
269. 34 Spencer Street Problem identified by Reference 4, field trip results show: High Flow along Spencer Street

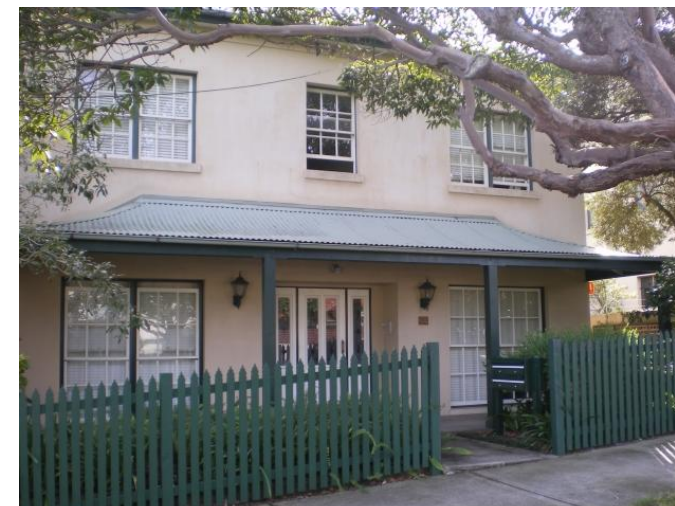
270. 32 Spencer Street Problem identified by Reference 4, field trip results show: High Flow along Spencer Street

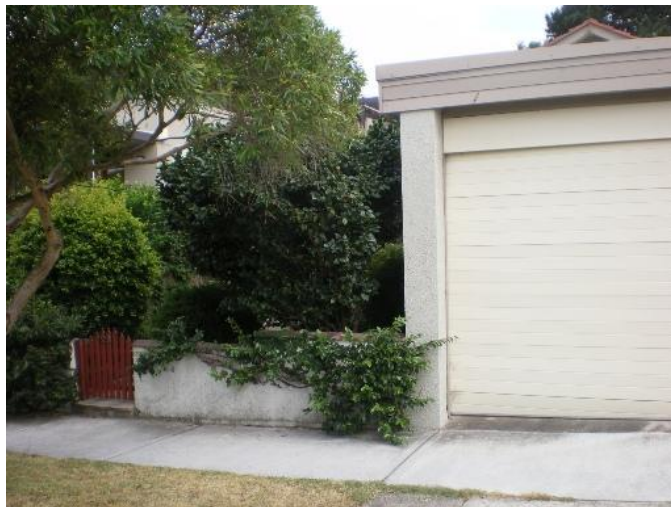
271. 30 Spencer Street Problem identified by Reference 4, field trip results show: High Flow along Spencer Street

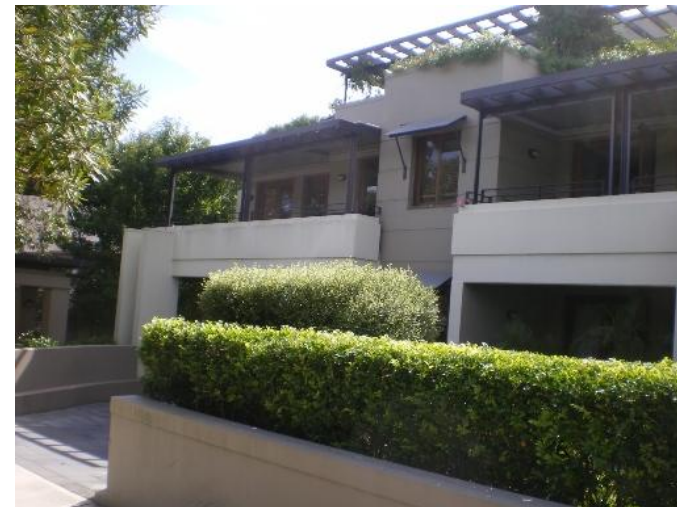
272. 28 Spencer Street Problem identified by Reference 4, field trip results show: High Flow along Spencer Street

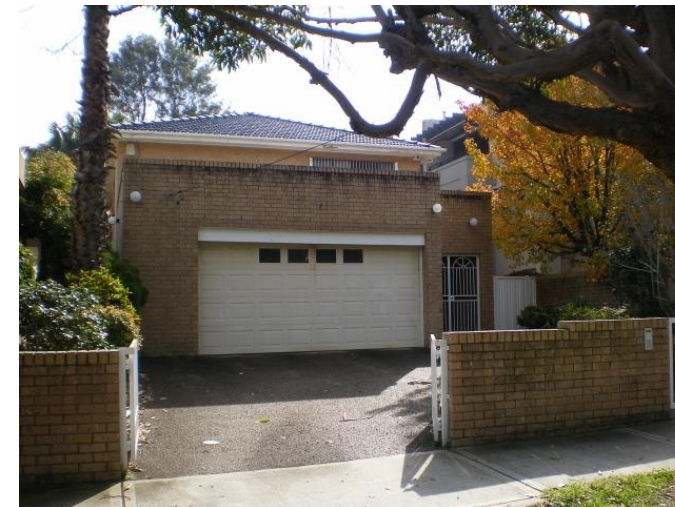
273. 24 Spencer Street Problem identified by Reference 4, field trip results show: High Flow along Spencer Street

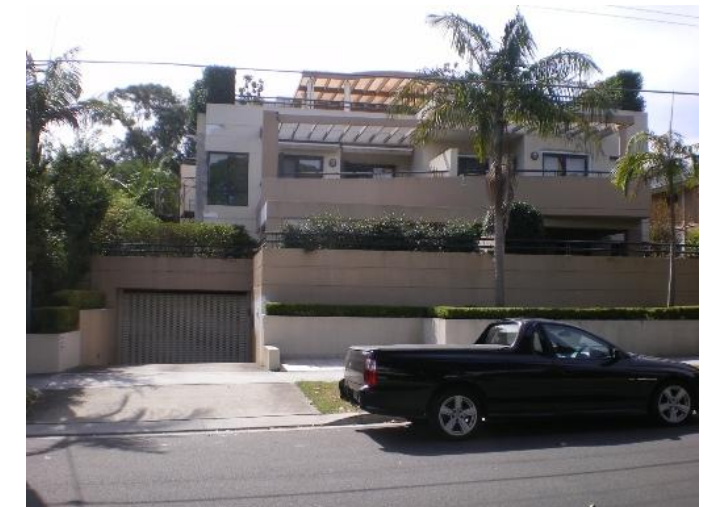
274. 22 Spencer Street Problem identified by Reference 4, field trip results show: High Flow along Spencer Street

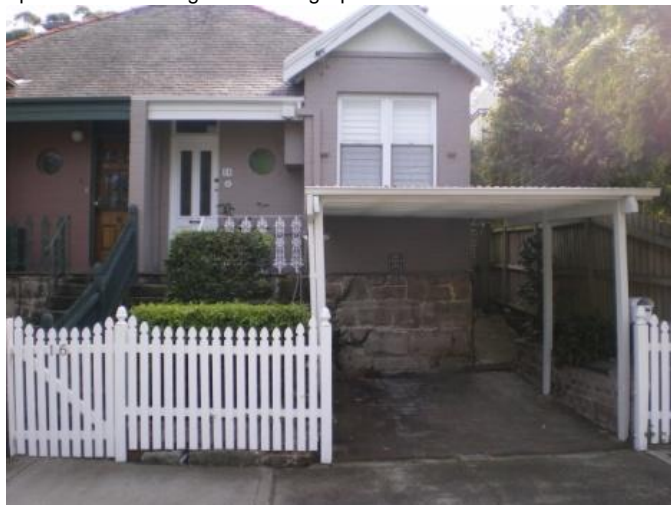
275. 18 Spencer Street Problem identified by Reference 4, field trip results show: Garage below road, High Flow along Spencer Street

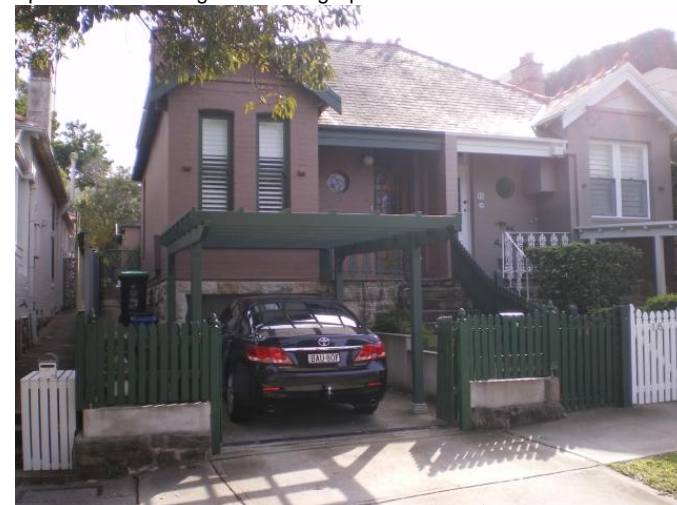
276. 16 Spencer Street Problem identified by Reference 4, field trip results show: High Flow along Spencer Street

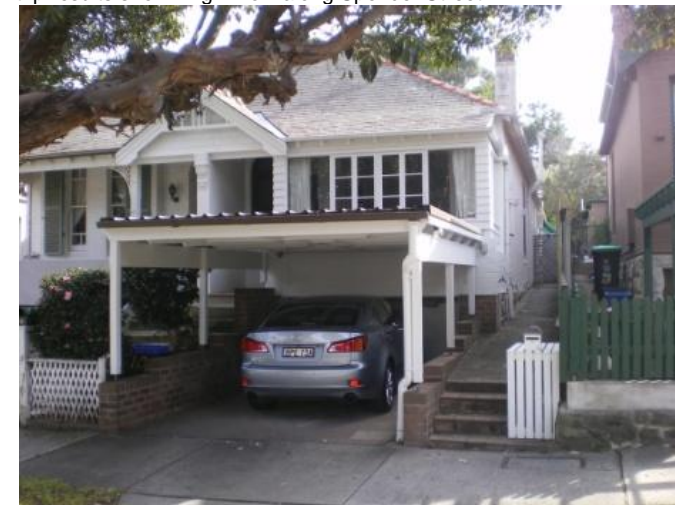
277. 14 Spencer Street Problem identified by Reference 4, field trip results show: High Flow along Spencer Street

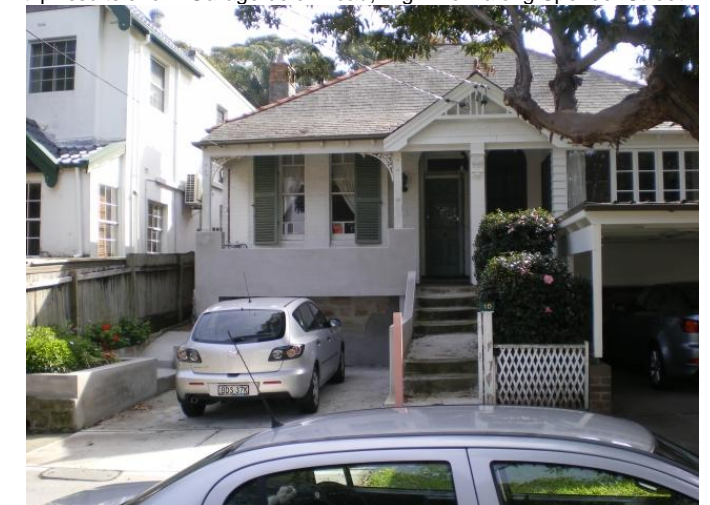
278. 12 Spencer Street Problem identified by Reference 4, field trip results show: High Flow along Spencer Street

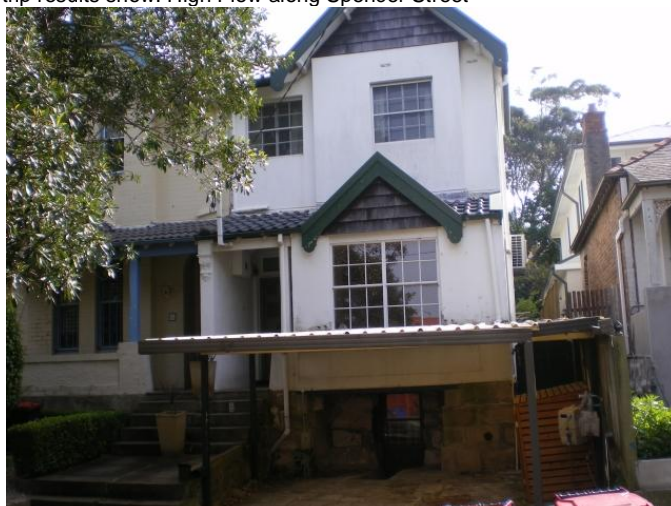
279. 10 Spencer Street Problem identified by Reference 4, field trip results show: High Flow along Spencer Street

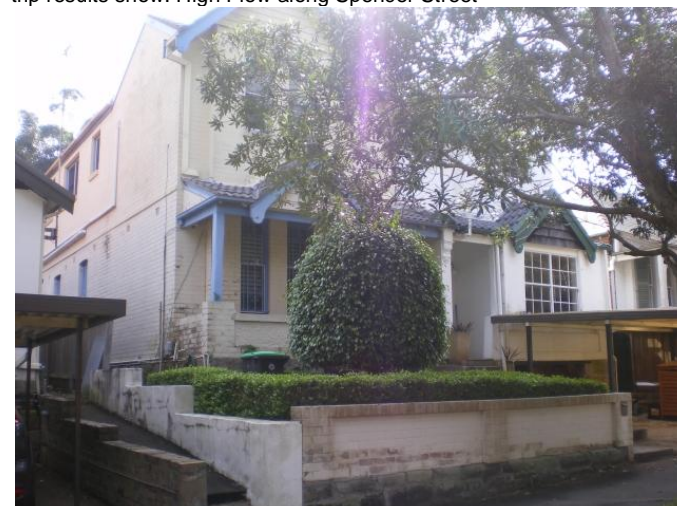
280. 8 Spencer Street Problem identified by Reference 4, field trip results show: High Flow along Spencer Street

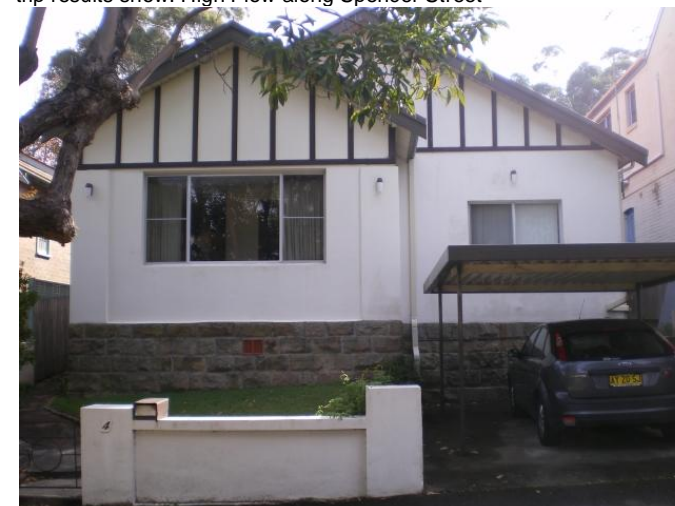
281. 6 Spencer Street Problem identified by Reference 4, field trip results show: High Flow along Spencer Street

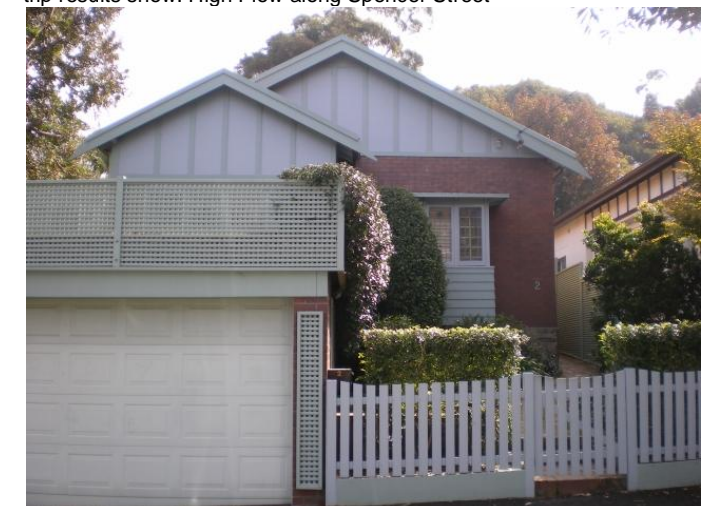
282. 4 Spencer Street Problem identified by Reference 4, field trip results show: High Flow along Spencer Street

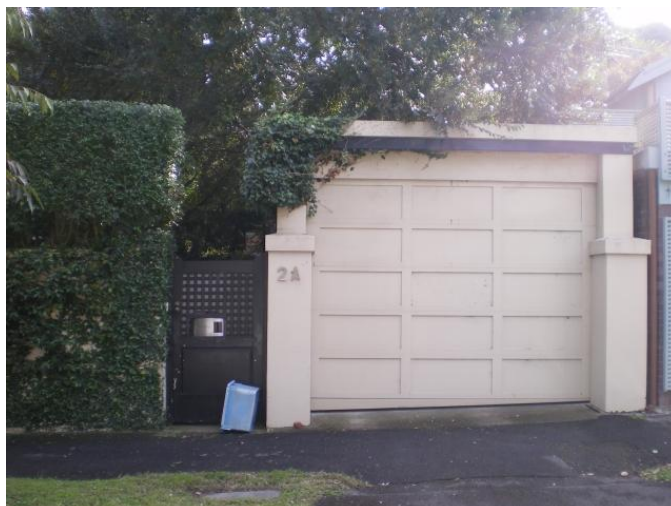
283. 2 Spencer Street Problem identified by Reference 4, field trip results show: High Flow along Spencer Street

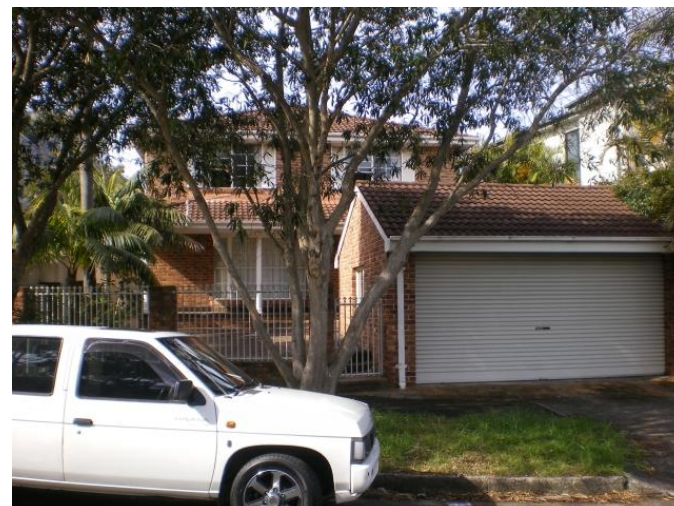
284. 2A Spencer Street Problem identified by Reference 4, field trip results show: High Flow along Spencer Street

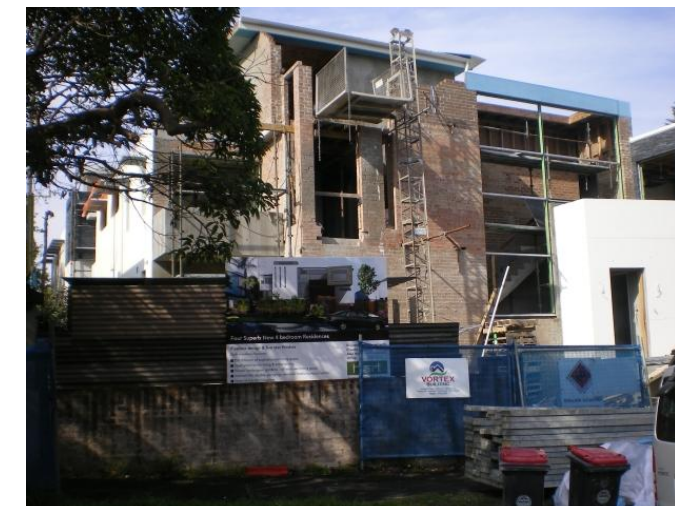
287. 49 Spencer Street Problem identified by Reference 4, field trip results show: High Flow along Spencer Street

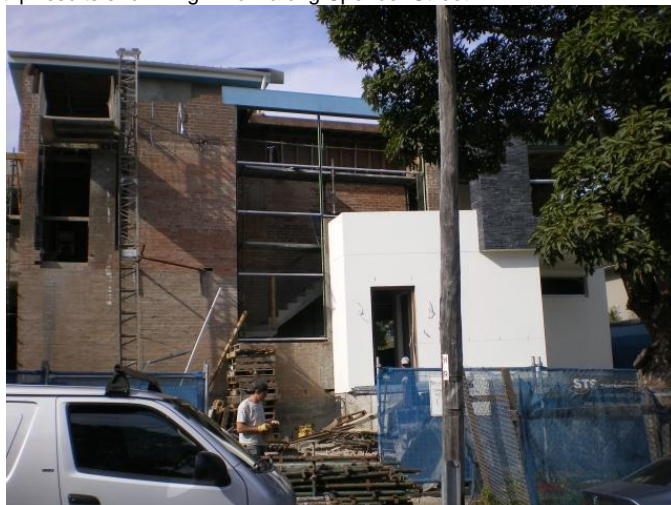
288. 47 Spencer Street Problem identified by Reference 4, field trip results show: High Flow along Spencer Street

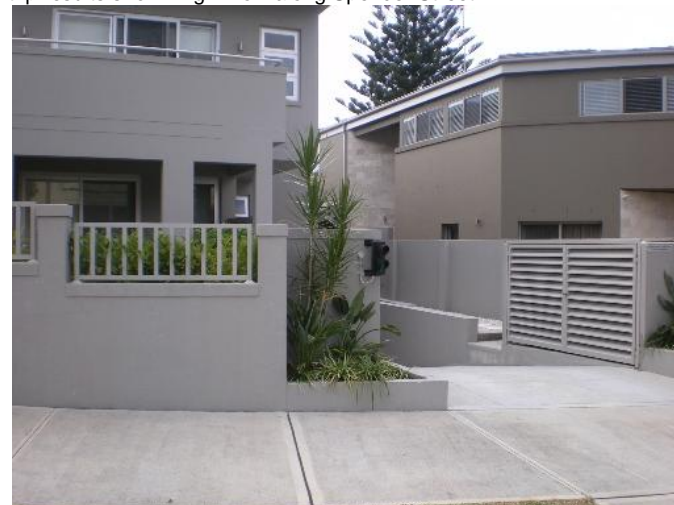
289. 45 Spencer Street Problem identified by Reference 4, field trip results show: High Flow along Spencer Street

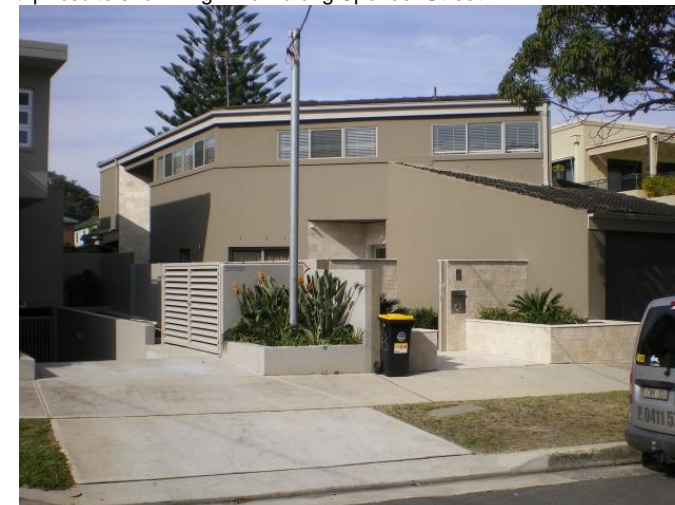
290. 43 Spencer Street Problem identified by Reference 4, field trip results show: Garage below road, High Flow along Spencer Street

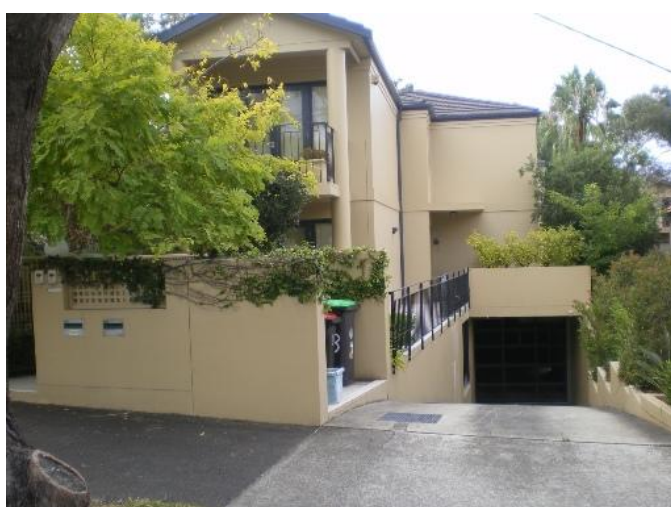
292. 37 Spencer Street Problem identified by Reference 4, field trip results show: Floor below road, Garage below road, High Flow along Spencer Street

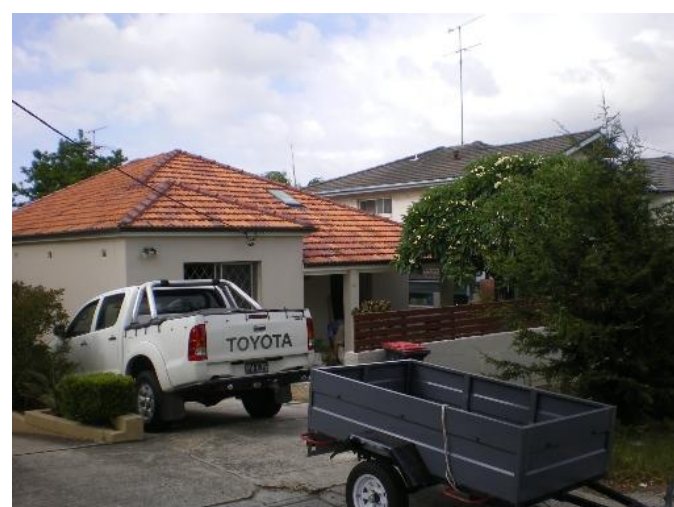
293. 35 Spencer Street Problem identified by Reference 4, field trip results show: Garage below road, Flow diversion, High Flow along Spencer Street

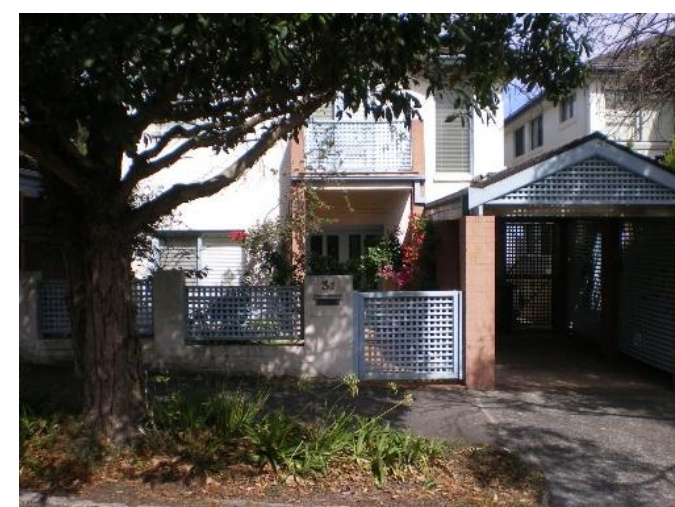
294. 33 Spencer Street Problem identified by Reference 4, field trip results show: Floor below road, Flow diversion, High Flow along Spencer Street

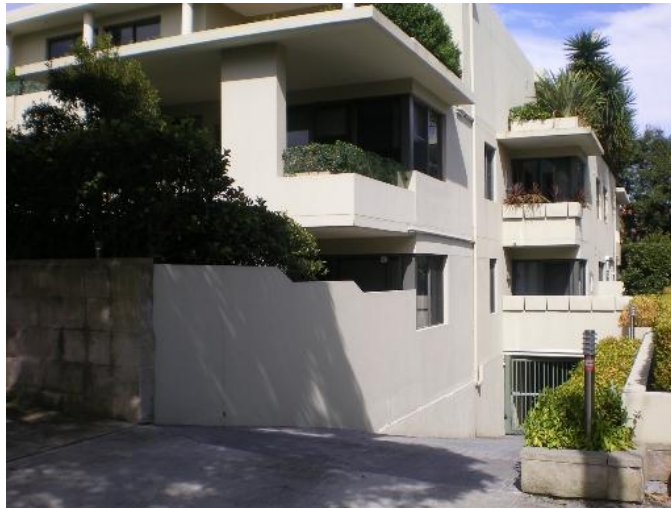
296. 29 Spencer Street Problem identified by Reference 4, field trip results show: Floor below road, Garage below road, High Flow along Spencer Street

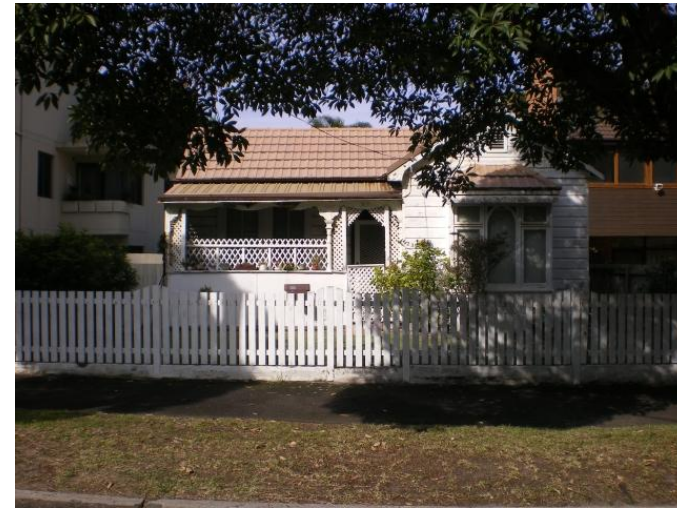
297. 25 Spencer Street Problem identified by Reference 4, field trip results show: High Flow along Spencer Street

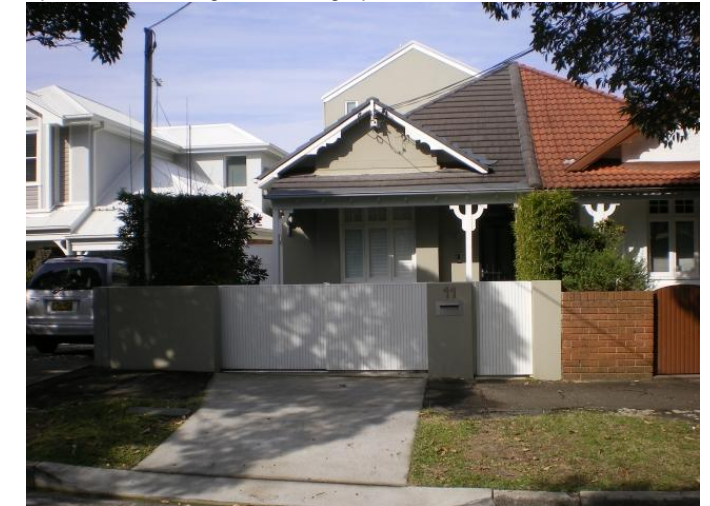
303. 13 Spencer Street Problem identified by Reference 4, field trip results show: Floor below road, Garage below road, High Flow along Spencer Street

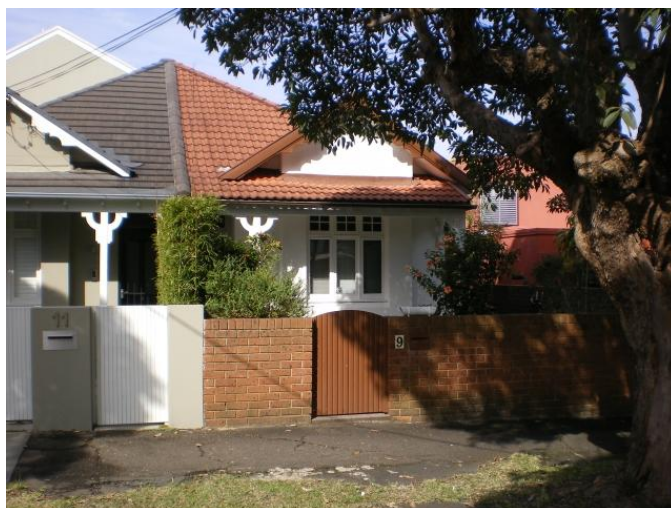
304. 11 Spencer Street Problem identified by Reference 4, field trip results show: High Flow along Spencer Street

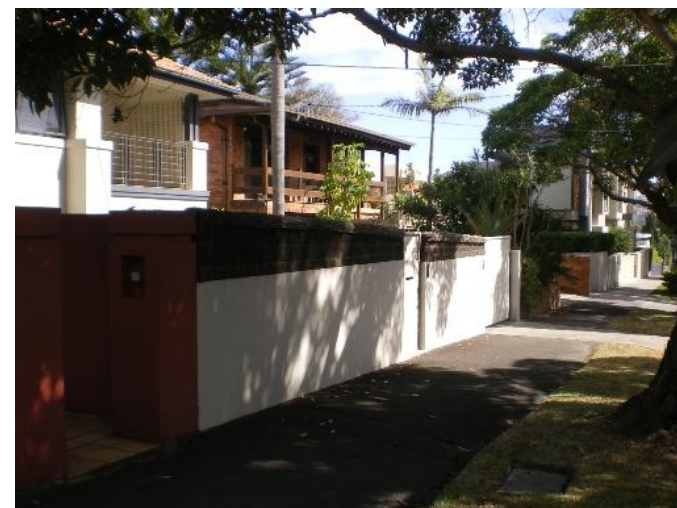
305. 9 Spencer Street Problem identified by Reference 4, field trip results show: High Flow along Spencer Street

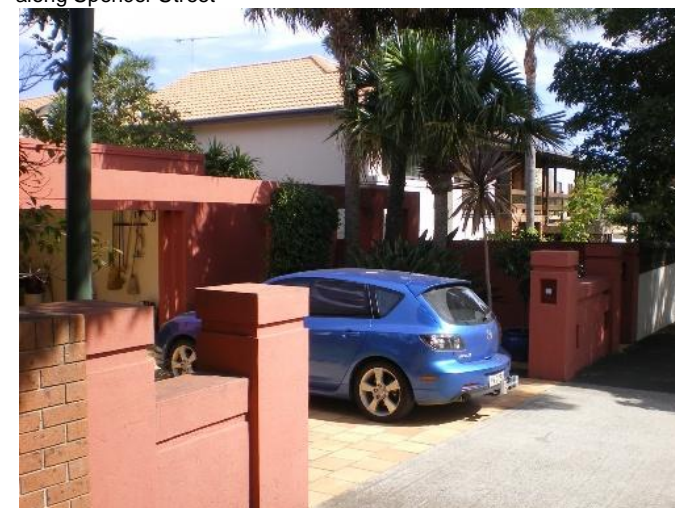
306. 5 Spencer Street Problem identified by Reference 4, field trip results show: Floor below road, Garage below road, High Flow along Spencer Street

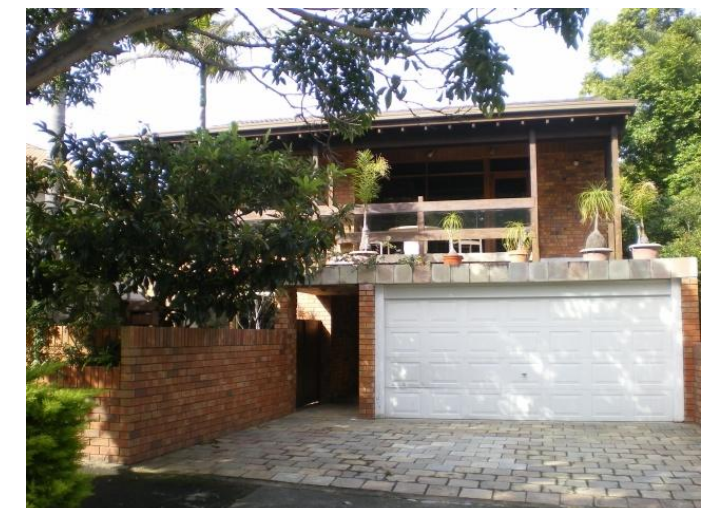
307. 3 Spencer Street Problem identified by Reference 4, field trip results show: Floor below road, Garage below road, High Flow along Spencer Street

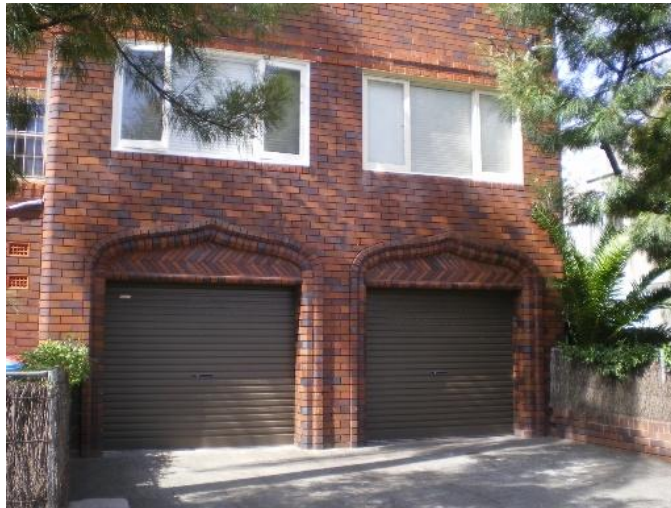
308. 1 Spencer Street Problem identified by Reference 4, field trip results show: High Flow along Spencer Street

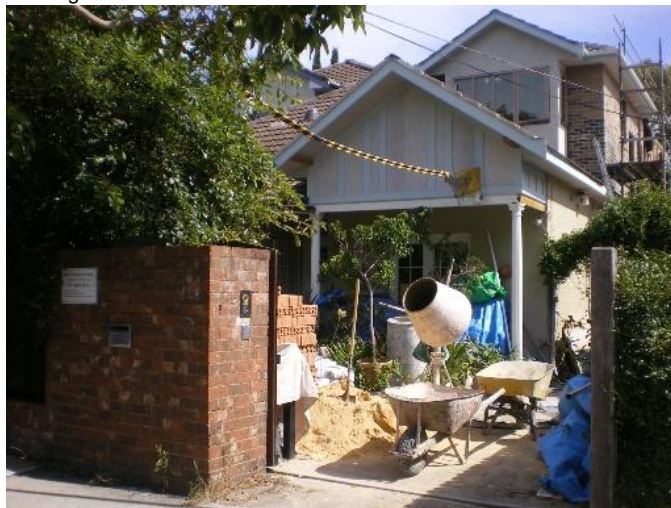
325. 63 Dover Road Problem identified by Reference 2, field trip results show: Ponding on street

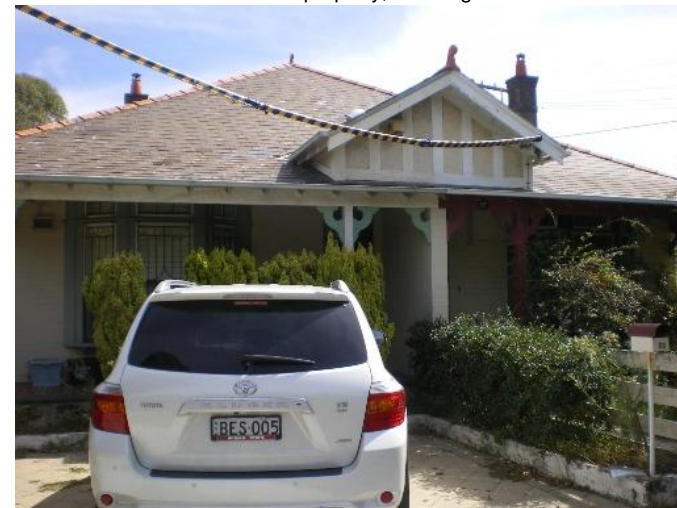
326. 61 Dover Road Problem identified by Reference 2, field trip results show: Ponding on street

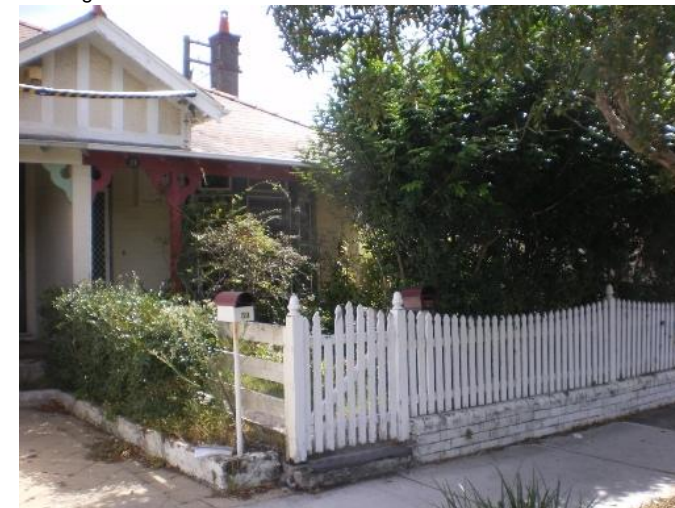
327. 59 Dover Road Problem identified by Reference 2, field trip results show: Ponding on street

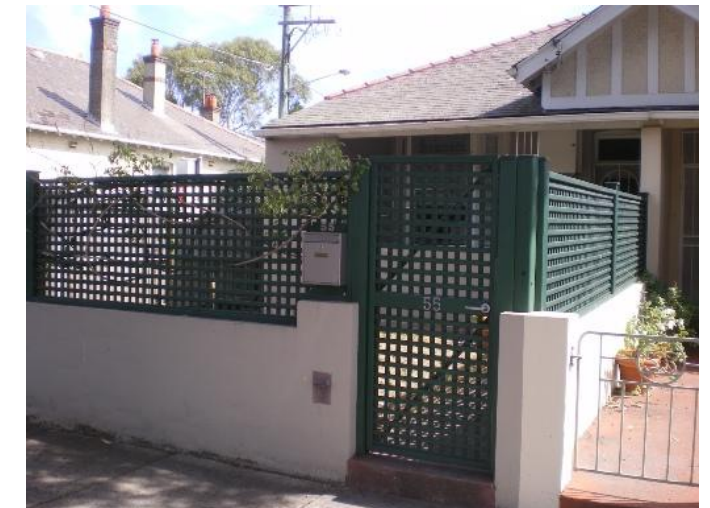
328. 57 Dover Road Problem identified by Reference 2, field trip results show: Ponding on street

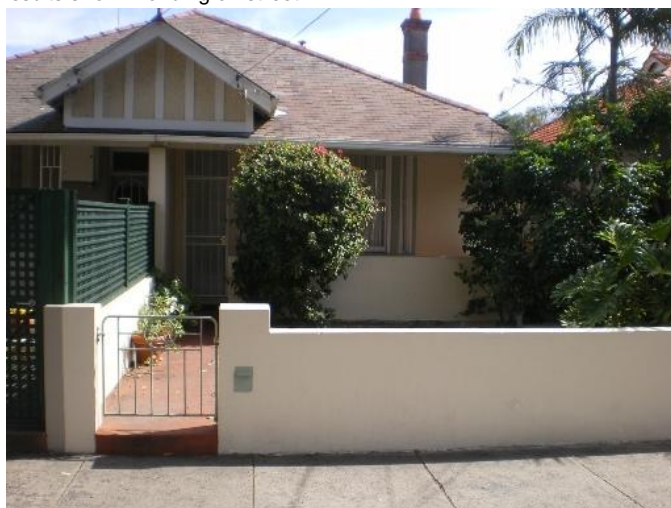
329. 55 Dover Road Problem identified by Reference 4, field trip results show: Ponding on street

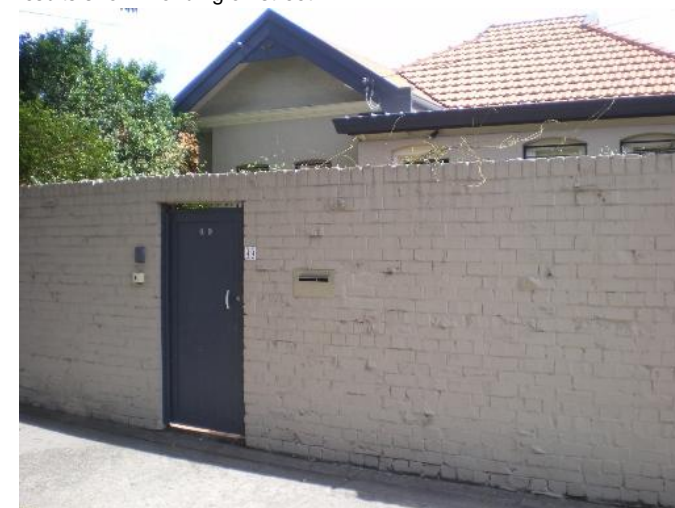
331. 51 Dover Road Problem identified by Reference 4, field trip results show: Ponding on street

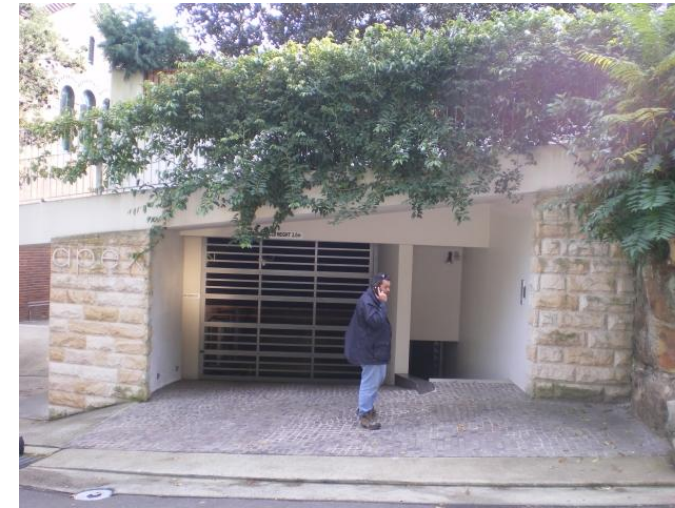
336. 58 Wilberforce Avenue Problem identified by Reference 4, field trip results show: No problem identified
