**FLOODING/DRAINAGE ISSUES IDENTIFIED FROM FIELD INSPECTION**

FIGURE B2  
LISTING OF FLOODING/DRAINAGE ISSUES

FIGURE B3a  
**REPORTED ISSUES BUT NOT INCLUDED IN FIELD INSPECTION**

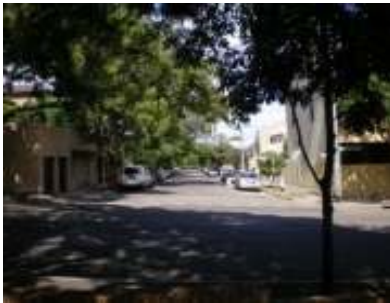
**113 Jersey Rd** Major overland flows and severe flooding during stated events (1984, Jan 87, Jan 89, Apr 89, and Jan 91). (blamed on regrading of park in 1987, barricades now exist diverting flow and have prevented above floor flooding).

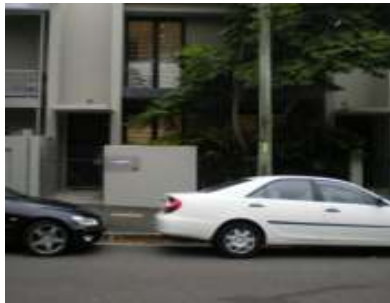
**86 Holdsworth St** Above floor flooding due to flows overtopping kerb in Holdsworth Street en route to Jersey Road.

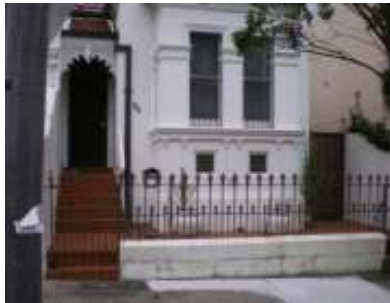
**173 Windsor St** Above floor level inundation

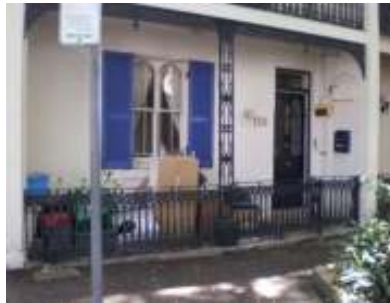
**159 Paddington St** Ground seepage enters residence during storms.

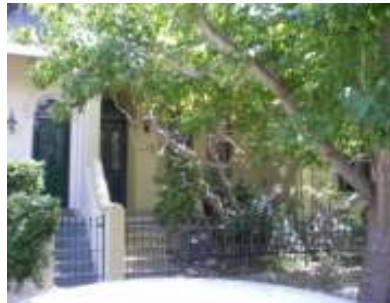
**133 Windsor St** Above floor flooding due to local drainage problem

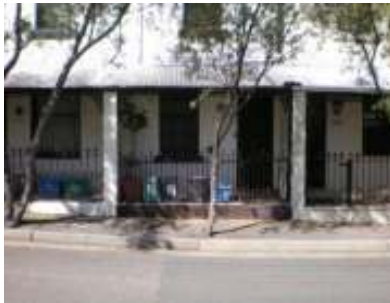
**184 Underwood St** Above floor flooding due to a drainage problem

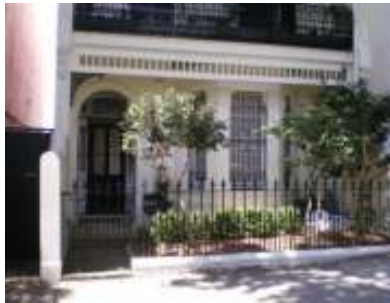
**14, 28, and 30 Windsor St** Inundation of below ground cellars

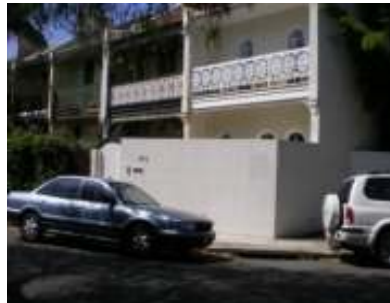
**21 Paddington St** Water to 0.15 below floor level.

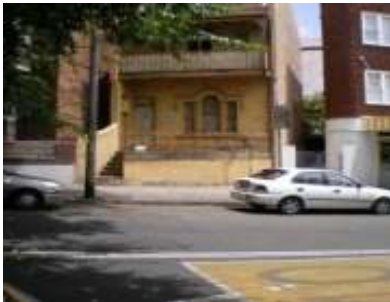
**1 Gurner St** Groundwater seepage due to storm events.

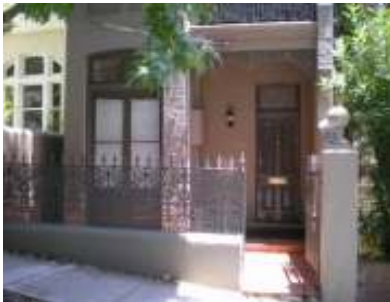
**280 Glenmore Rd** Groundwater seepage due to storm events.

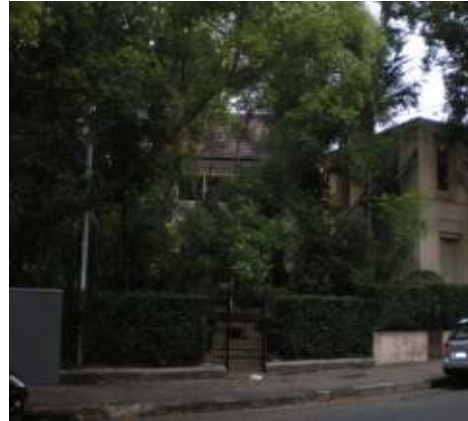
**113 Jersey Rd** Major overland flows and severe flooding during stated events (1984, Jan 87, Jan 89, Apr 89, and Jan 91). (blamed on regrading of park in 1987, barricades now exist diverting flow and have prevented above floor flooding).

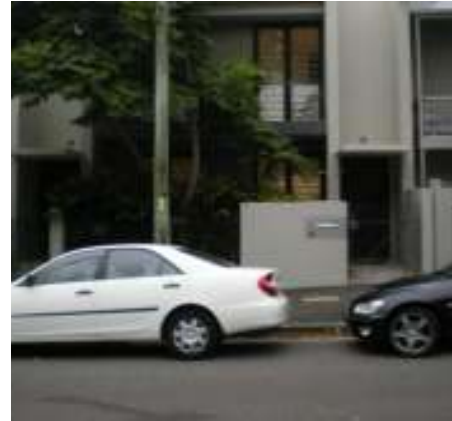
**86 Holdsworth St** Above floor flooding due to flows overtopping kerb in Holdsworth Street en route to Jersey Road.

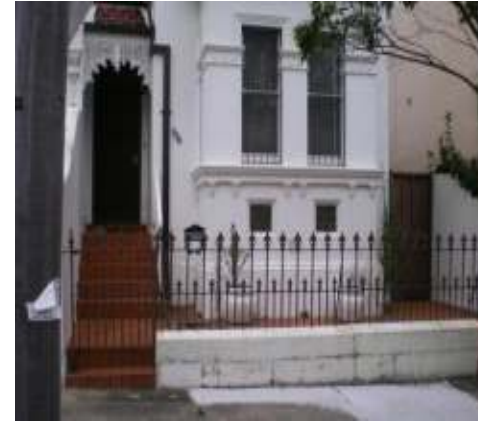
**173 Windsor St** Above floor level inundation.

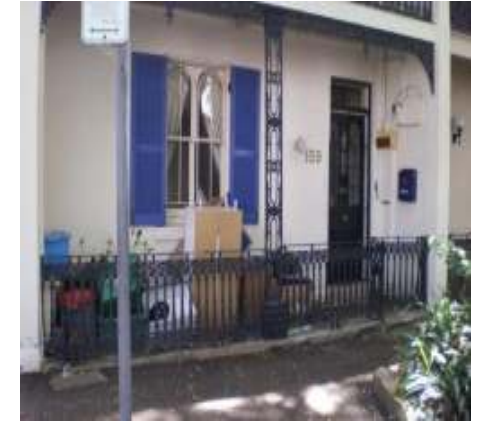
**159 Paddington St** Ground seepage enters residence during storms.

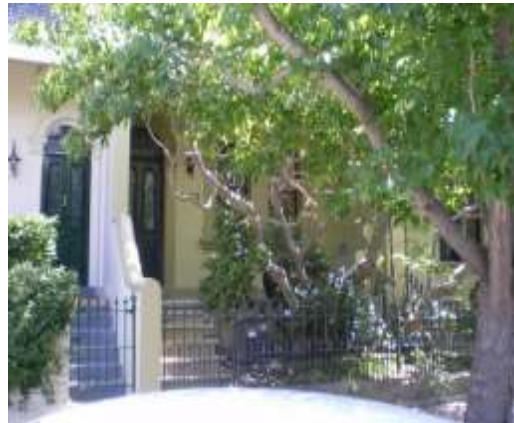
**133 Windsor St** Above floor flooding due to local drainage problem

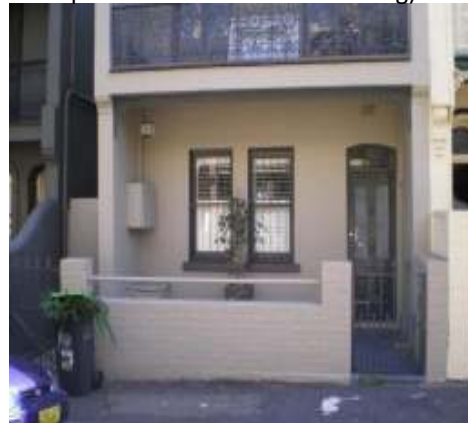
**121 Underwood St** Rising groundwater causes inundation of the basement during major storm events.

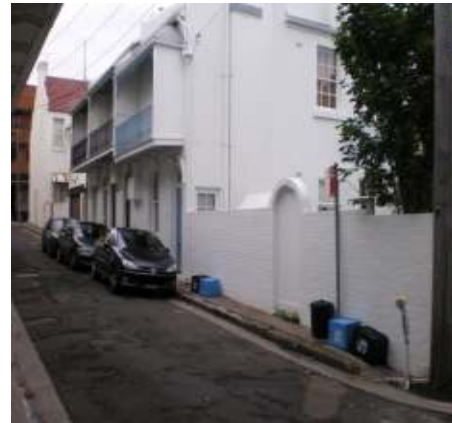
**1 Tivoli St** Water up to 0.08 m at front of house (89), water to 0.05 m below floor level (91).

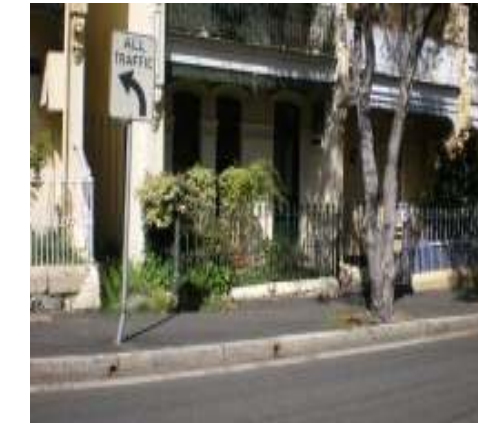
**130 Underwood St** Property inundated to 0.3m, and above floor flooding to 0.05m (89), property inundation to 0.2m (91).

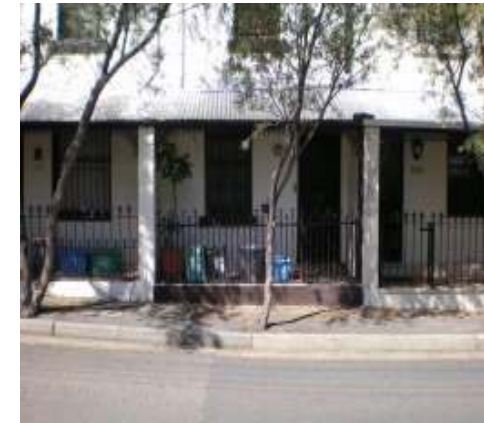
**184 Underwood St** Above floor flooding due to a drainage problem.

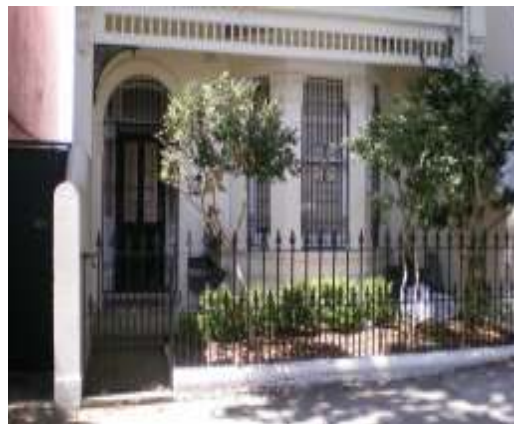
**14, 28, and 30 Windsor St** Inundation of below ground cellars.

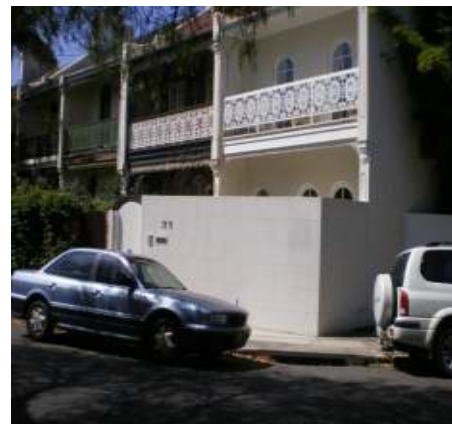
**21 Paddington St** Water to 0.15m below floor level.

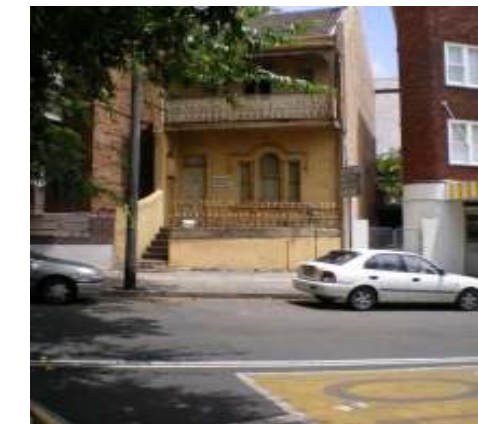
**1 Gurner St** Groundwater seepage due to storm events.

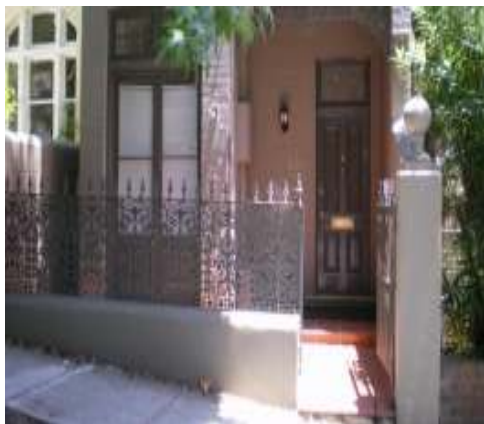
**280 Glenmore Rd** Groundwater seepage due to storm events.

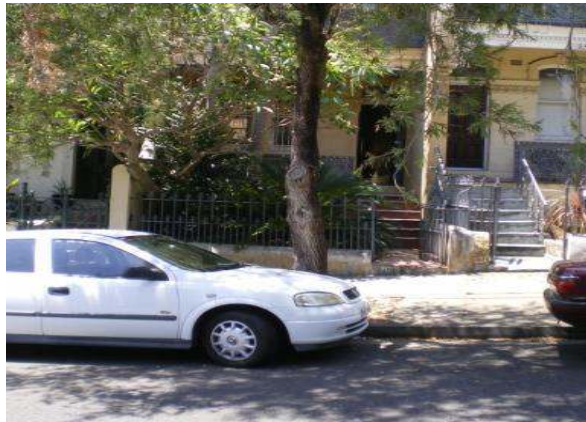
**311 Glenmore Rd** Groundwater seepage due to storm events.

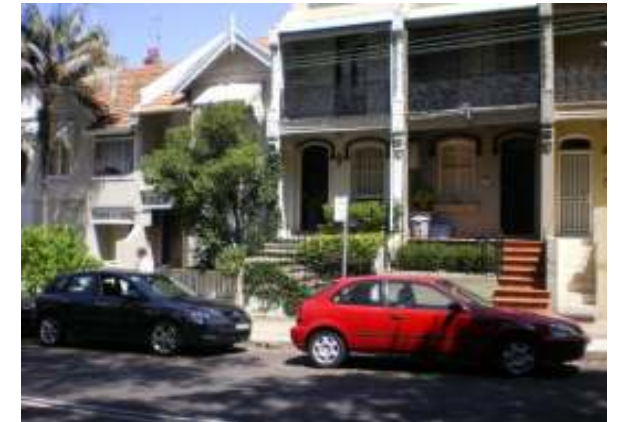
**440 and 450 Glenmore Rd** Above floor flooding reported, but no clear reason found.

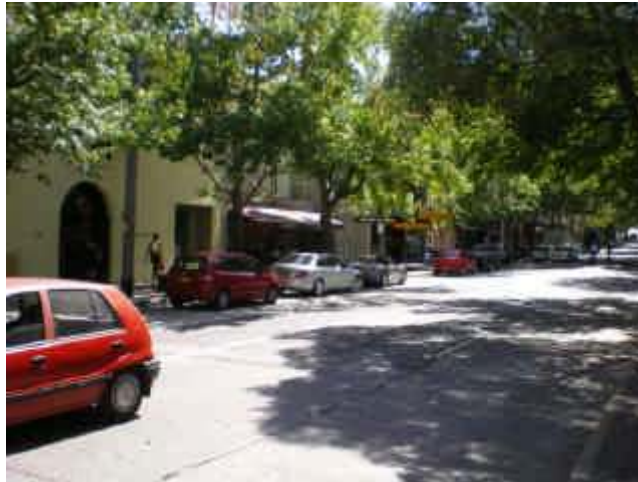
1. **Ponding & Ground Floor Inundation** Low point in road. Ponding and inundation of 126 Queen St reported.

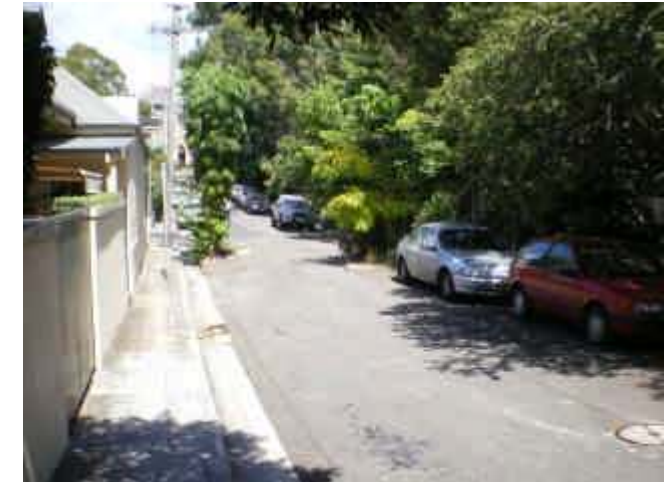
4. **Ponding & Flow Diversion** Low point in intersection forcing water through park to the right in picture

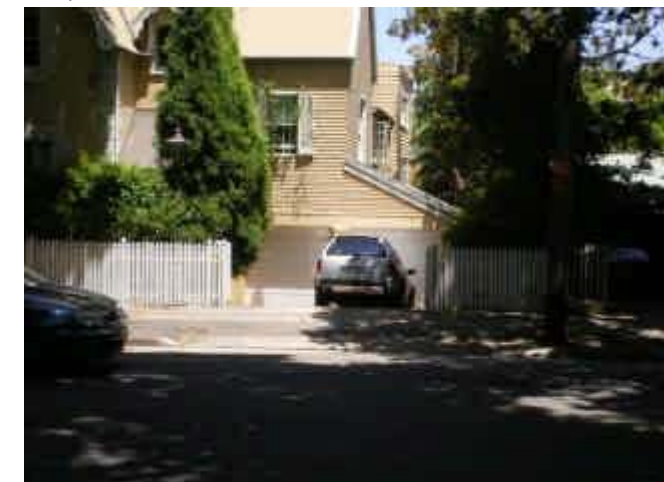
8. **Garage Below Road** Ocean St

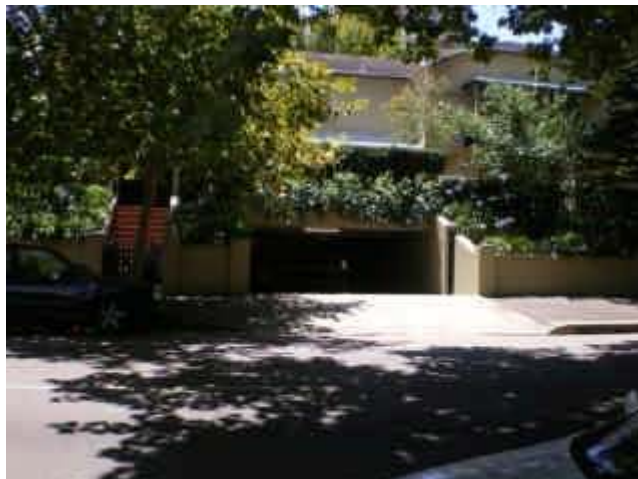
9. **Garage Below Road** Ocean St

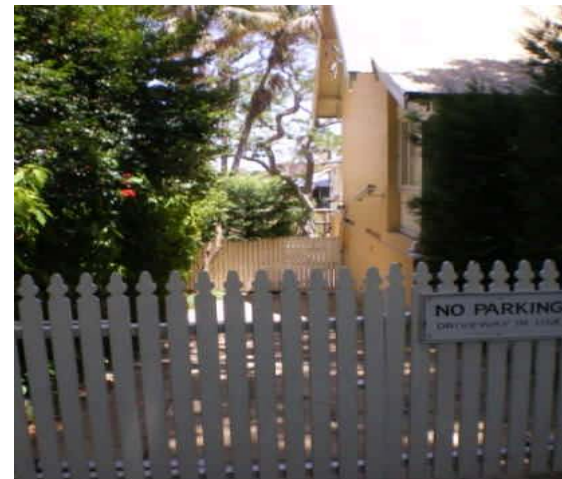
10. **Other** Backyard or other properties at rear of building on Ocean St possibly inundated

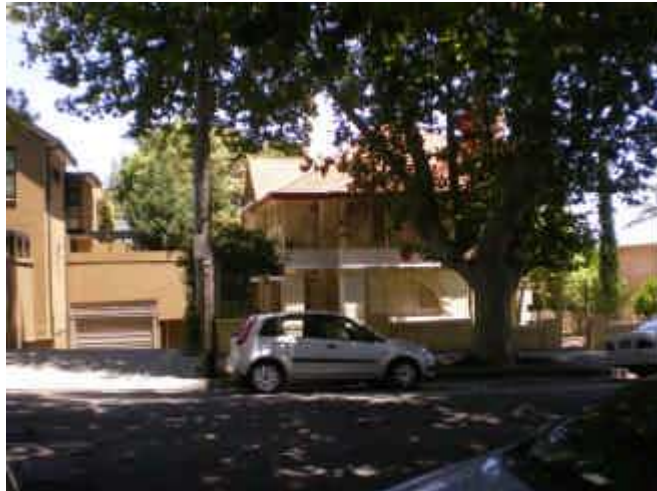
13. **Garage Below Road** Ocean St

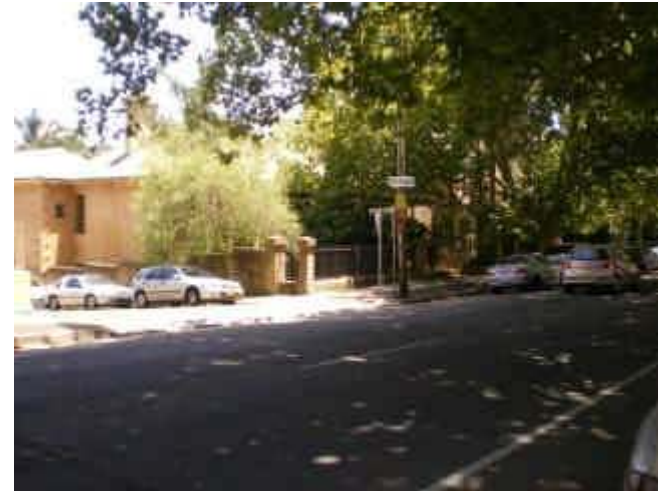
14. **Flow Diversion** Possible flow diversion into Tara St from Ocean St, which carries 1-2m<sup>3</sup>/s.

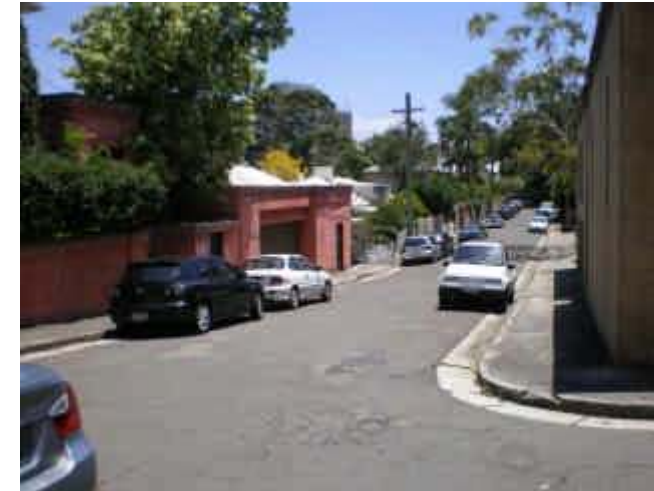
15. **Ponding** Low point in Tara St

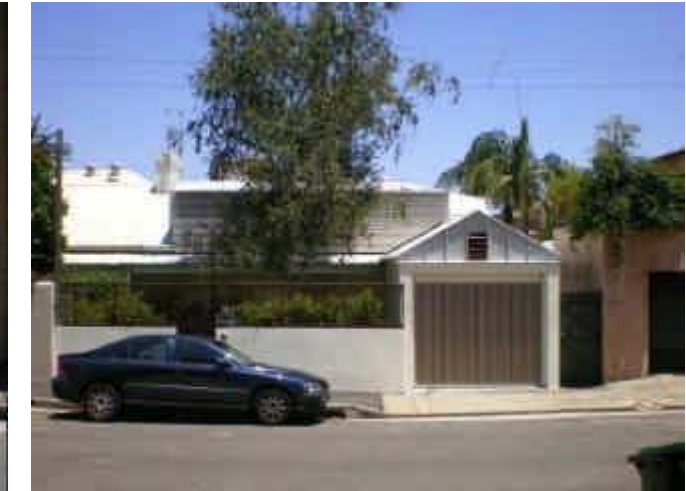
16. **Flow Diversion** Previously inundated above floor level, but fence and garage now in place to divert flow

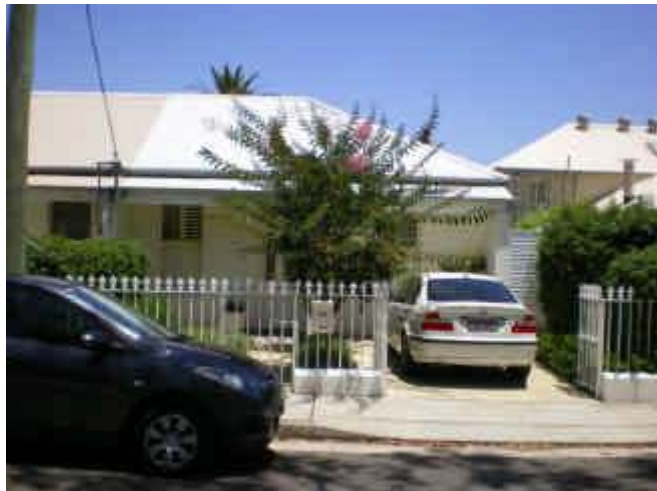
17. **Ground Floor Inundation** Example of surrounding properties that may now be at risk of inundation.

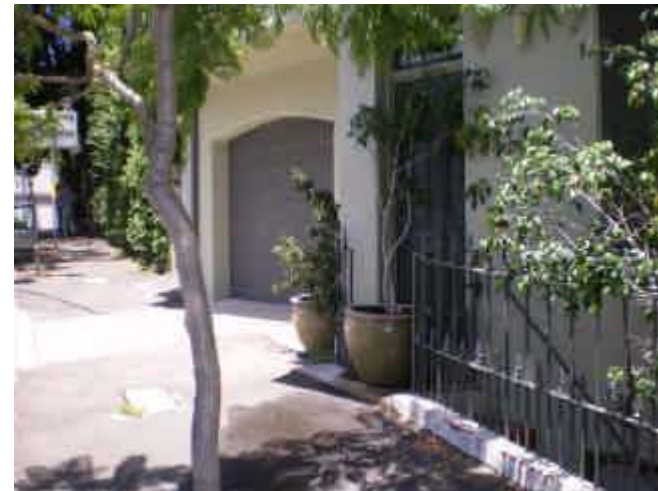
18. **Floor Below Road** Quarry St

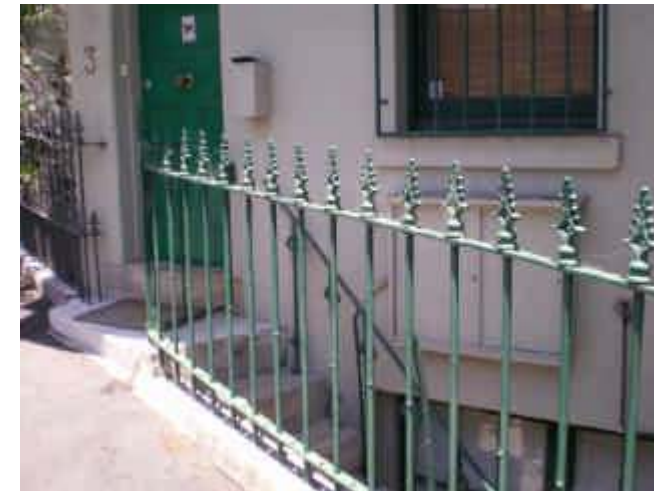
19. **Floor Below Road** Quarry St

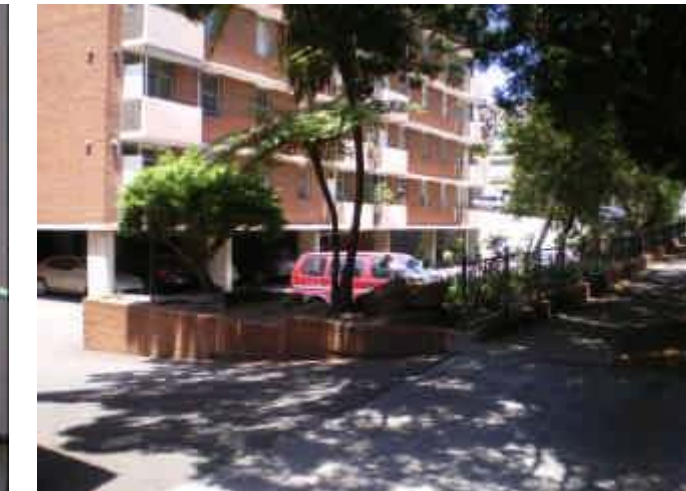
20. **Garage Below Road** Rear of 204 Jersey Rd

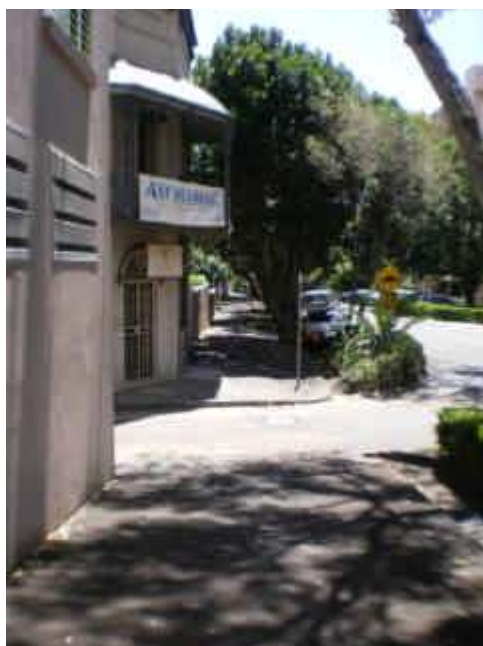
21. **Ponding & Ground Floor Inundation** Possibly property inundation, but the building is being refurbished

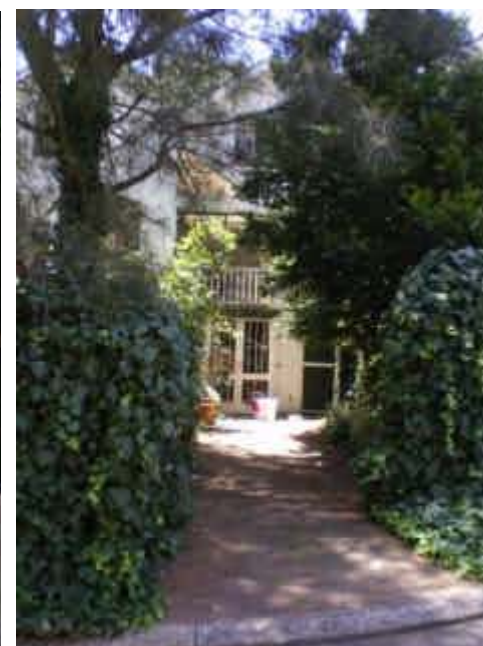
23. **Ground floor Inundation** Example of property at risk at Sutherland Ave

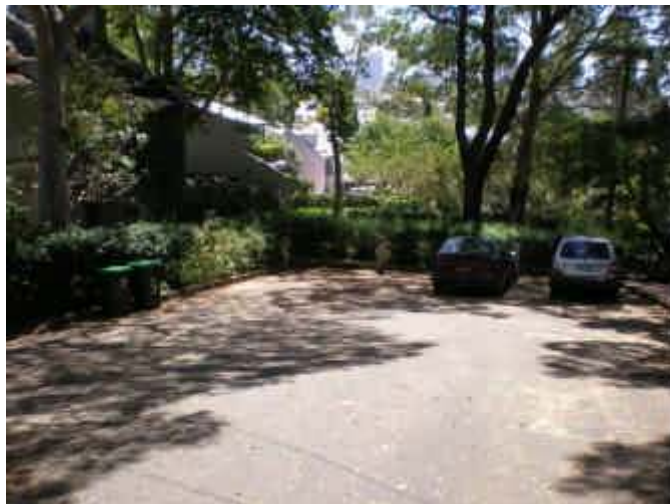
29. **Ponding & Flow Diversion** Upper part of Harris Street. Possible flow path (see 30) to left in picture

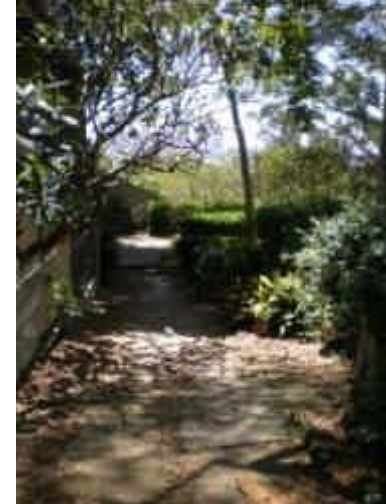
30. **Flow Diversion** Possible flowpath to lower Harris Street

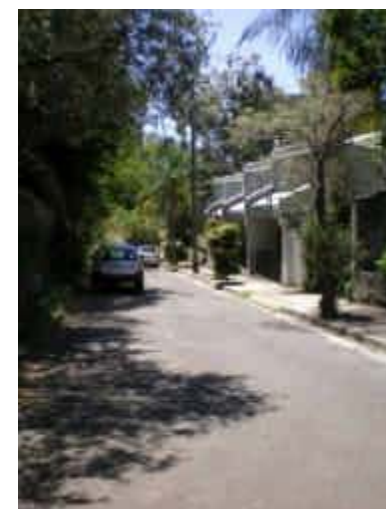
34. **No Flow Path** Ponding and possibly floor inundation (see 116 for close up)

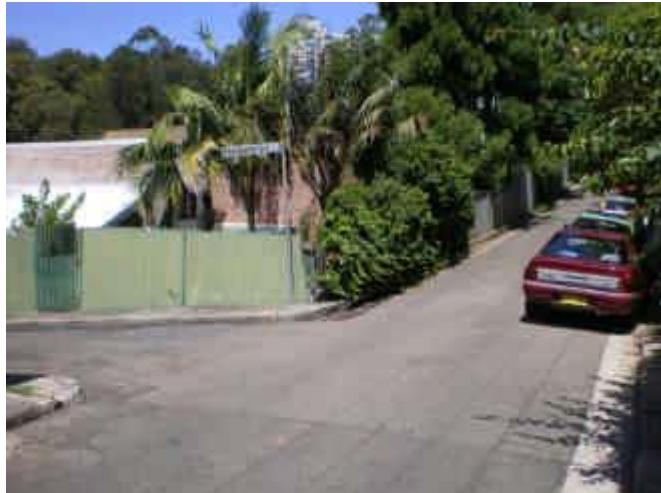
37. **Floor Below Road** Rear end of previous properties (Sutherland Ave). Walls/fences offers protection from inundation to varying extent

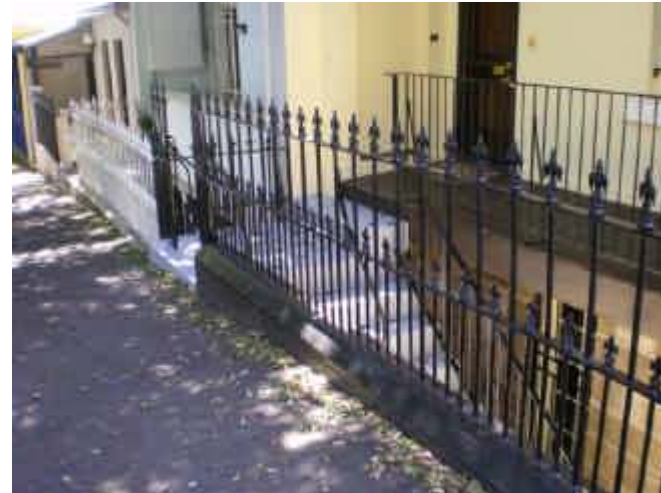
38. **Floor Below Road** One of several properties potentially inundated on Sutherland St

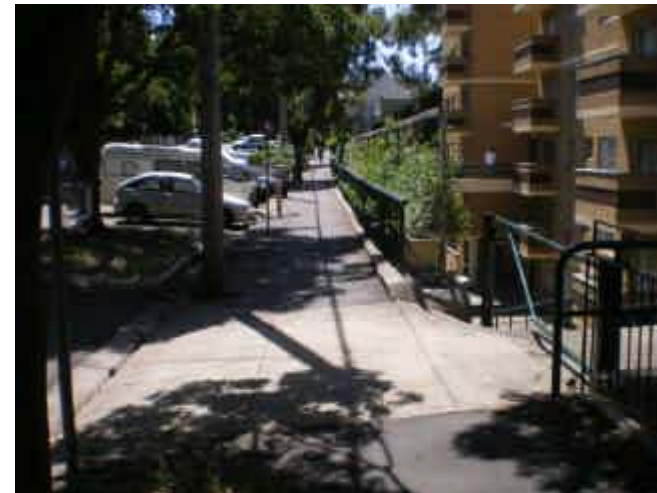
39. **Ponding & Floor Below Road** Low point in road

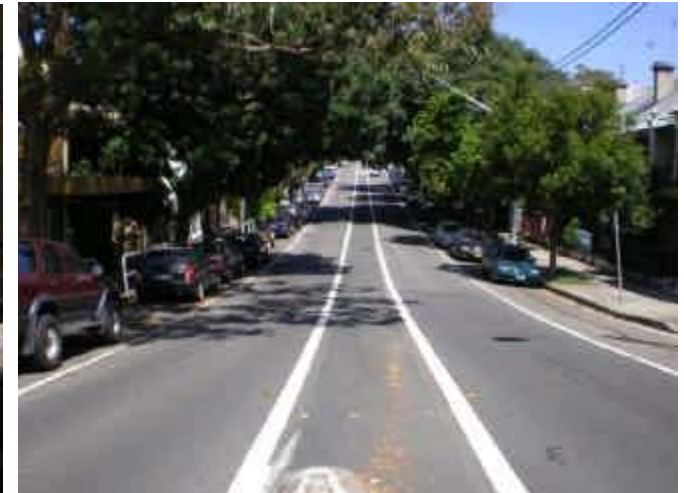
40. **Ponding** Low point in Hargrave St.

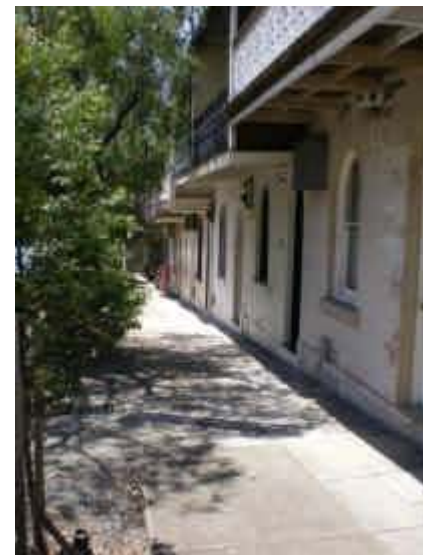
42. **Ground Floor Inundation** Possibly floor inundation due to large flow on Hargrave St (5-10 m<sup>3</sup>/s).

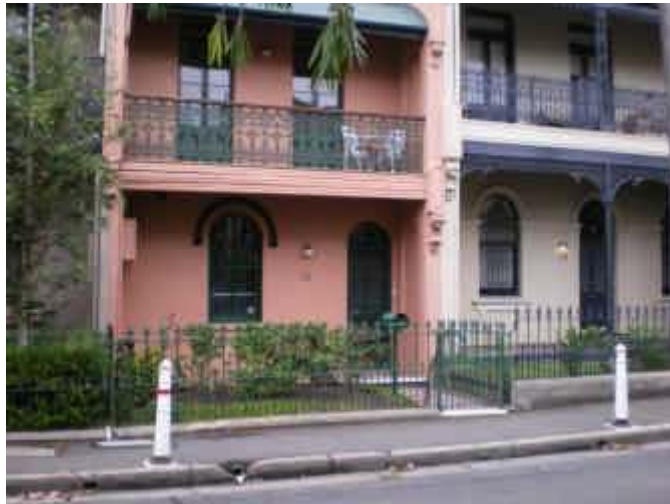
49. **Ground Floor Inundation** Example of house at risk of being inundated.

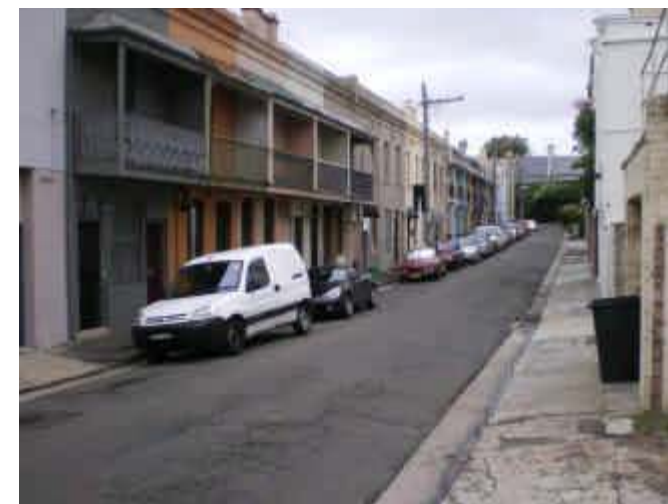
51. **Ground Floor Inundation** Example of house at risk of being inundated.

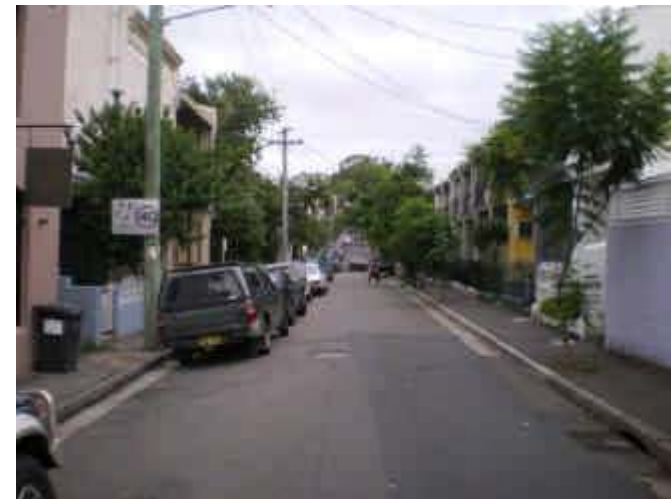
54. **Ponding & Floor Below Road** Low point in Underwood St(see 55).

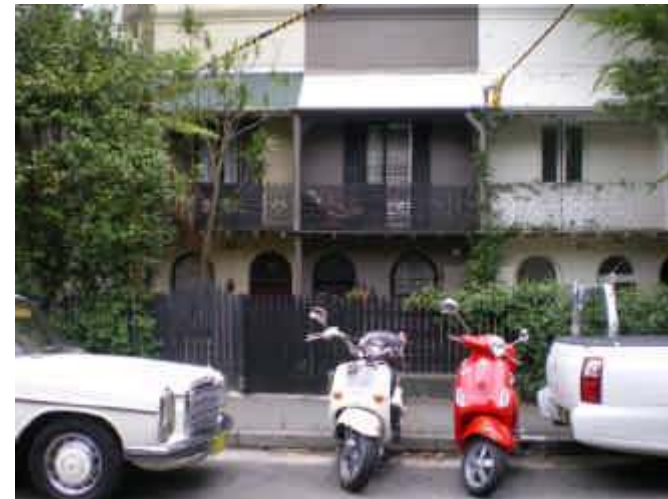
55. **Floor Below Road** Example of properties at risk of being inundated.

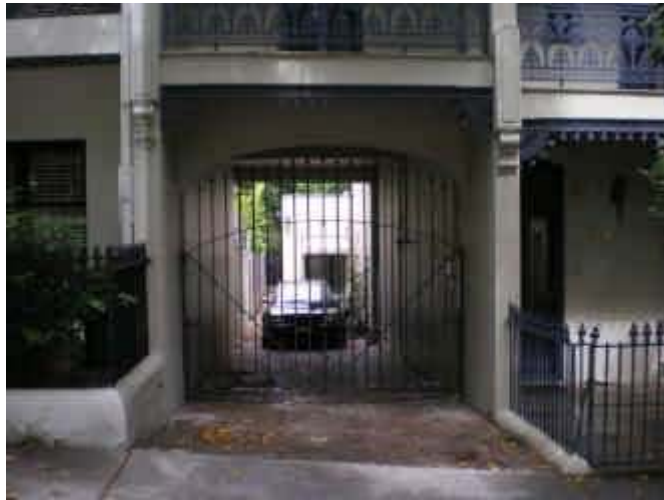
61. **Garage Below Road & Floor Below Road** On Campbell Ave

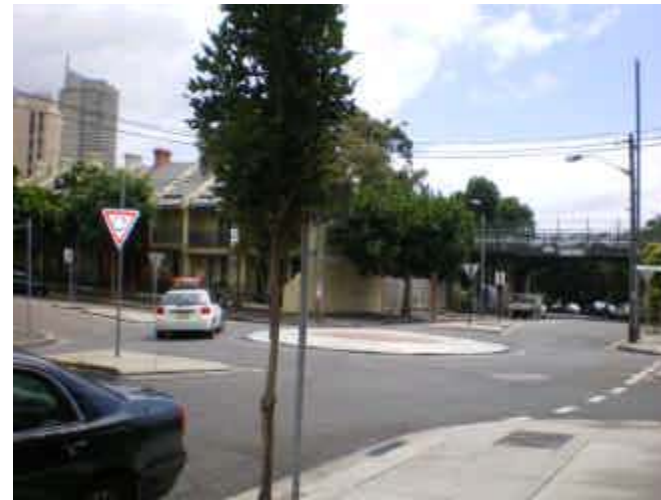
62. **Ponding** Intersection Campbell ave\Boundary St

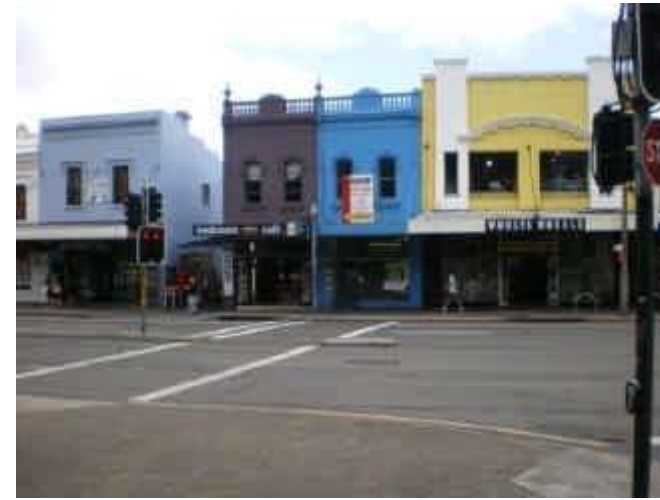
63. **Ponding & Ground Floor Inundation** Low point in Oxford St

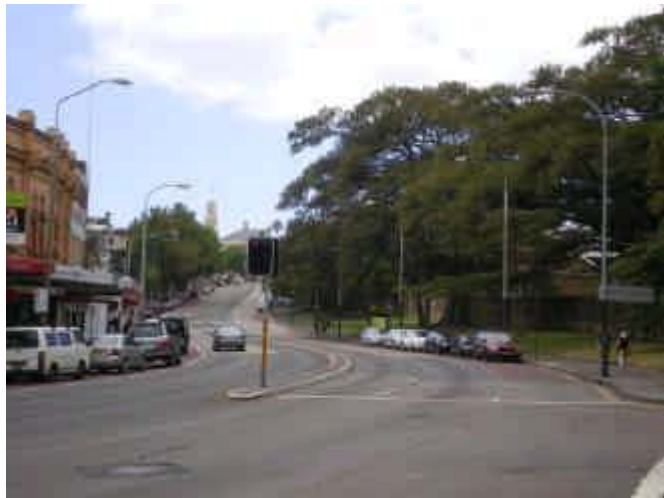
65. **Ponding** Low point in Oxford St. Footpath reported to have been flooded previously

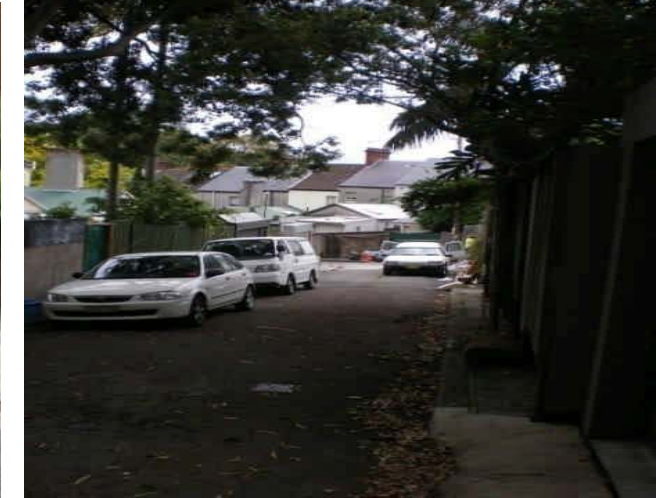
68. **Flow Diversion** Possible flow path from Liverpool St through Boundary Ln to Boundary Street

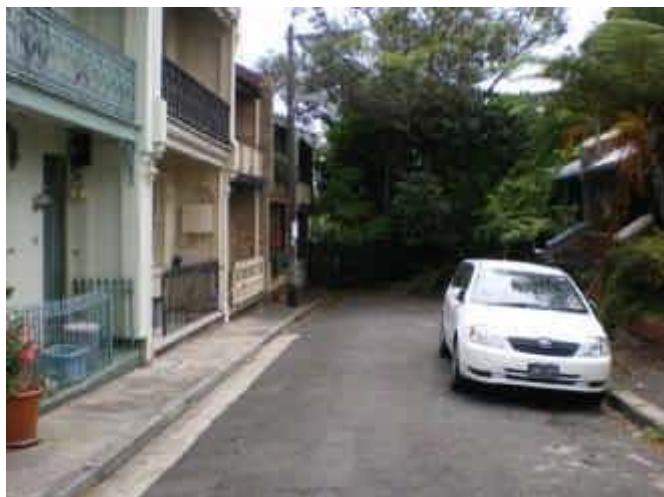
69. **No Flow Path** Ponding and possibly floor inundation will occur at the northern end of Prospect St.

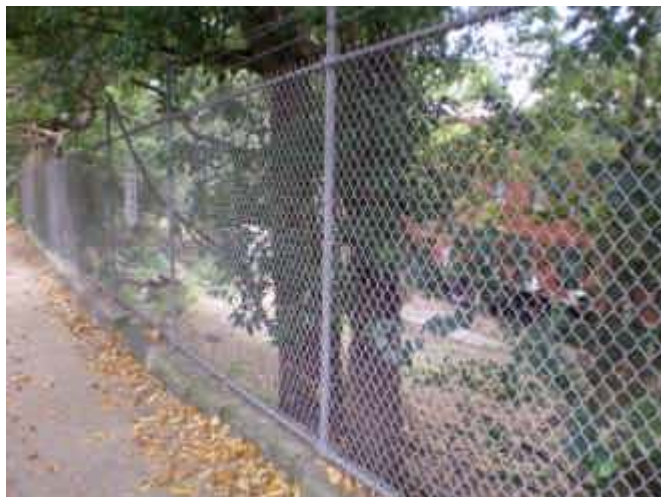
70. **Garage Below Road** The hospital car park could potentially be inundated by waters from Brown St.

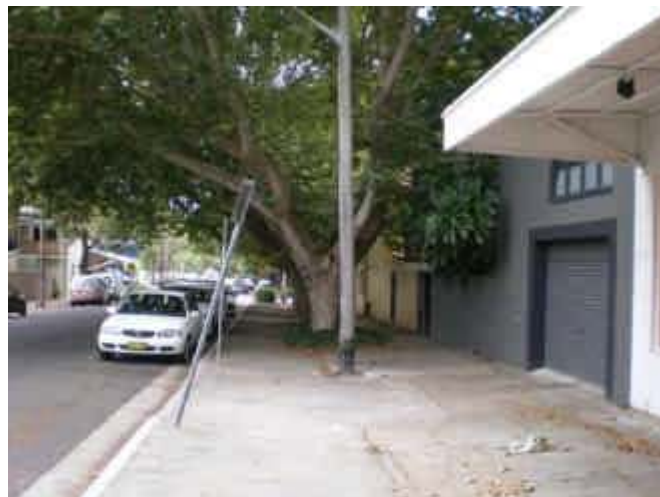
71. **Ponding** Footpath lower than road

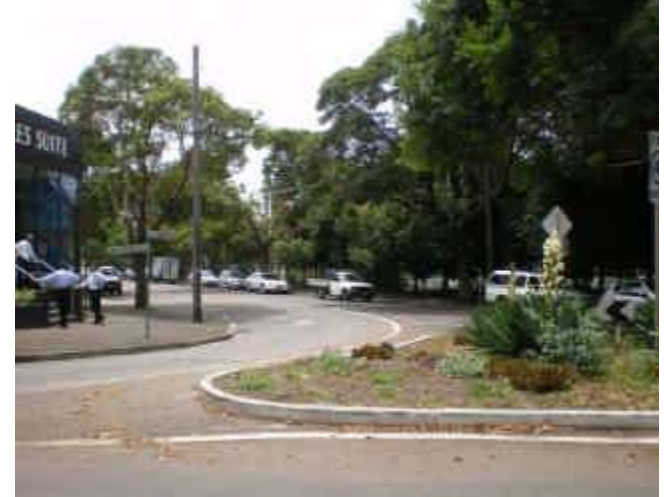
72. **Ponding** Intersection Boundary St\Nield Ave

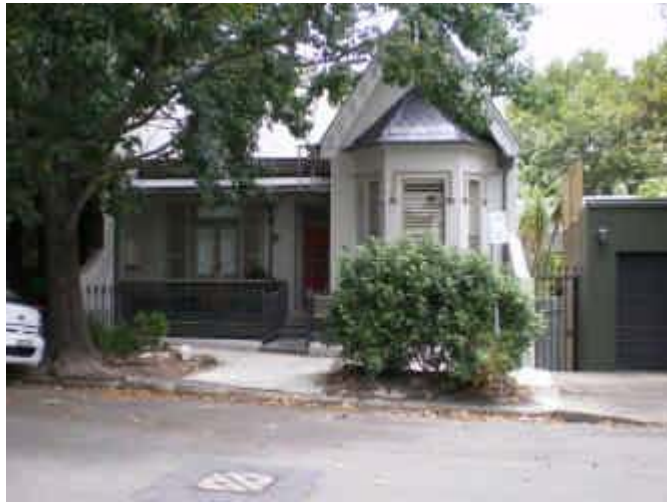
73. **Floor Below Road** Example of property at risk of being inundated.

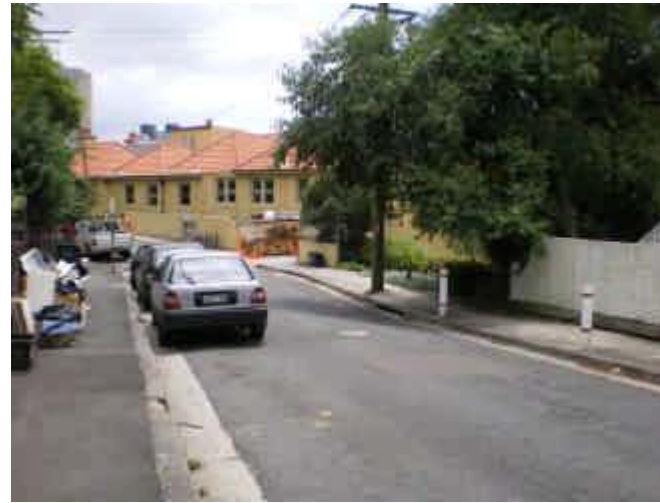
75. **Ponding** Low point in Cooper St. Water may flow into the reserve and down to Stephen St.

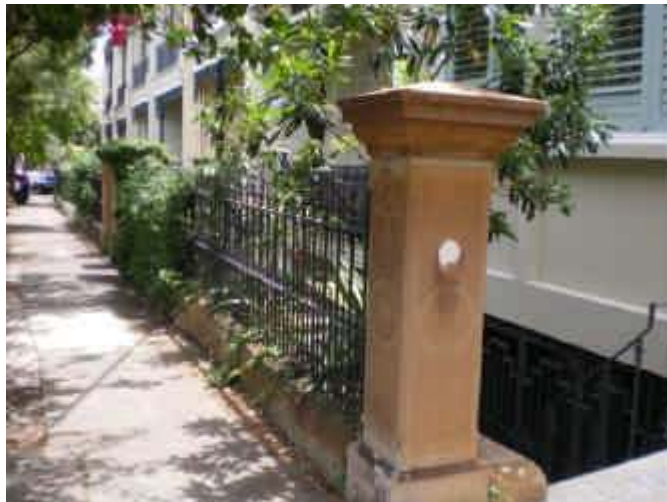
77. **Floor below Road** Example of property on Glenmore Rd at risk of being inundated.

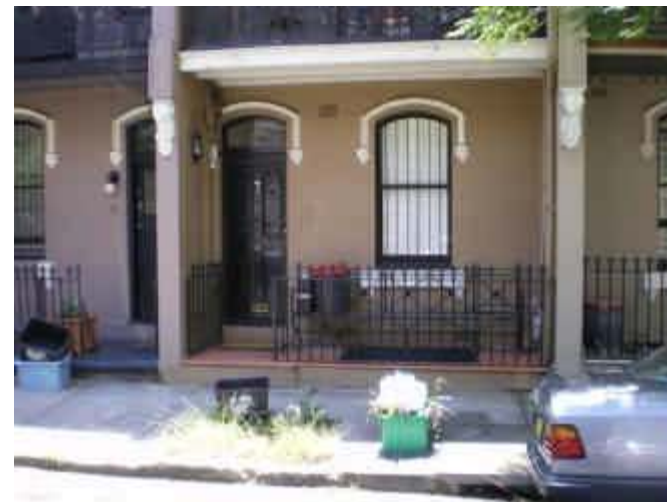
78. **Ponding & Ground Floor Inundation** Example of property at risk of being inundated due to ponding at a low point in Olive St. However, only seepage reported though

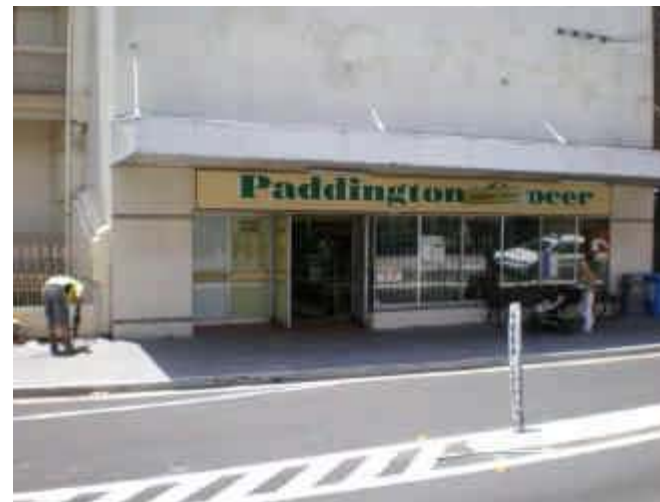
79. **Ponding & Ground Floor Inundation** Low point in Glenmore Rd.

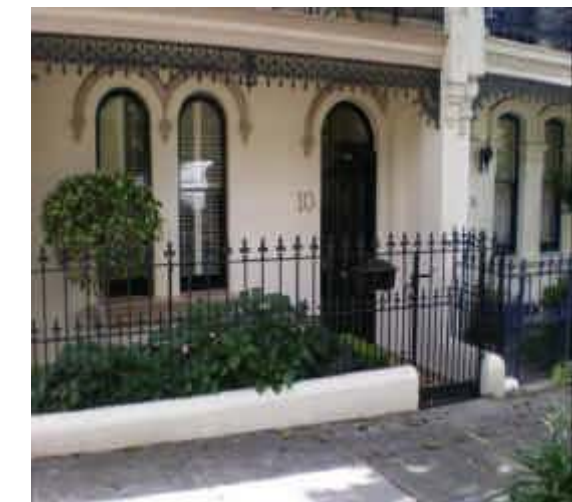
80. **Ground Floor Inundation** Example of property on Duxford St at risk of being inundated.

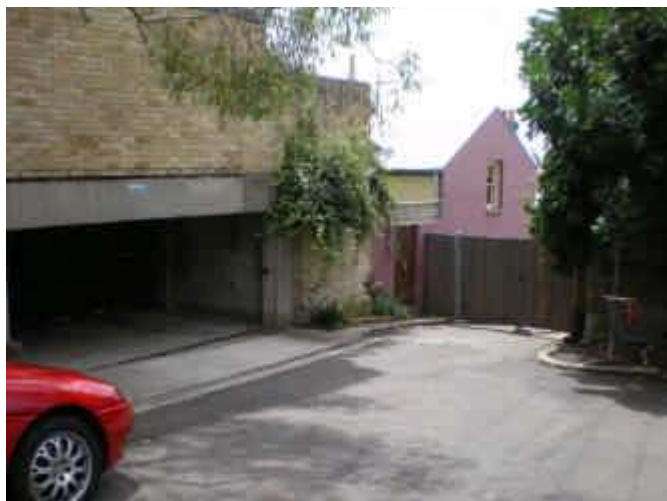
81. **Ponding** Gates blocking flow path down Bennetts Grove Ave

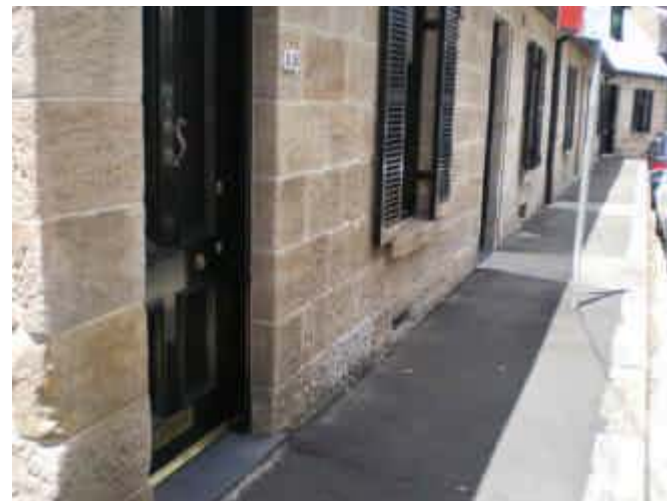
82. **Ground Floor Inundation** Properties at risk of being inundated on Underwood St.

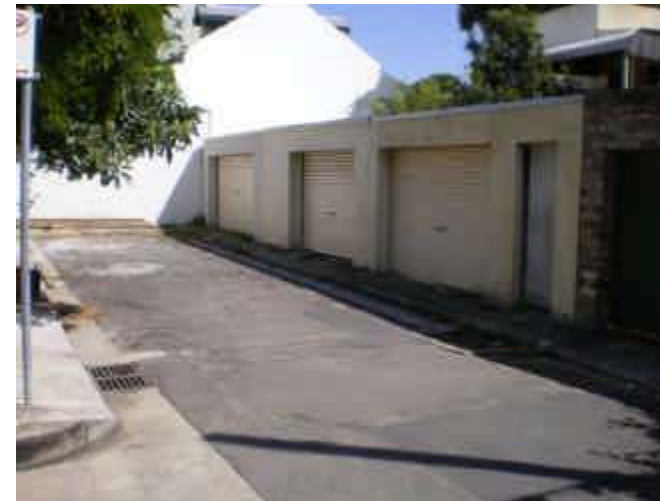
83. **No Flow Path** Ponding in Ashton Lane

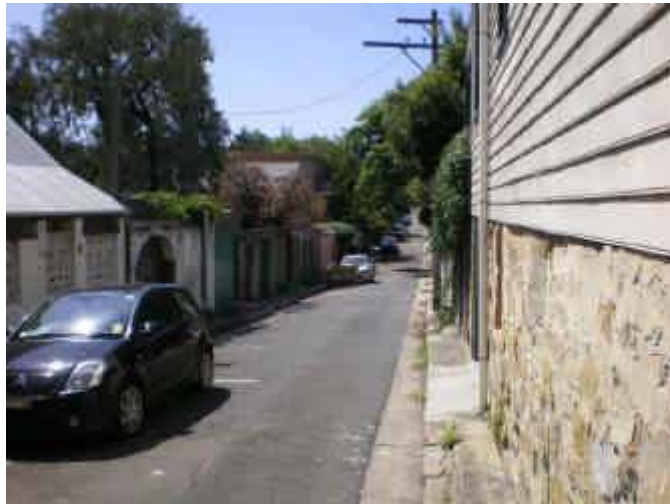
85. **Ponding** Hargrave Ln low point.

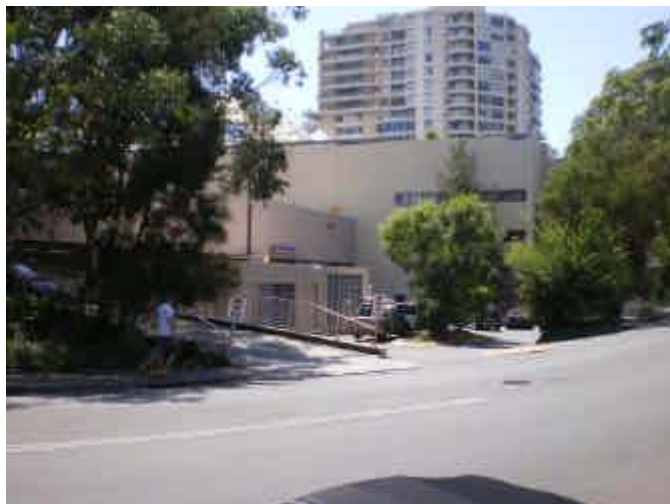
89. **Garage Below Road** Aldi car park/loading area at risk of being flooded

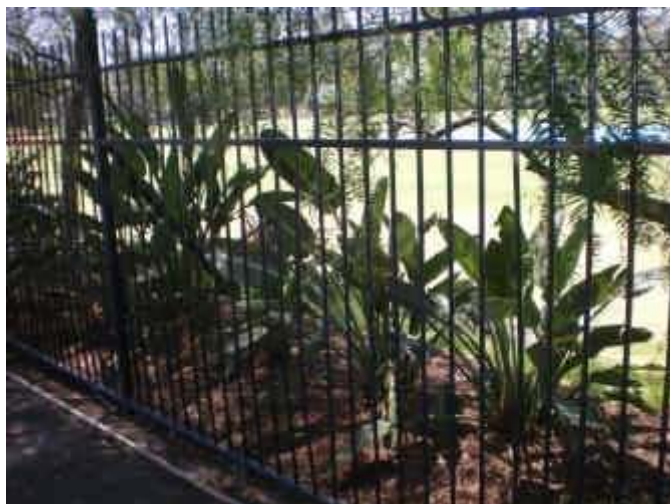
93. **Flow Diversion** Water could enter to the sportsground from Nield Ave

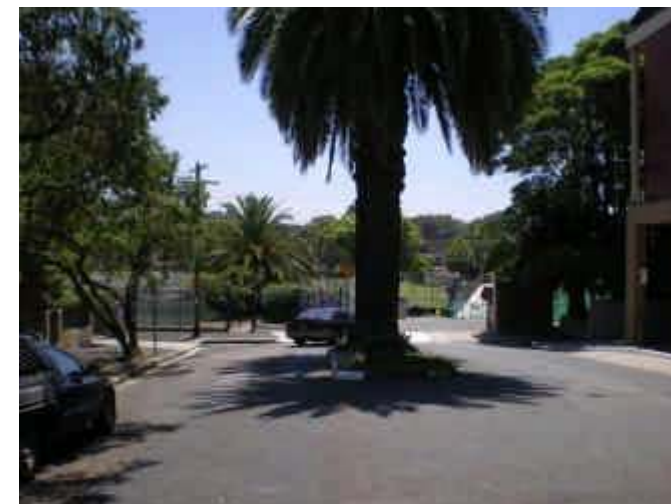
95. **Ponding** Potentially flow from Alma St will pond at the end and inundate the sportsground and the tennis club parking space.
