**FLOODING/DRAINAGE ISSUES IDENTIFIED FROM FIELD INSPECTION**

FIGURE B2  
LISTING OF FLOODING/DRAINAGE ISSUES

FIGURE B3a  
**REPORTED ISSUES BUT NOT INCLUDED IN FIELD INSPECTION**

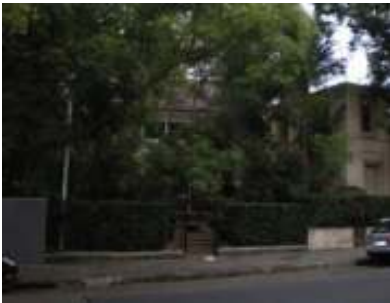
**John St near Ocean St** Localized drainage problems

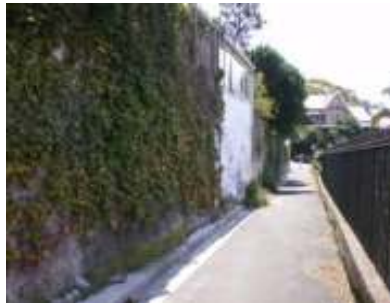
**14, 28, and 30 Windsor St** Rear

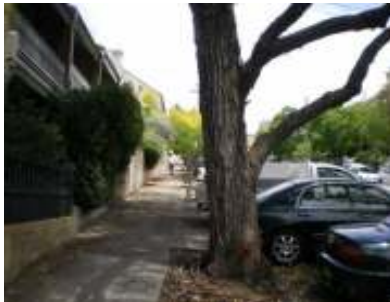
**Goodhope St** Flows to a depth of 0.15m on footpath reported. According to model no flow, but possibly up to 10m<sup>3</sup>/s.

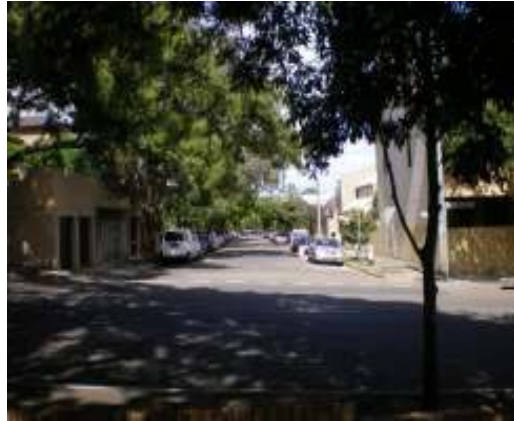
**John St near Ocean St** Localized drainage problems.

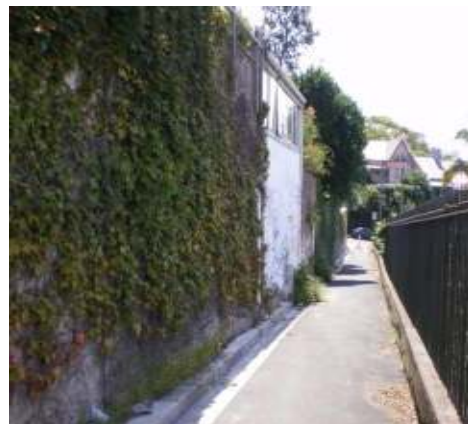
**14, 28, and 30 Windsor St** Rear

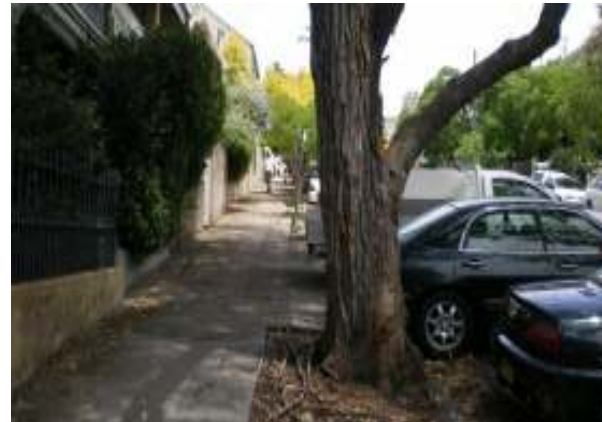
**Goodhope St** Flows to a depth of 0.15m on footpath reported. According to model no flow, but possibly up to 10m<sup>3</sup>/s.

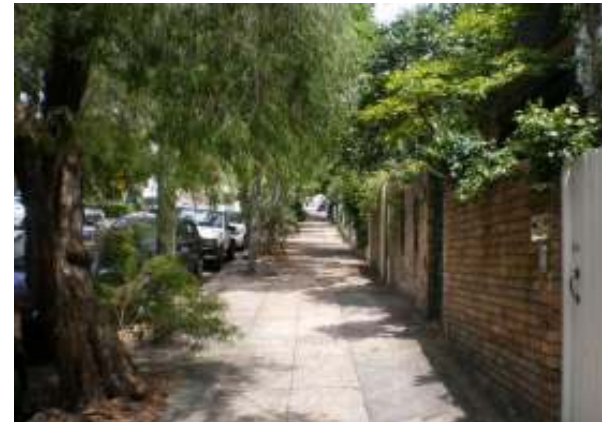
**440 and 450 Glenmore Rd** Above floor flooding reported, but no clear reason found.

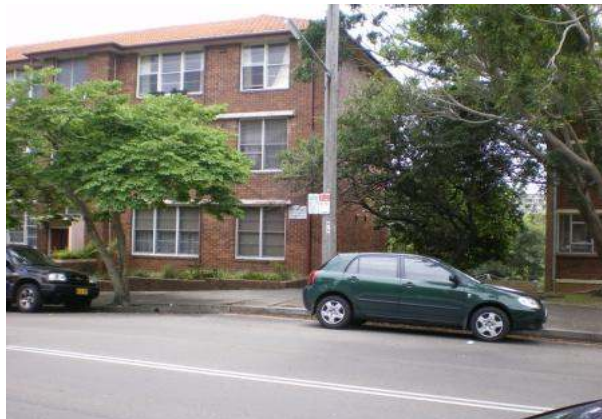
**29 Lawson St** Above floor level inundation reported, but no potential flows causing it could be found.

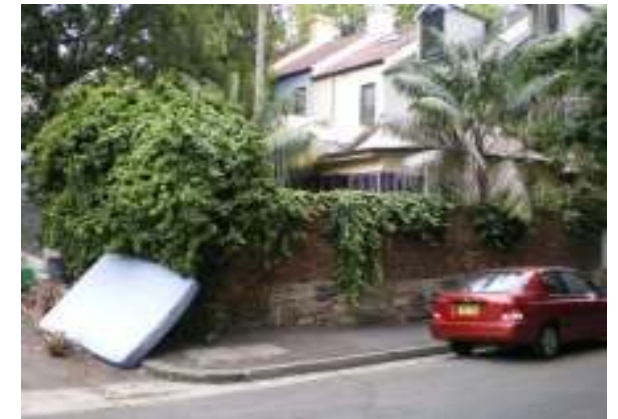
**72 Brown St** Rising ground water reported after storm events (front and rear).

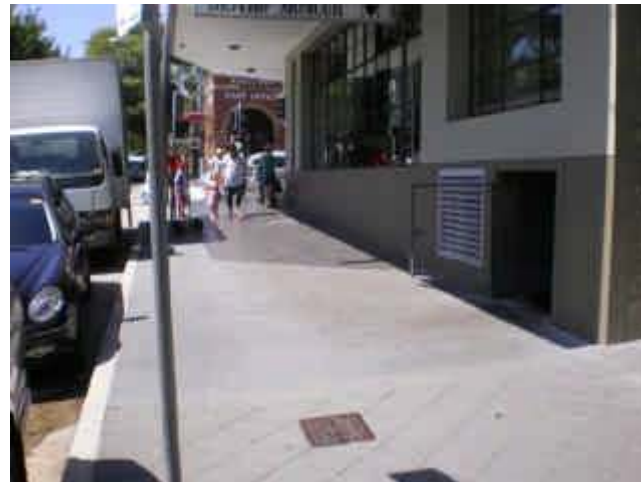
2. **Floor Below Road** Bar cellar door on Moncur St

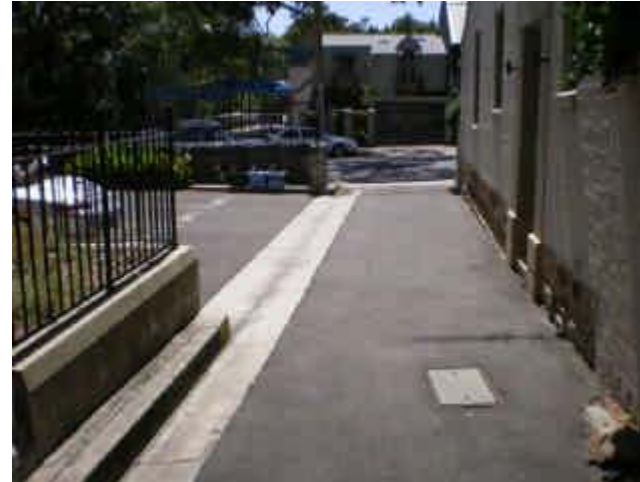
3. **Ponding** Localized flooding reported in Britannia Ln just off Moncur St

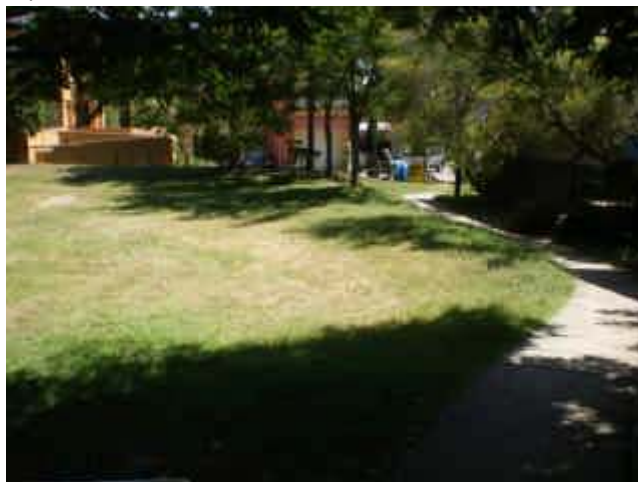
5. **Flow Diversion** Flowpath through park

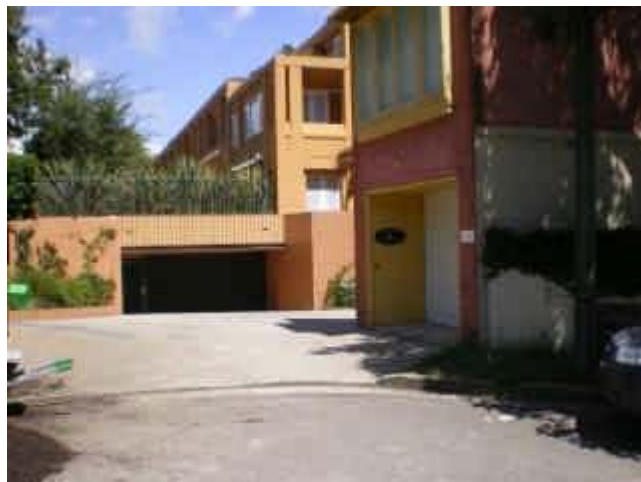
6. **Garage Below Road**

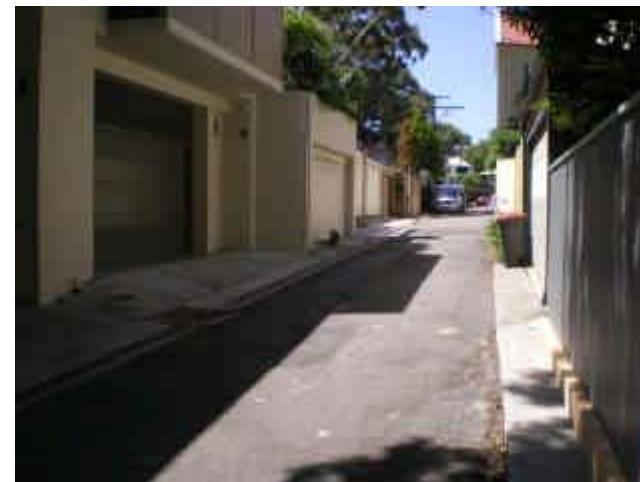
7. **Large Flow** Alley way to take 10-20m<sup>3</sup>/s

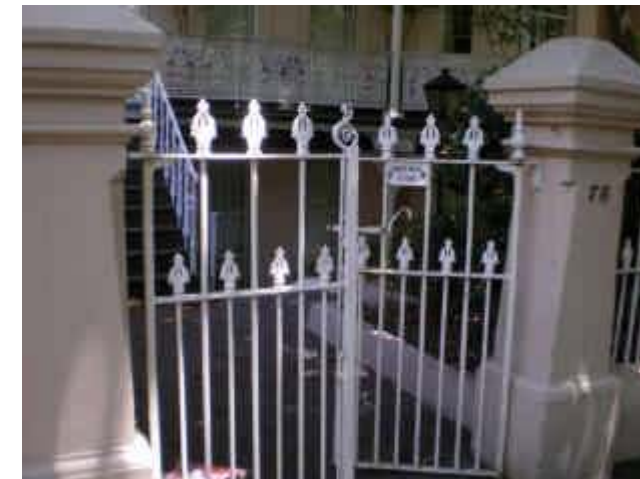
11. **Floor Below Road** Ocean St

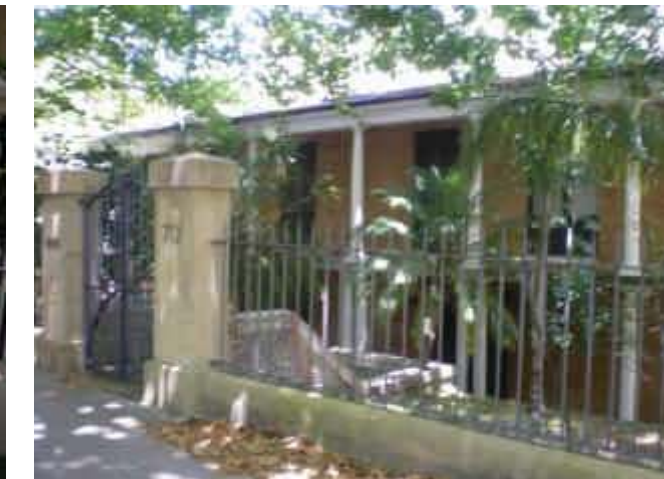
12. **Floor Below Road** Ocean St

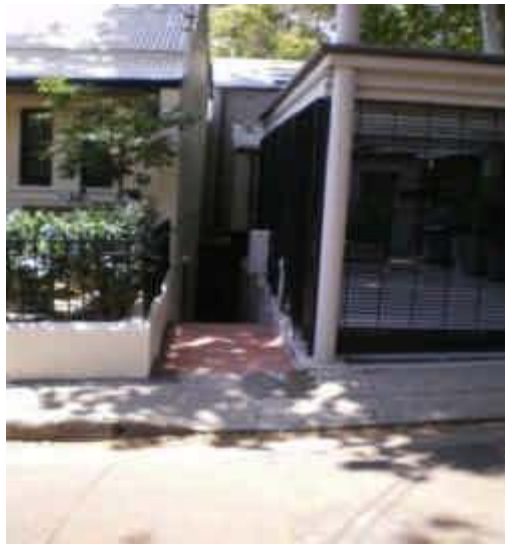
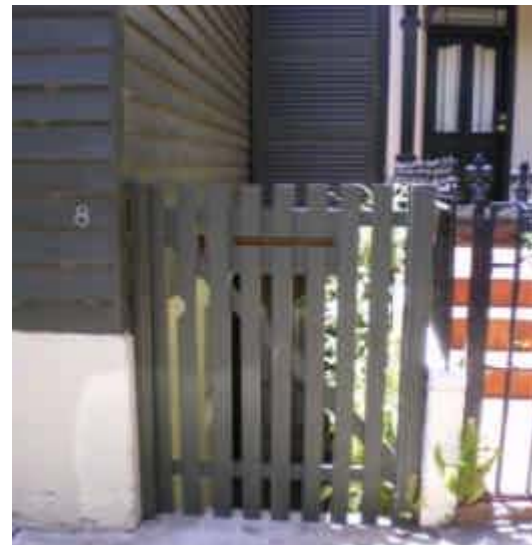
25 & 26. **Floor Below Road** Examples of several properties on Sutherland Avenue with floors lower than the road

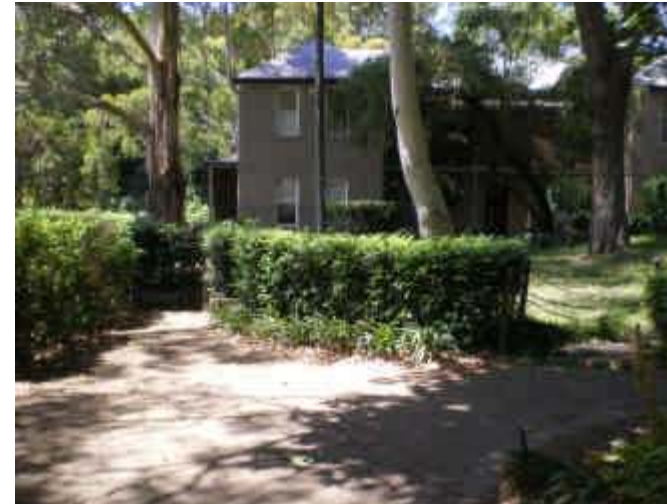
31. **Flow Diversion** Continued flow path

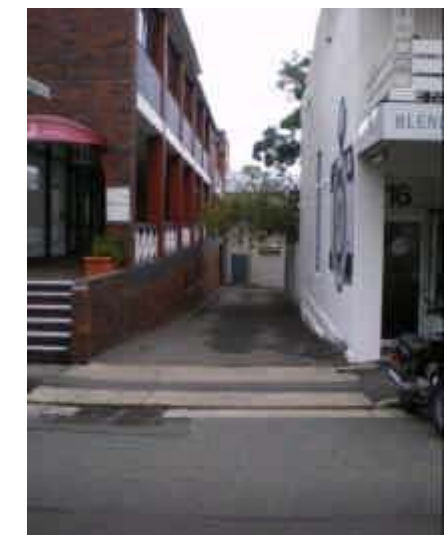
48. **Garage Below Road**

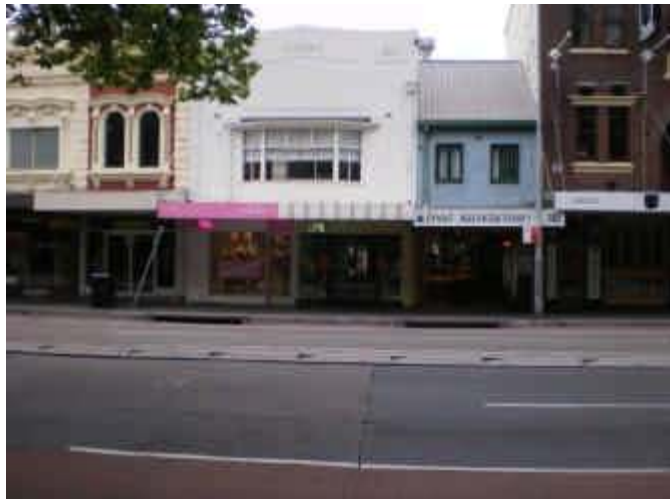
53. **Ground Floor Inundation** Example of properties at risk of being inundated.

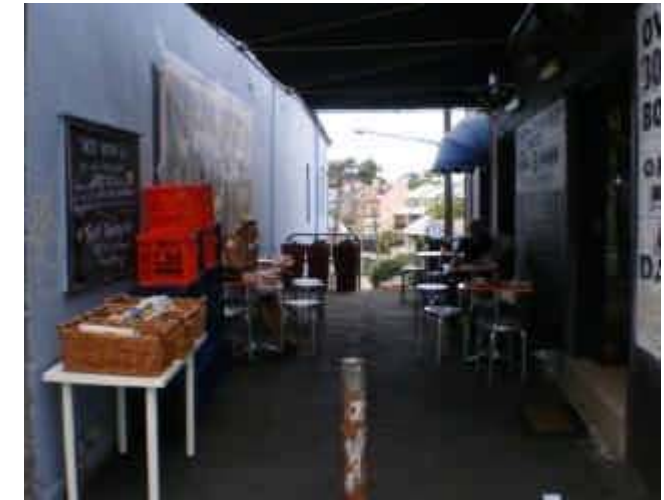
64. **Flow Diversion** Possible flow path off Oxford St through Kidman Ln

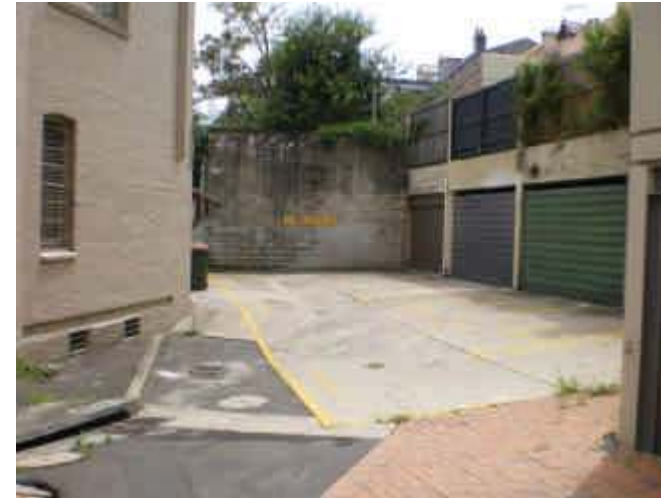
66. **No Flow Path** Downhill from Kidman Ln

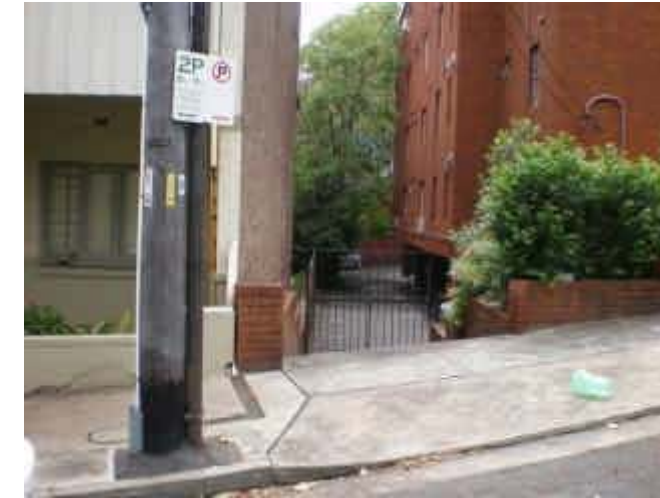
67. **Garage Below Road**

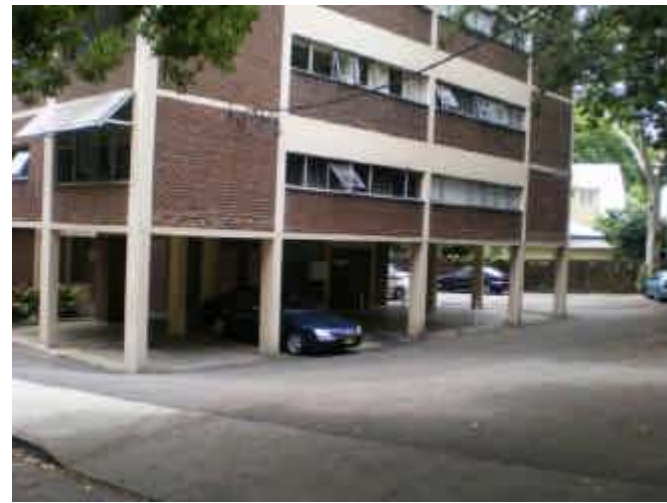
74. **Garage Below Road**

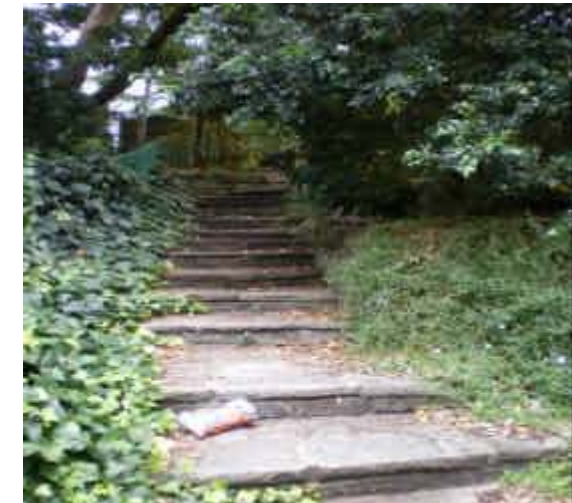
76. **Flow Diversion** Possible flow path from Cooper St to Stephen St

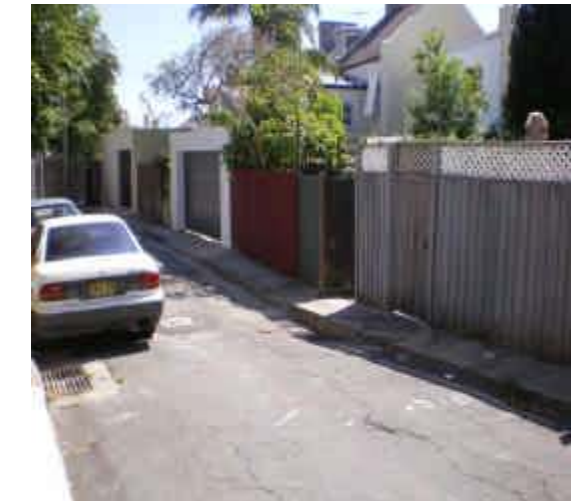
84. **Ponding** Hopetoun Ln low point.
